ASBESTOS SURVEY REPORT

(Refurbishment / Demolition Survey)

**Location: Council Depot,
Anglesea Terrace, Cork**

Report No. PE24-905

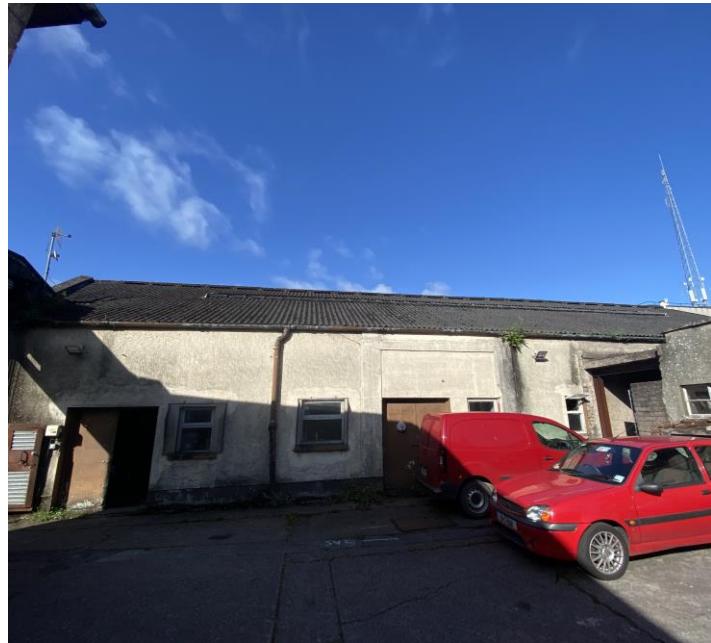
Created By	Andrew Hickey
Date	23rd August 2024
Site Details	Council Depot, Anglesea Terrace, Cork
Client Name	Land Development Agency
Survey Type	R/D Asbestos Survey
Site Ref	PE 24-905
Building Ref.	Building 1
Location	Roof
Extent/ Amount	360 m ² approx. floor area

MATERIAL ASSESSMENT		PRIORITY ASSESSMENT	
Product type	Cement sheeting	Normal occupant activity	N/A
Extent of damage	Weathered	Likelihood of disturbance	N/A
Surface treatment	None	Human exposure potential	N/A
Asbestos type	Chrysotile	Maintenance activity	N/A
Material assessment score: N/A		TOTAL SCORE: N/A	Priority assessment score: N/A

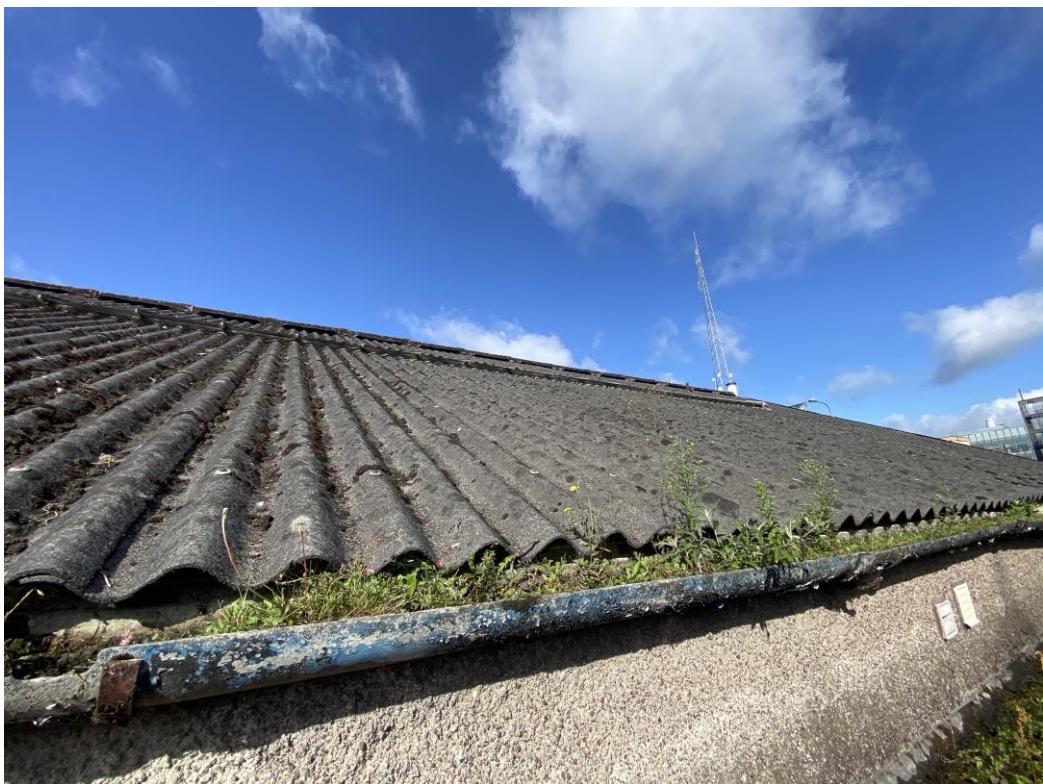
View of the asbestos cement sheeting externally

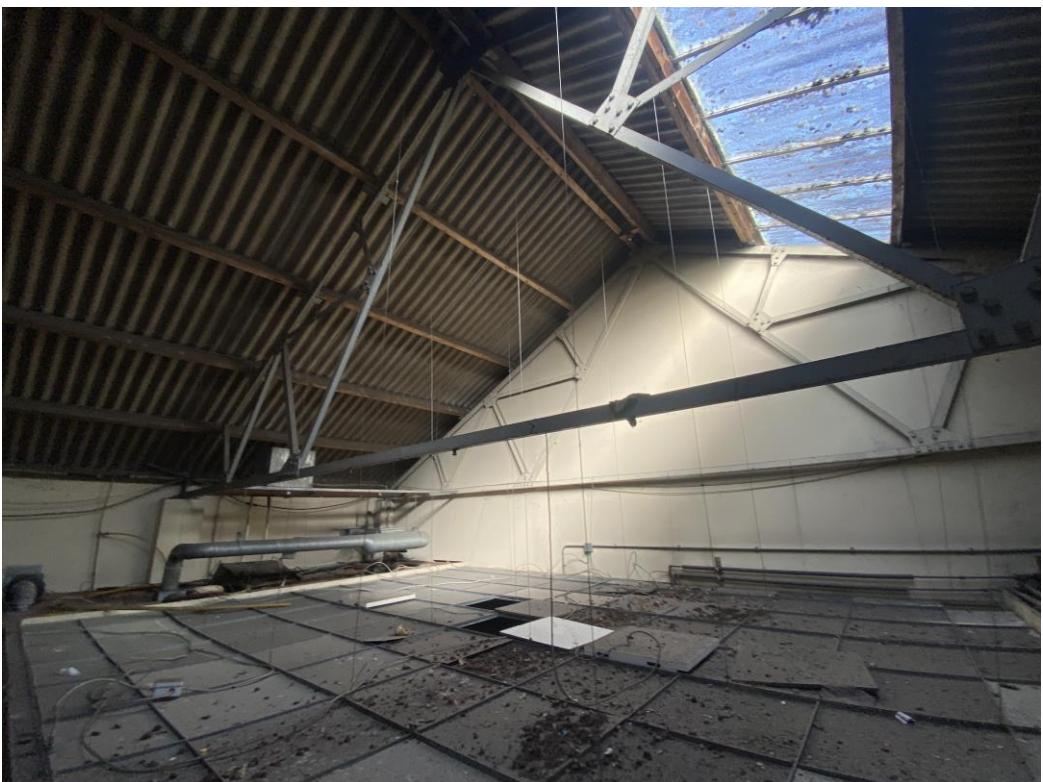
View of the asbestos cement sheeting internally

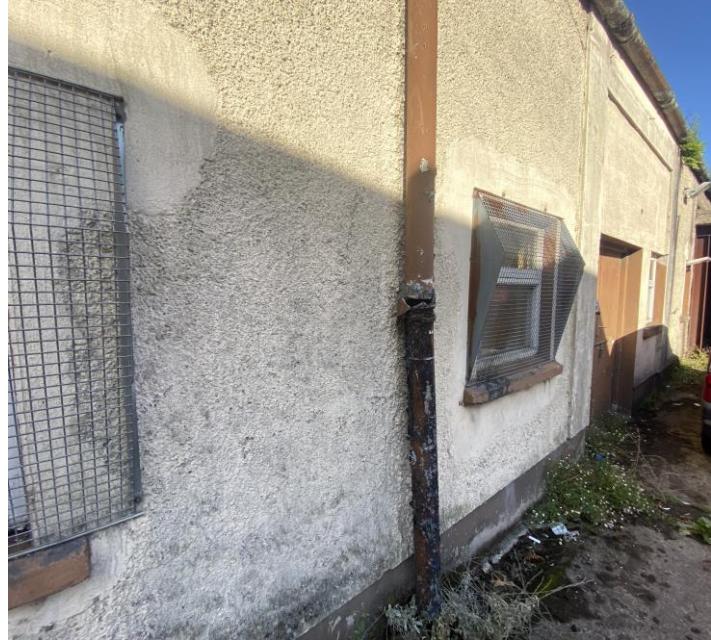
Created By	Andrew Hickey
Date	23rd August 2024
Site Details	Council Depot, Anglesea Terrace, Cork
Client Name	Land Development Agency
Survey Type	R/D Asbestos Survey
Site Ref	PE 24-905
Building Ref.	Building 1
Location	Perimeter of the building
Extent/ Amount	60 linear meters approx.

MATERIAL ASSESSMENT		PRIORITY ASSESSMENT	
Product type	Cement gutters and downpipes	Normal occupant activity	N/A
Extent of damage	Medium	Likelihood of disturbance	N/A
Surface treatment	None	Human exposure potential	N/A
Asbestos type	Chrysotile	Maintenance activity	N/A
Material assessment score: N/A		TOTAL SCORE: N/A	Priority assessment score: N/A

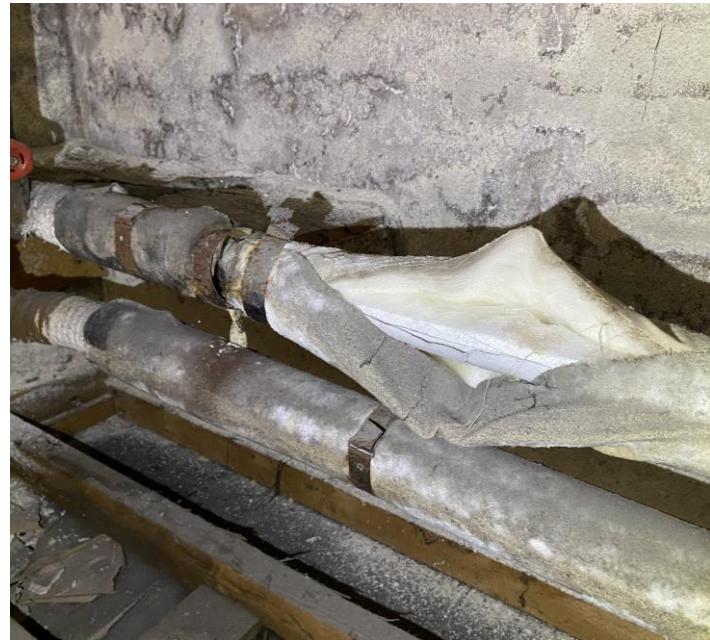
Created By	Andrew Hickey
Date	23rd August 2024
Site Details	Council Depot, Anglesea Terrace, Cork
Client Name	Land Development Agency
Survey Type	R/D Asbestos Survey
Site Ref	PE 24-905
Building Ref.	Building 1
Location	Attic
Extent/ Amount	15 linear meters approx. x 2

MATERIAL ASSESSMENT		PRIORITY ASSESSMENT	
Product type	Paper	Normal occupant activity	N/A
Extent of damage	Medium	Likelihood of disturbance	N/A
Surface treatment	None	Human exposure potential	N/A
Asbestos type	Chrysotile	Maintenance activity	N/A
Material assessment score: N/A		TOTAL SCORE: N/A	Priority assessment score: N/A

The paper insulation should be removed under controlled conditions by a specialist asbestos removal contractor and disposed of as asbestos waste before the demolition works commence

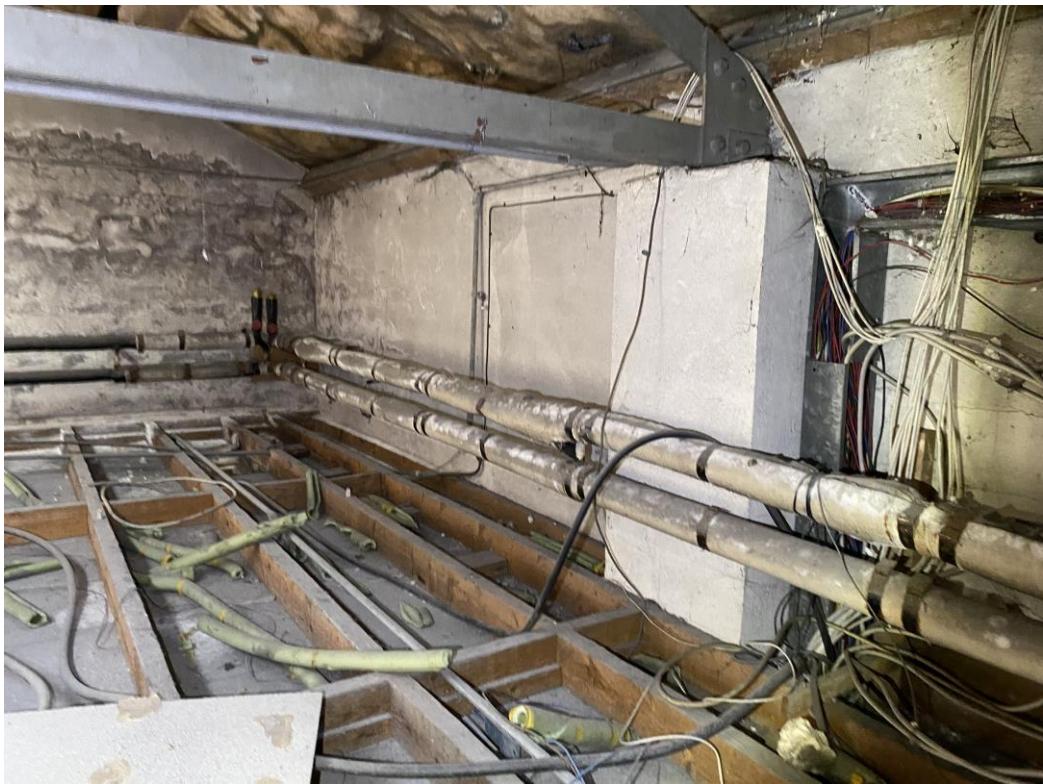
View of the two pipes in the attic area

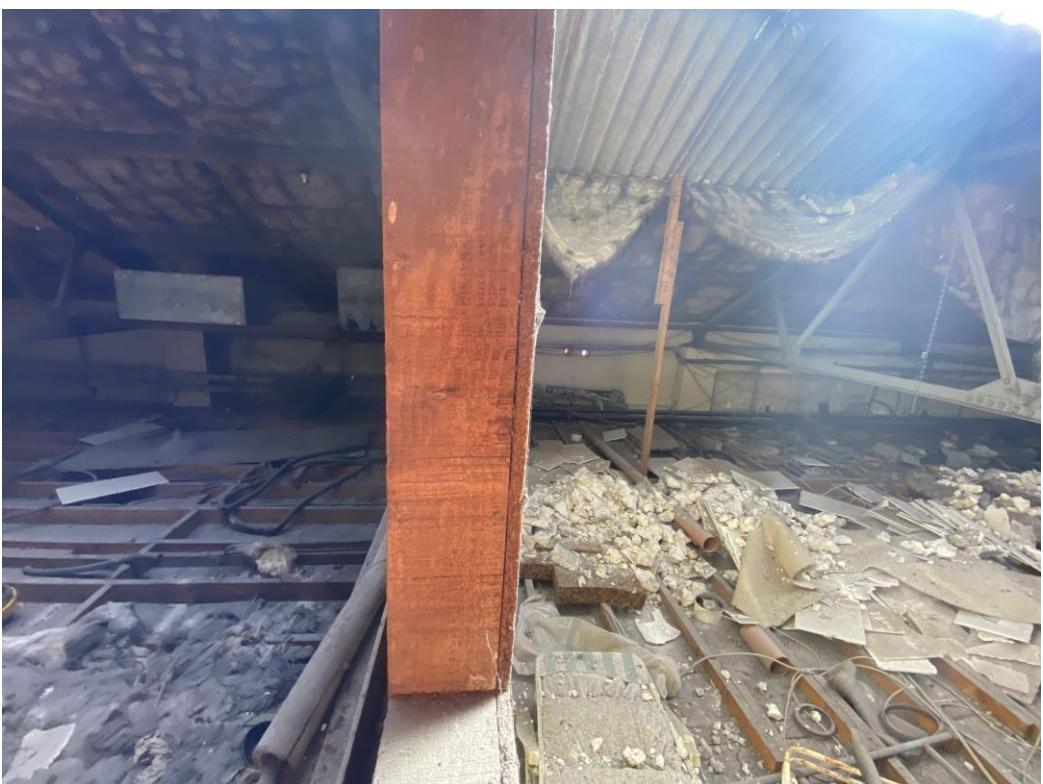
View of the pipe work on both sides of the partition in the attic

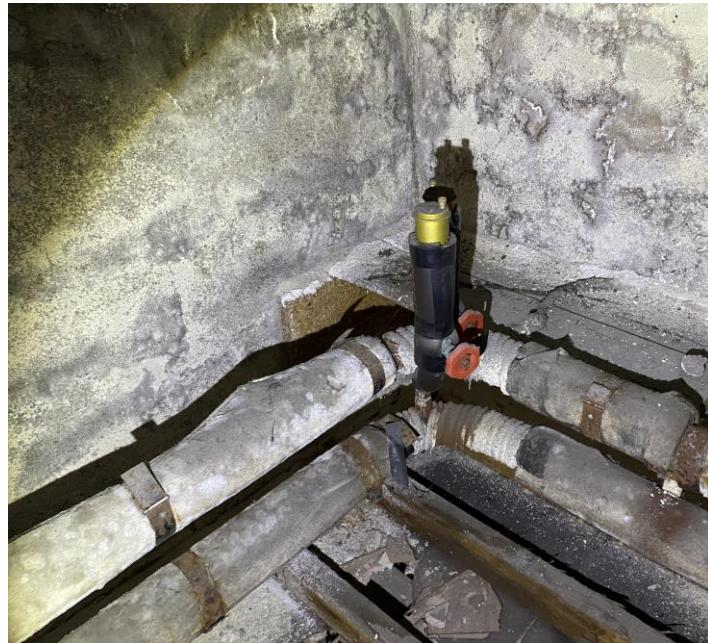
Created By	Andrew Hickey
Date	23rd August 2024
Site Details	Council Depot, Anglesea Terrace, Cork
Client Name	Land Development Agency
Survey Type	R/D Asbestos Survey
Site Ref	PE 24-905
Building Ref.	Building 1
Location	Attic
Extent/ Amount	On the pipework bends

MATERIAL ASSESSMENT		PRIORITY ASSESSMENT	
Product type	Rope insulation	Normal occupant activity	N/A
Extent of damage	Medium	Likelihood of disturbance	N/A
Surface treatment	None	Human exposure potential	N/A
Asbestos type	Chrysotile	Maintenance activity	N/A
Material assessment score: N/A		TOTAL SCORE: N/A	Priority assessment score: N/A

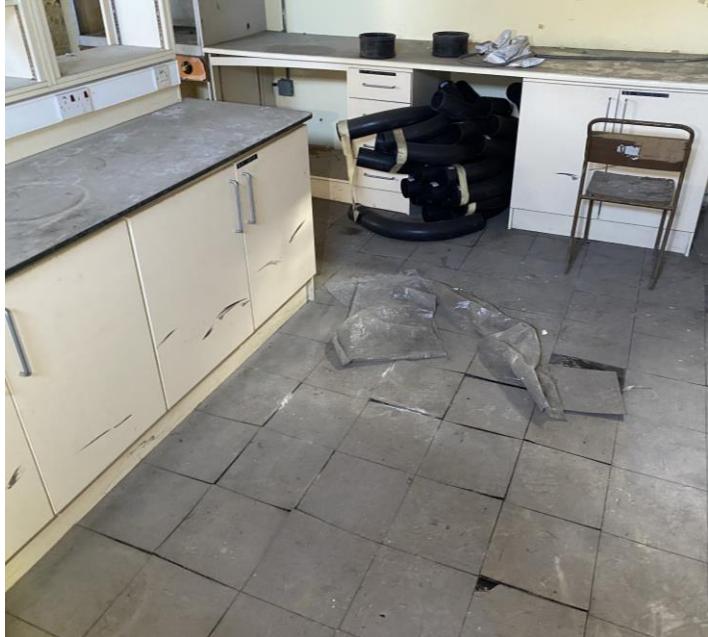
Created By	Andrew Hickey
Date	23rd August 2024
Site Details	Council Depot, Anglesea Terrace, Cork
Client Name	Land Development Agency
Survey Type	R/D Asbestos Survey
Site Ref	PE 24-905
Building Ref.	Building 1
Location	The lab area of the building
Extent/ Amount	85 m ² total approx.

MATERIAL ASSESSMENT		PRIORITY ASSESSMENT	
Product type	Bitumen adhesive	Normal occupant activity	N/A
Extent of damage	High	Likelihood of disturbance	N/A
Surface treatment	Well bound material	Human exposure potential	N/A
Asbestos type	Chrysotile	Maintenance activity	N/A
Material assessment score: N/A		TOTAL SCORE: N/A	Priority assessment score: N/A

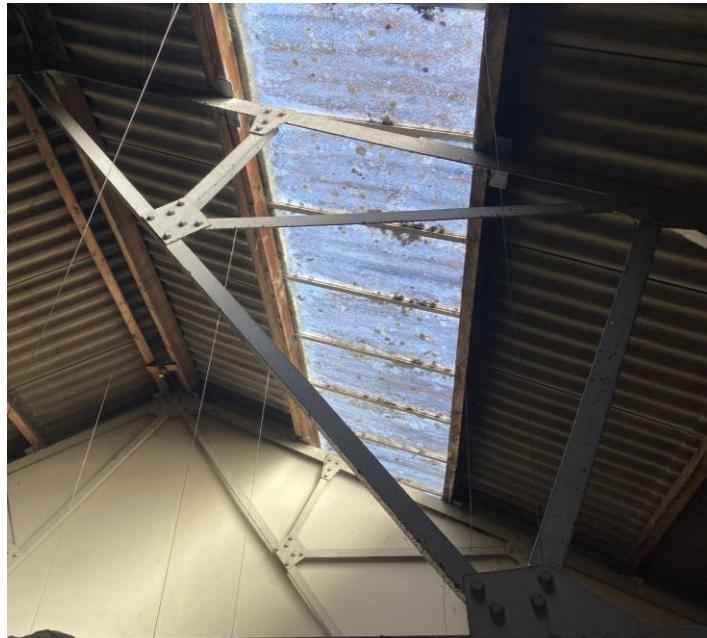
Created By	Andrew Hickey
Date	23rd August 2024
Site Details	Council Depot, Anglesea Terrace, Cork
Client Name	Land Development Agency
Survey Type	R/D Asbestos Survey
Site Ref	PE 24-905
Building Ref.	Building 1
Location	Roof
Extent/ Amount	Roof lights

MATERIAL ASSESSMENT		PRIORITY ASSESSMENT	
Product type	Rope seals	Normal occupant activity	N/A
Extent of damage	Low	Likelihood of disturbance	N/A
Surface treatment	None	Human exposure potential	N/A
Asbestos type	Crocidolite (presumed)	Maintenance activity	N/A
Material assessment score: N/A		TOTAL SCORE: N/A	Priority assessment score: N/A

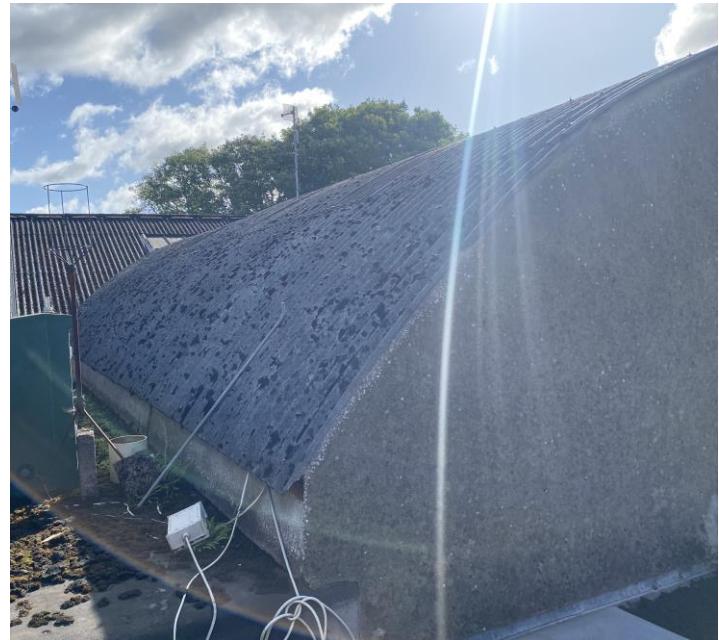
Created By	Andrew Hickey
Date	23rd August 2024
Site Details	Council Depot, Anglesea Terrace, Cork
Client Name	Land Development Agency
Survey Type	R/D Asbestos Survey
Site Ref	PE 24-905
Building Ref.	Building 2
Location	Roof
Extent/ Amount	130 m ² approx. floor area

MATERIAL ASSESSMENT		PRIORITY ASSESSMENT	
Product type	Cement sheeting	Normal occupant activity	N/A
Extent of damage	Weathered	Likelihood of disturbance	N/A
Surface treatment	None	Human exposure potential	N/A
Asbestos type	Chrysotile & Crocidolite	Maintenance activity	N/A
Material assessment score: N/A		TOTAL SCORE: N/A	Priority assessment score: N/A

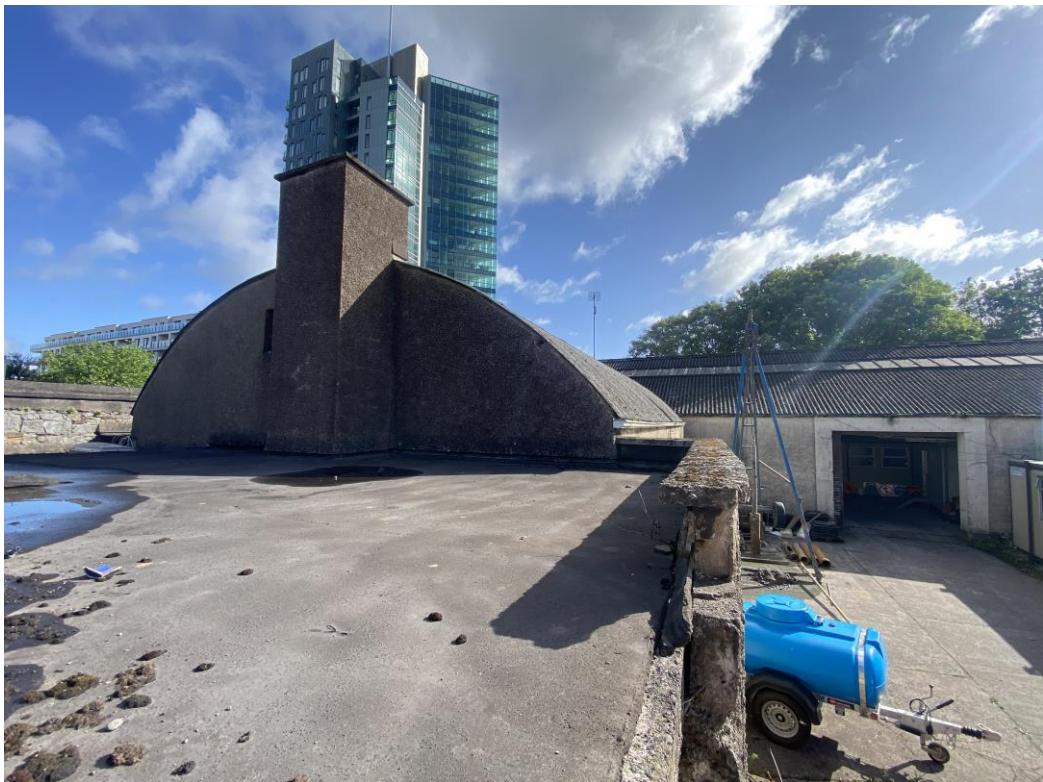
View of the asbestos cement sheeting externally

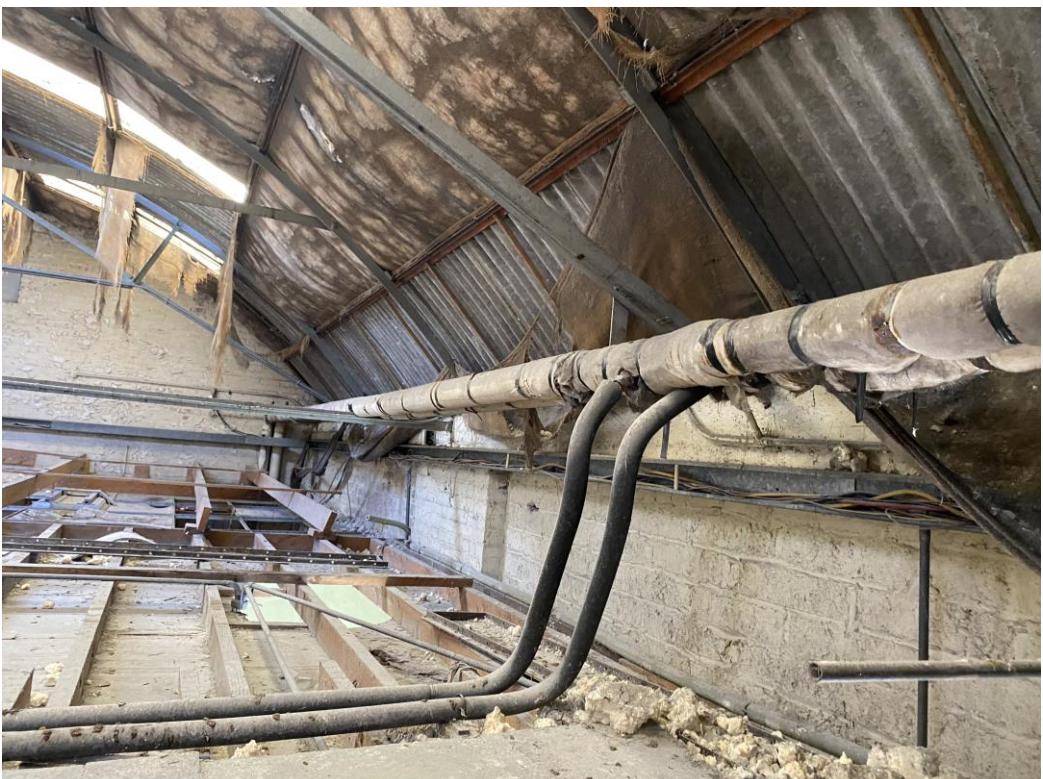
View of the asbestos cement sheeting internally

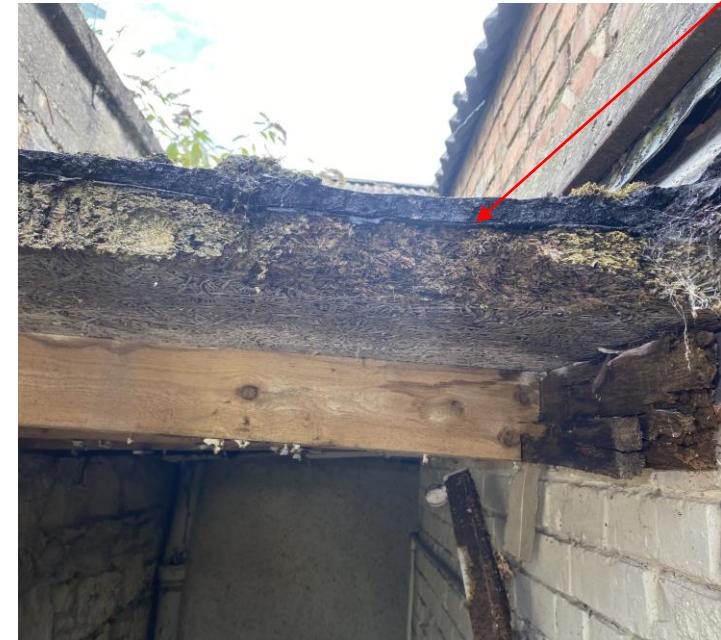
Created By	Andrew Hickey
Date	23rd August 2024
Site Details	Council Depot, Anglesea Terrace, Cork
Client Name	Land Development Agency
Survey Type	R/D Asbestos Survey
Site Ref	PE 24-905
Building Ref.	Building 2
Location	Flat roof
Extent/ Amount	90 m ² approx.

MATERIAL ASSESSMENT	PRIORITY ASSESSMENT
Product type	Felt	Normal occupant activity N/A
Extent of damage	Medium	Likelihood of disturbance N/A
Surface treatment	Well bound material	Human exposure potential N/A
Asbestos type	Chrysotile	Maintenance activity N/A
Material assessment score: N/A		TOTAL SCORE: N/A
		Priority assessment score: N/A

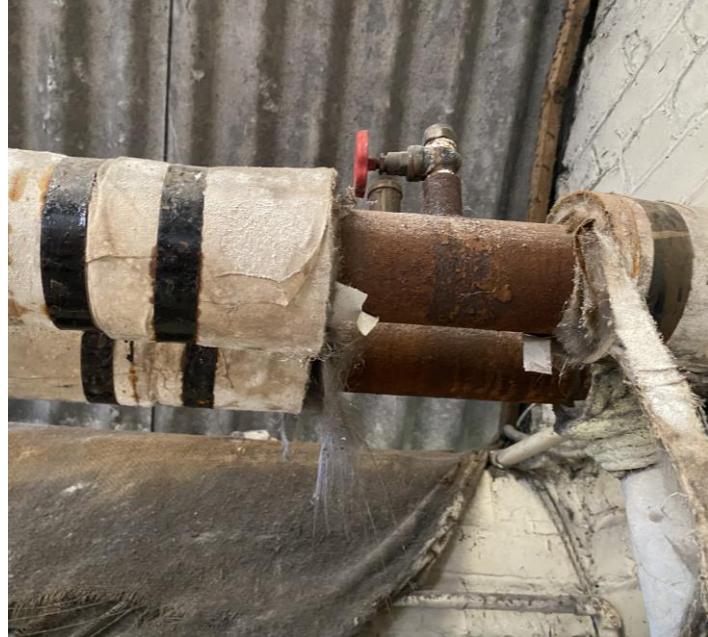
Created By	Andrew Hickey
Date	23rd August 2024
Site Details	Council Depot, Anglesea Terrace, Cork
Client Name	Land Development Agency
Survey Type	R/D Asbestos Survey
Site Ref	PE 24-905
Building Ref.	Building 2
Location	Boiler room & attic
Extent/ Amount	15m ² & (15 lin. m. x 2)

MATERIAL ASSESSMENT		PRIORITY ASSESSMENT	
Product type	Paper	Normal occupant activity	N/A
Extent of damage	Medium	Likelihood of disturbance	N/A
Surface treatment	None	Human exposure potential	N/A
Asbestos type	Chrysotile	Maintenance activity	N/A
Material assessment score: N/A		TOTAL SCORE: N/A	Priority assessment score: N/A

The paper insulation should be removed under controlled conditions by a specialist asbestos removal contractor and disposed of as asbestos waste before the demolition works commence

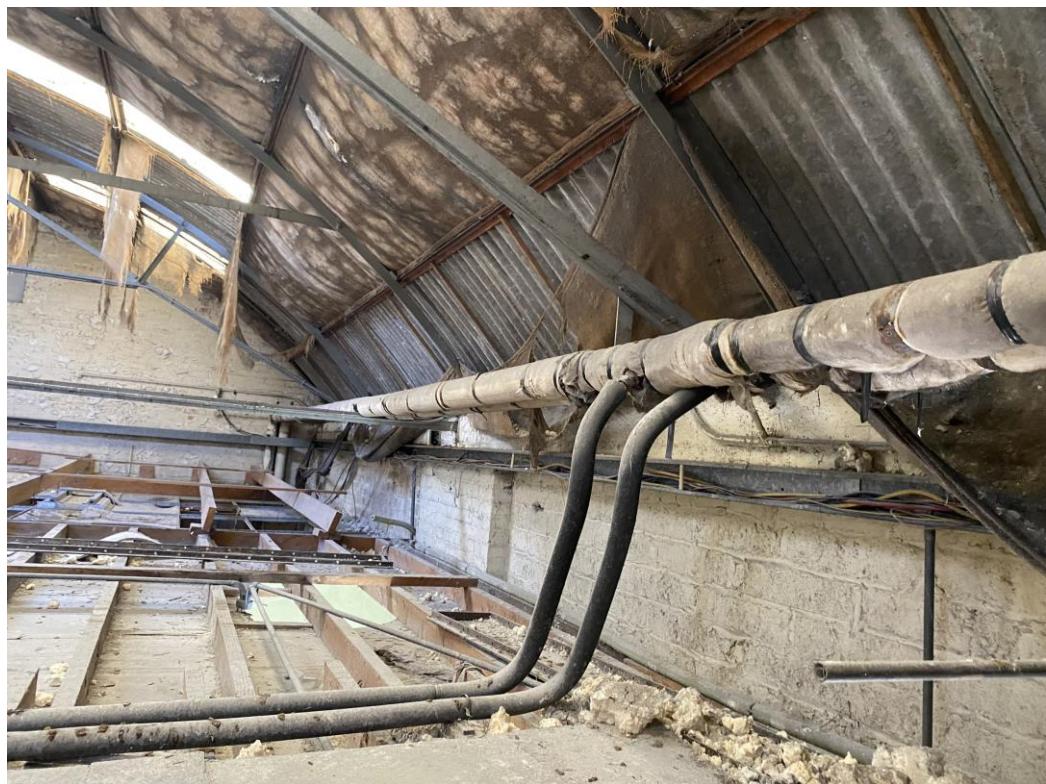
View of the two pipes in the attic area

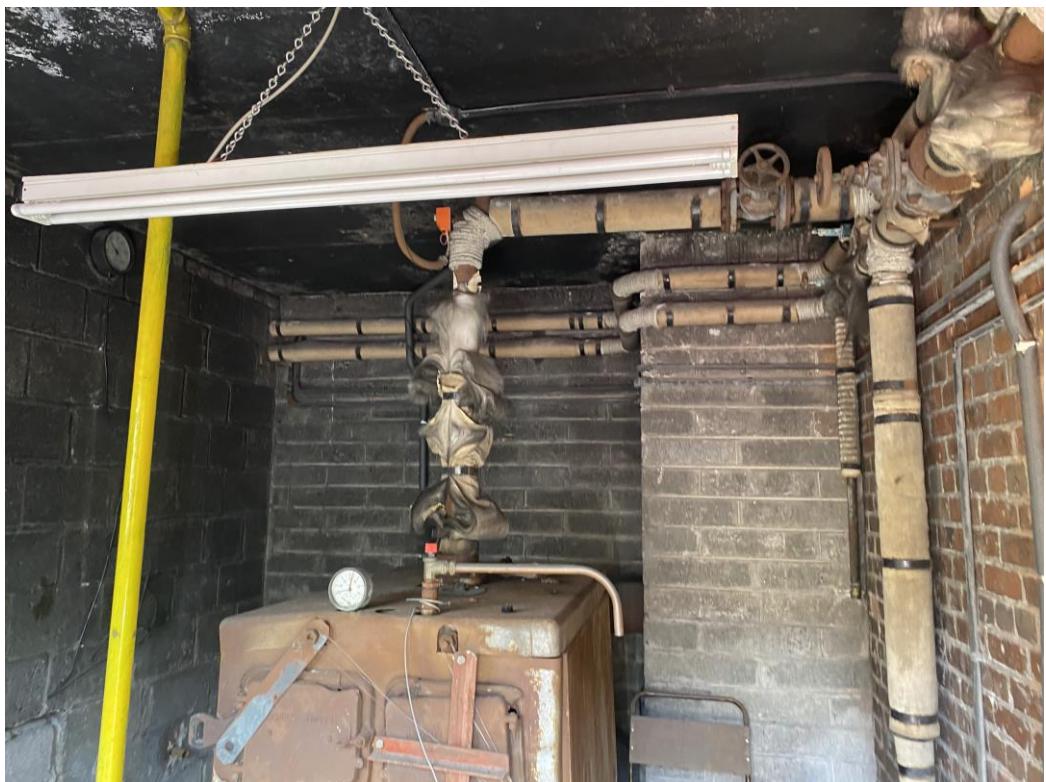
View of the pipework in the boiler room

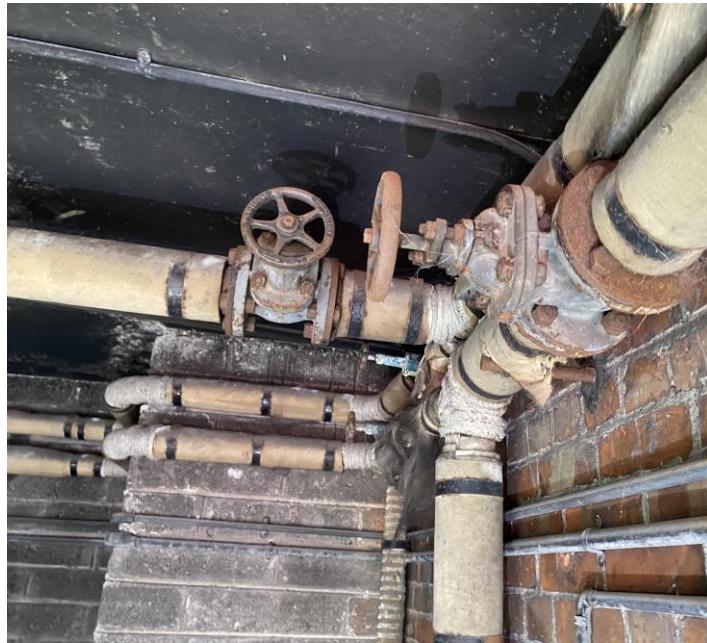
Created By	Andrew Hickey
Date	23rd August 2024
Site Details	Council Depot, Anglesea Terrace, Cork
Client Name	Land Development Agency
Survey Type	R/D Asbestos Survey
Site Ref	PE 24-905
Building Ref.	Building 2
Location	Boiler room & attic
Extent/ Amount	On the pipework bends

MATERIAL ASSESSMENT		PRIORITY ASSESSMENT	
Product type	Rope insulation	Normal occupant activity	N/A
Extent of damage	Medium	Likelihood of disturbance	N/A
Surface treatment	None	Human exposure potential	N/A
Asbestos type	Chrysotile	Maintenance activity	N/A
Material assessment score: N/A		TOTAL SCORE: N/A	Priority assessment score: N/A

The rope insulation should be removed under controlled conditions by a specialist asbestos removal contractor and disposed of as asbestos waste before the demolition works commence

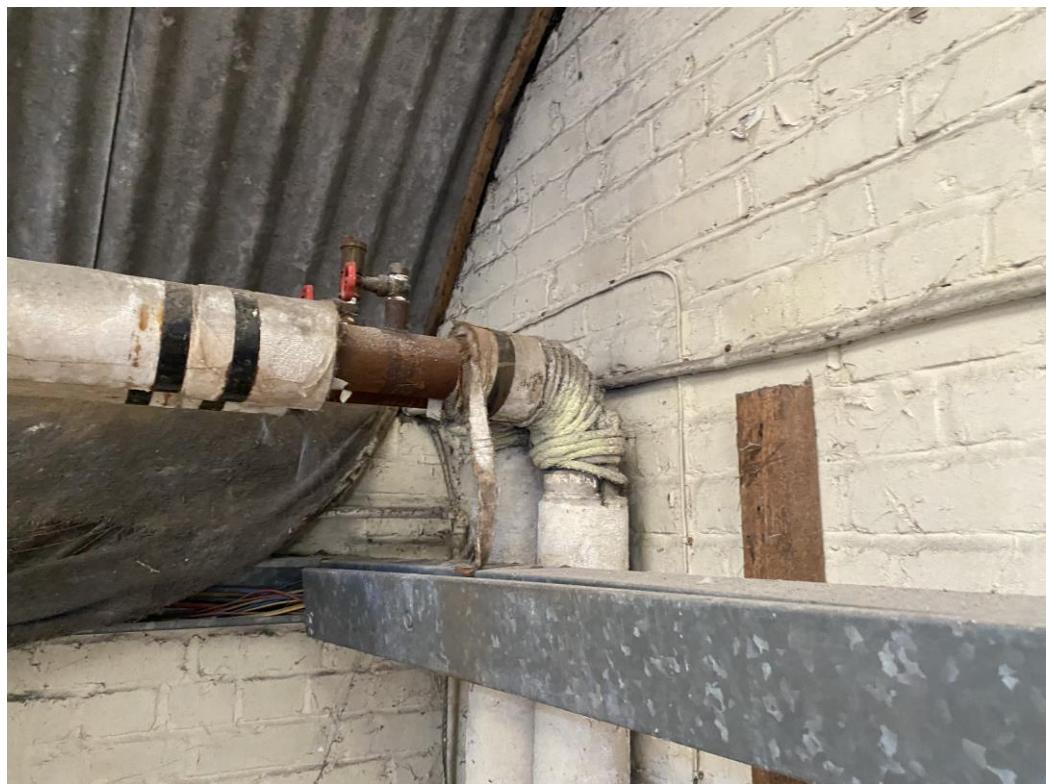
View of the two pipes in the attic area

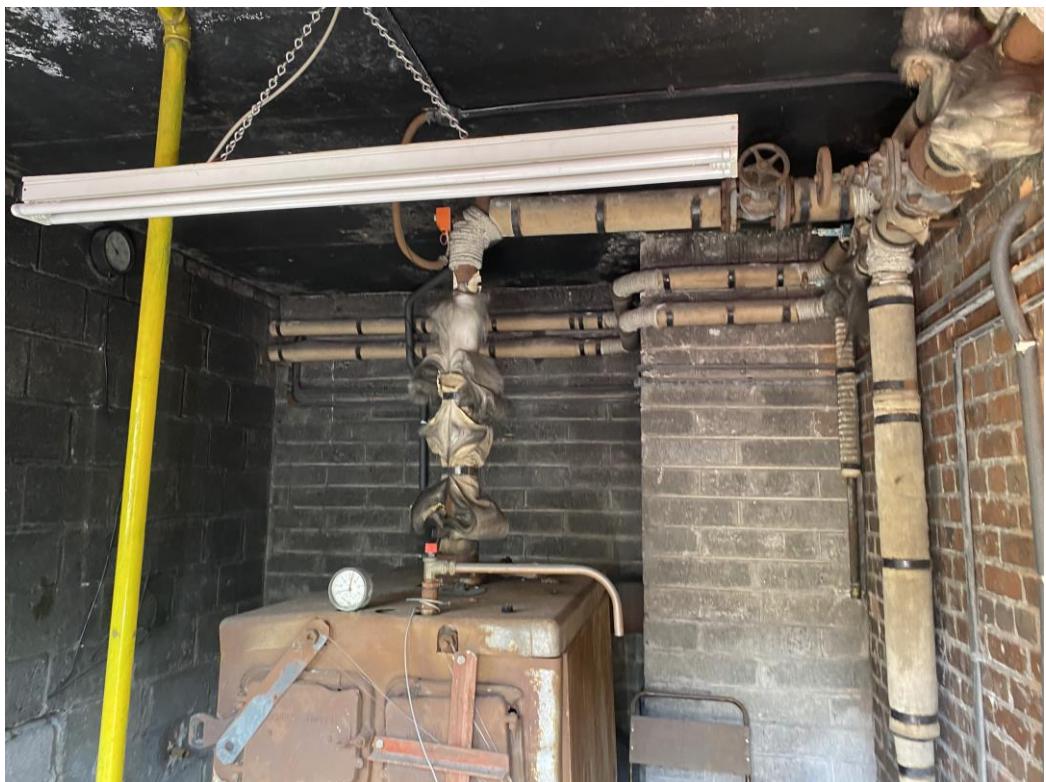
View of the pipework in the boiler room

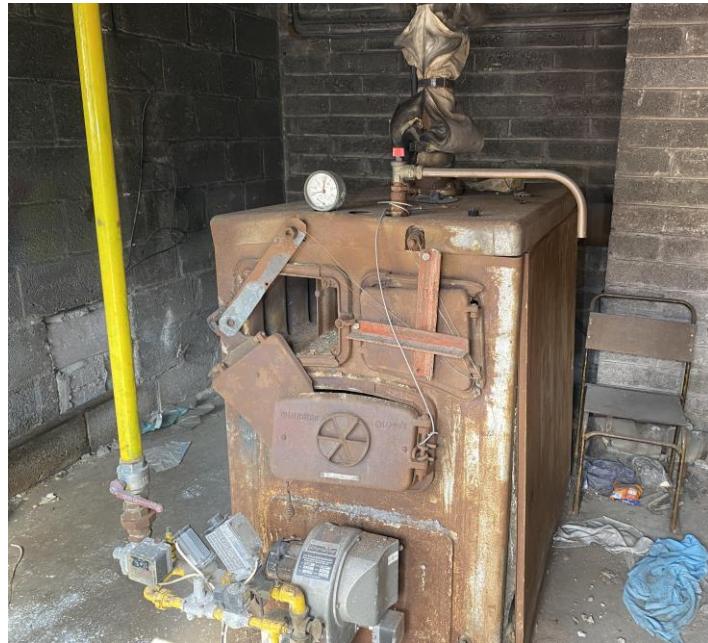
Created By	Andrew Hickey
Date	23rd August 2024
Site Details	Council Depot, Anglesea Terrace, Cork
Client Name	Land Development Agency
Survey Type	R/D Asbestos Survey
Site Ref	PE 24-905
Building Ref.	Building 2
Location	Boiler room
Extent/ Amount	1 boiler unit

MATERIAL ASSESSMENT		PRIORITY ASSESSMENT	
Product type	Rope (presumed)	Normal occupant activity	N/A
Extent of damage	Unknown	Likelihood of disturbance	N/A
Surface treatment	None	Human exposure potential	N/A
Asbestos type	Chrysotile	Maintenance activity	N/A
Material assessment score: N/A		TOTAL SCORE: N/A	Priority assessment score: N/A

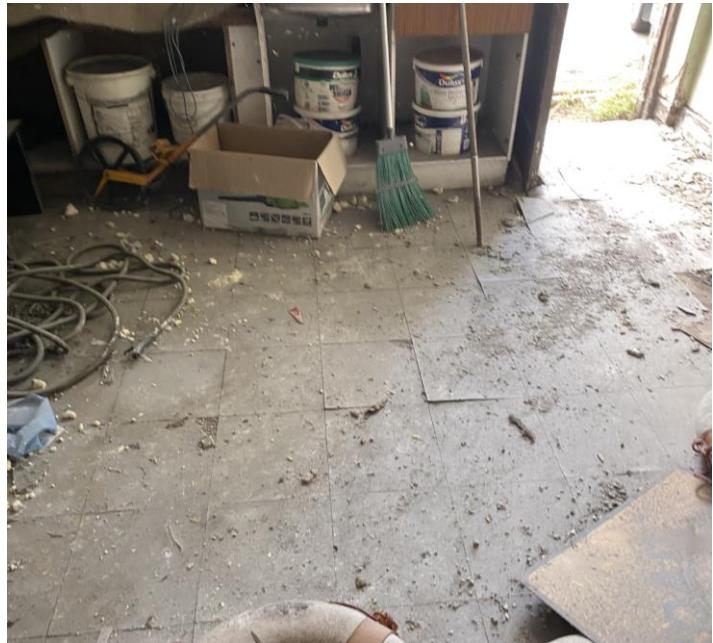
Created By	Andrew Hickey
Date	23rd August 2024
Site Details	Council Depot, Anglesea Terrace, Cork
Client Name	Land Development Agency
Survey Type	R/D Asbestos Survey
Site Ref	PE 24-905
Building Ref.	Building 2
Location	Throughout the building
Extent/ Amount	160 m ² total approx.

MATERIAL ASSESSMENT		PRIORITY ASSESSMENT	
Product type	Bitumen adhesive	Normal occupant activity	N/A
Extent of damage	High	Likelihood of disturbance	N/A
Surface treatment	Well bound material	Human exposure potential	N/A
Asbestos type	Chrysotile	Maintenance activity	N/A
Material assessment score: N/A		TOTAL SCORE: N/A	Priority assessment score: N/A

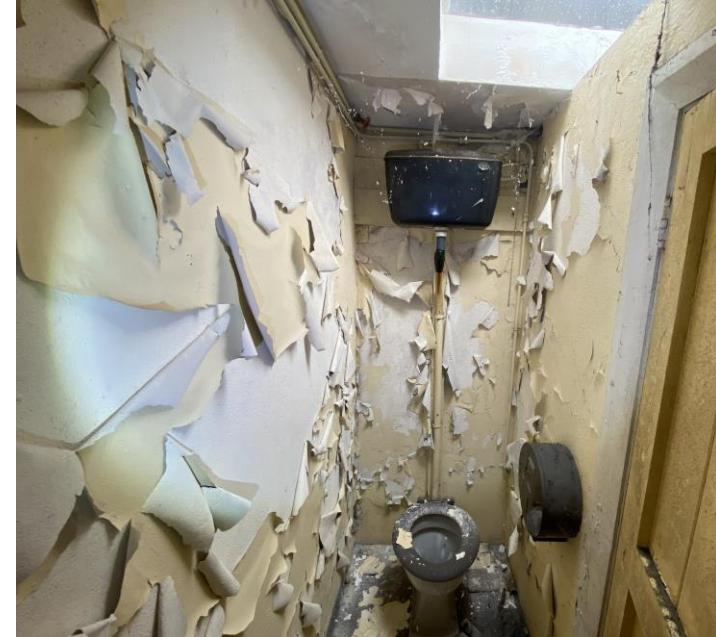
Created By	Andrew Hickey
Date	23rd August 2024
Site Details	Council Depot, Anglesea Terrace, Cork
Client Name	Land Development Agency
Survey Type	R/D Asbestos Survey
Site Ref	PE 24-905
Building Ref.	Building 2
Location	Toilet area
Extent/ Amount	2 cisterns

MATERIAL ASSESSMENT		PRIORITY ASSESSMENT	
Product type	Resin toilet cistern	Normal occupant activity	N/A
Extent of damage	Low	Likelihood of disturbance	N/A
Surface treatment	Composite material	Human exposure potential	N/A
Asbestos type	Amosite	Maintenance activity	N/A
Material assessment score: N/A		TOTAL SCORE: N/A	Priority assessment score: N/A

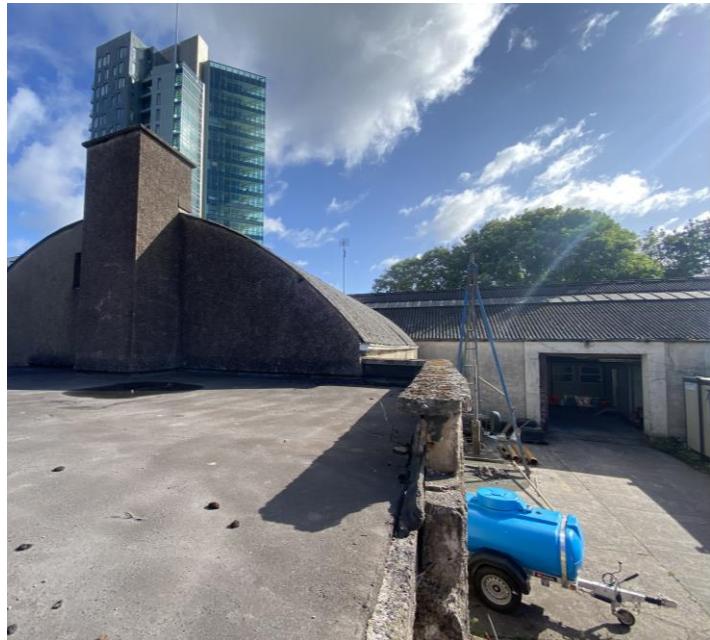
Created By	Andrew Hickey
Date	23rd August 2024
Site Details	Council Depot, Anglesea Terrace, Cork
Client Name	Land Development Agency
Survey Type	R/D Asbestos Survey
Site Ref	PE 24-905
Building Ref.	Building 3
Location	Roof
Extent/ Amount	400 m ² approx. floor area

MATERIAL ASSESSMENT		PRIORITY ASSESSMENT	
Product type	Cement sheeting	Normal occupant activity	N/A
Extent of damage	Weathered	Likelihood of disturbance	N/A
Surface treatment	None	Human exposure potential	N/A
Asbestos type	Chrysotile	Maintenance activity	N/A
Material assessment score: N/A		TOTAL SCORE: N/A	Priority assessment score: N/A

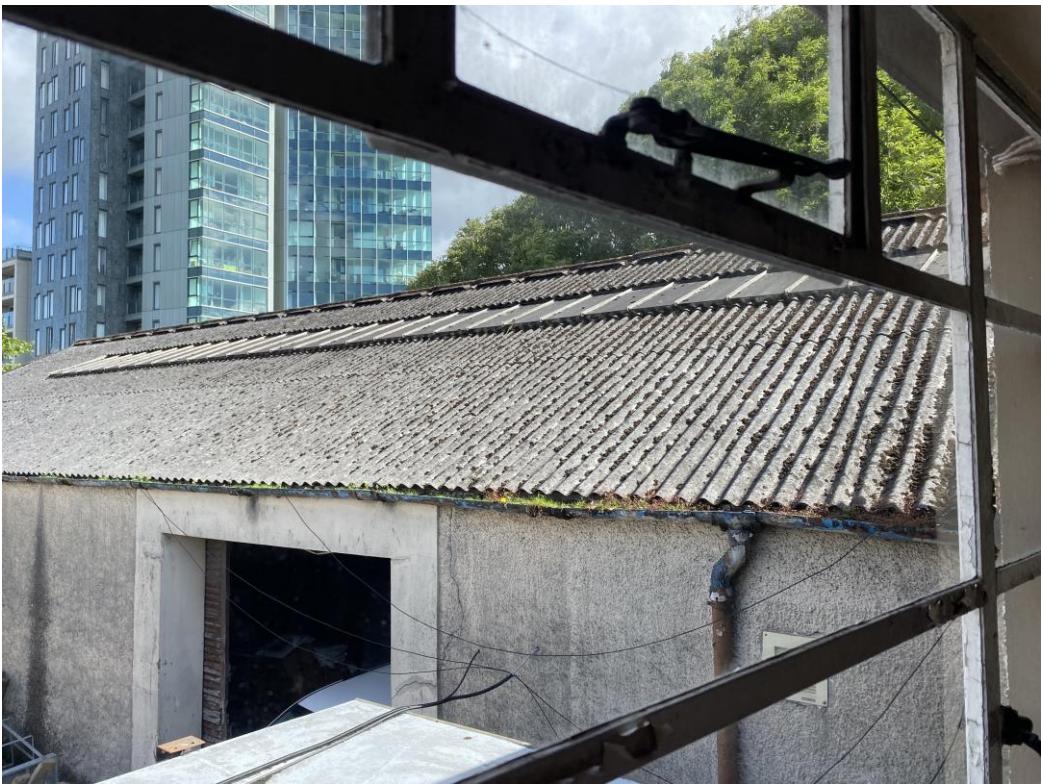
View of the asbestos cement sheeting externally

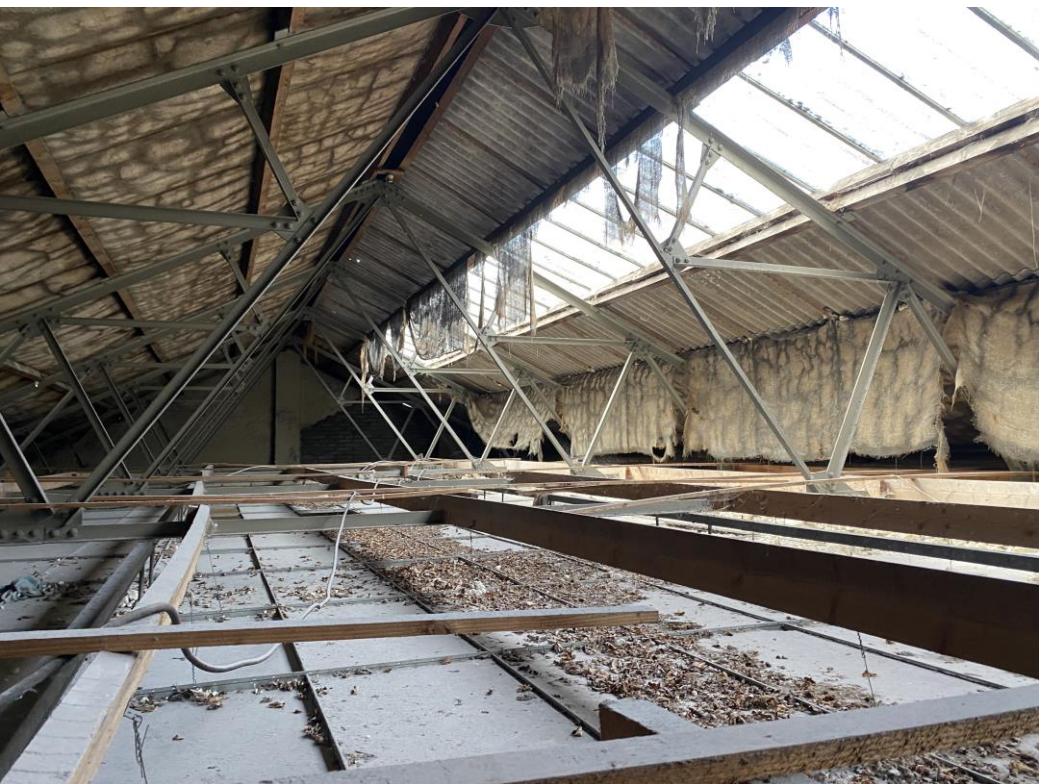
View of the asbestos cement sheeting internally

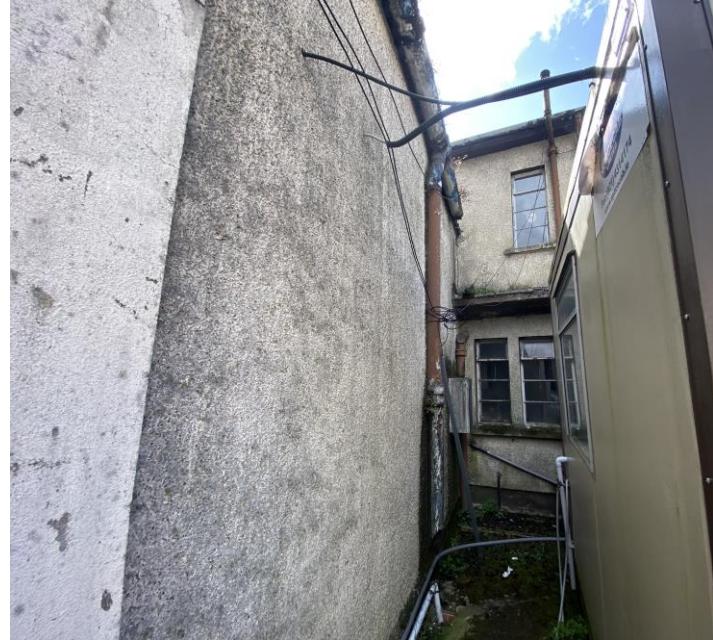
Created By	Andrew Hickey
Date	23rd August 2024
Site Details	Council Depot, Anglesea Terrace, Cork
Client Name	Land Development Agency
Survey Type	R/D Asbestos Survey
Site Ref	PE 24-905
Building Ref.	Building 3
Location	Perimeter of the building
Extent/ Amount	75 linear meters approx.

MATERIAL ASSESSMENT		PRIORITY ASSESSMENT	
Product type	Cement gutters and downpipes	Normal occupant activity	N/A
Extent of damage	Medium	Likelihood of disturbance	N/A
Surface treatment	None	Human exposure potential	N/A
Asbestos type	Chrysotile	Maintenance activity	N/A
Material assessment score: N/A		TOTAL SCORE: N/A	Priority assessment score: N/A

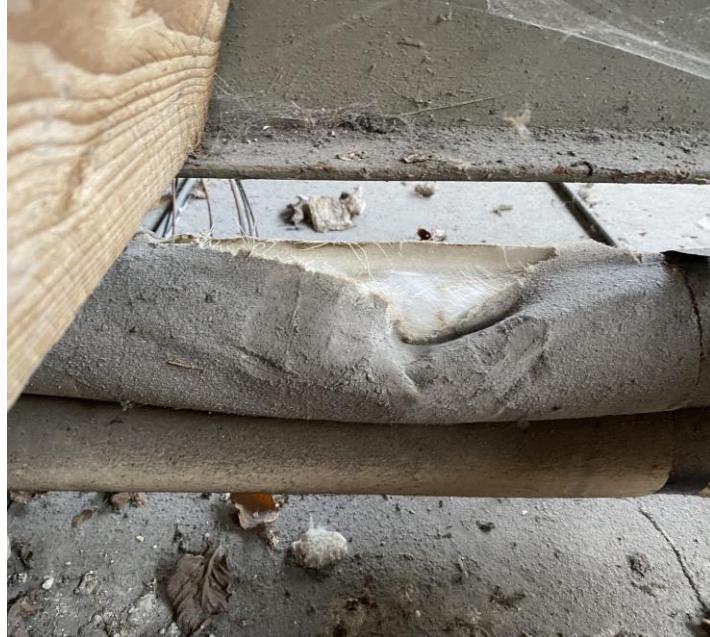
Created By	Andrew Hickey
Date	23rd August 2024
Site Details	Council Depot, Anglesea Terrace, Cork
Client Name	Land Development Agency
Survey Type	R/D Asbestos Survey
Site Ref	PE 24-905
Building Ref.	Building 3
Location	Ceiling void
Extent/ Amount	40 linear meters approx. x 2

MATERIAL ASSESSMENT		PRIORITY ASSESSMENT	
Product type	Paper	Normal occupant activity	N/A
Extent of damage	Low	Likelihood of disturbance	N/A
Surface treatment	None	Human exposure potential	N/A
Asbestos type	Chrysotile	Maintenance activity	N/A
Material assessment score: N/A		TOTAL SCORE: N/A	Priority assessment score: N/A

The paper insulation should be removed under controlled conditions by a specialist asbestos removal contractor and disposed of as asbestos waste before the demolition works commence

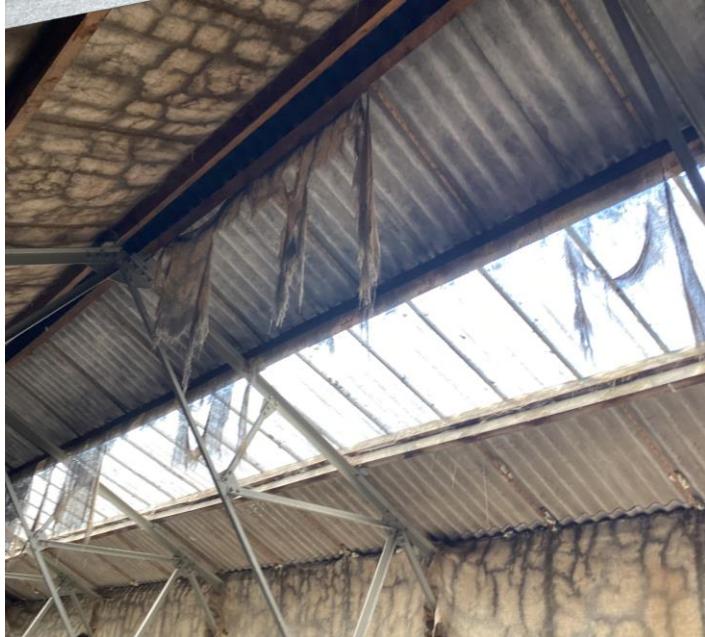
Created By	Andrew Hickey
Date	23rd August 2024
Site Details	Council Depot, Anglesea Terrace, Cork
Client Name	Land Development Agency
Survey Type	R/D Asbestos Survey
Site Ref	PE 24-905
Building Ref.	Building 3
Location	Roof
Extent/ Amount	Roof lights

MATERIAL ASSESSMENT	PRIORITY ASSESSMENT
Product type	Rope seals	Normal occupant activity
Extent of damage	Low	Likelihood of disturbance
Surface treatment	None	Human exposure potential
Asbestos type	Crocidolite (presumed)	Maintenance activity
Material assessment score: N/A		TOTAL SCORE: N/A
		Priority assessment score: N/A

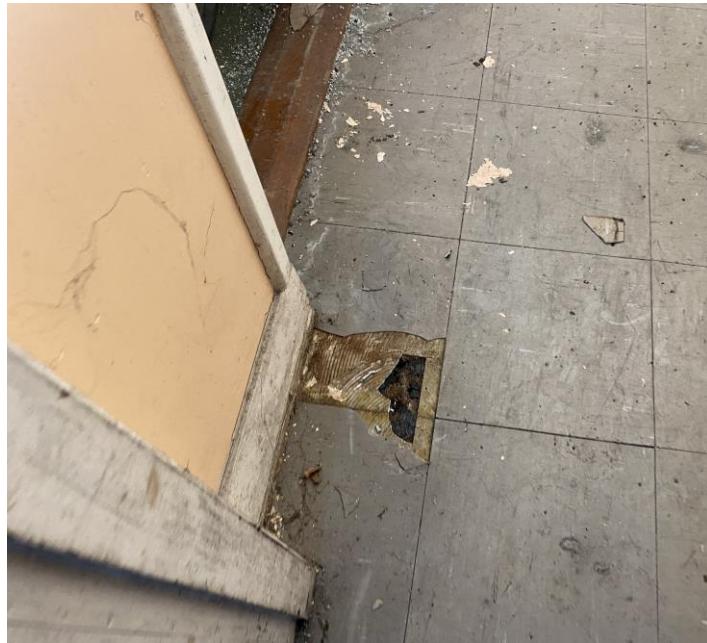
Created By	Andrew Hickey
Date	23rd August 2024
Site Details	Council Depot, Anglesea Terrace, Cork
Client Name	Land Development Agency
Survey Type	R/D Asbestos Survey
Site Ref	PE 24-905
Building Ref.	Building 4
Location	Throughout building
Extent/ Amount	120 m ² total approx.

MATERIAL ASSESSMENT		PRIORITY ASSESSMENT	
Product type	Floor tiles & bitumen adhesive	Normal occupant activity	N/A
Extent of damage	Medium	Likelihood of disturbance	N/A
Surface treatment	Composite & well bound material	Human exposure potential	N/A
Asbestos type	Chrysotile	Maintenance activity	N/A
Material assessment score: N/A		TOTAL SCORE: N/A	Priority assessment score: N/A

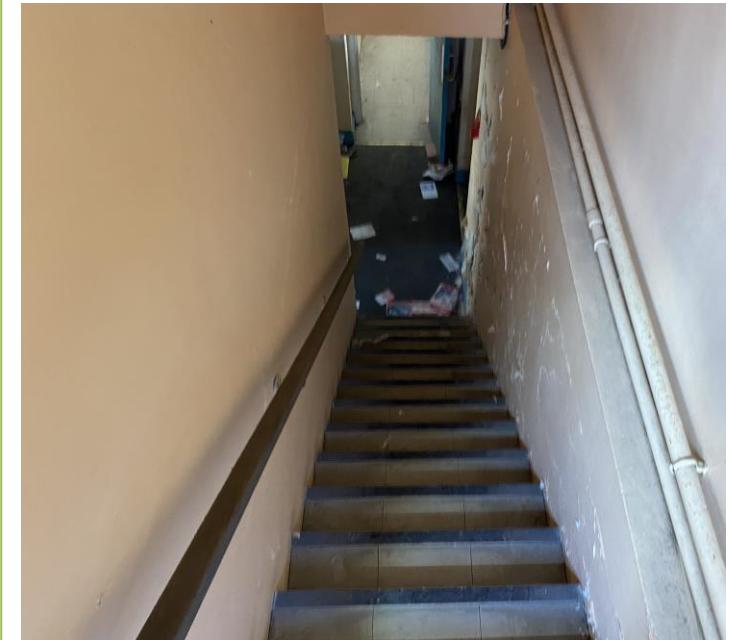
Created By	Andrew Hickey
Date	23rd August 2024
Site Details	Council Depot, Anglesea Terrace, Cork
Client Name	Land Development Agency
Survey Type	R/D Asbestos Survey
Site Ref	PE 24-905
Building Ref.	Building 4
Location	Stairwell
Extent/ Amount	1 per step

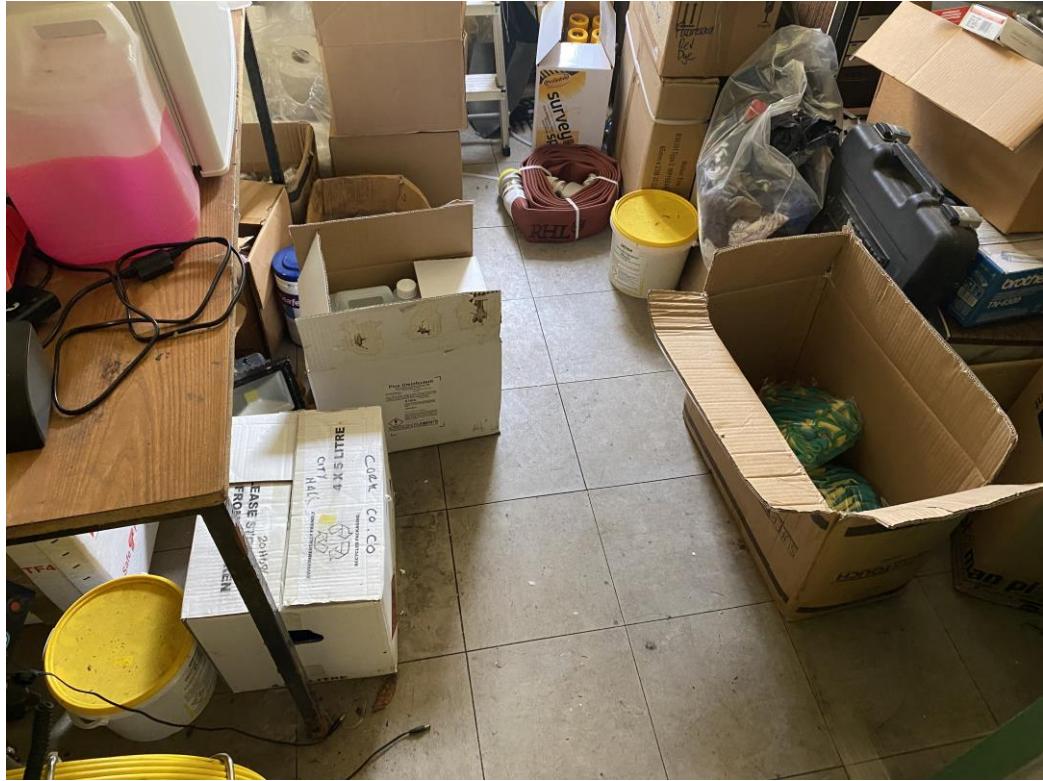
Floor tiles sampled in the office areas of building 1
