ASBESTOS SURVEY REPORT

(Refurbishment / Demolition Survey)

**Location: Council Depot,
Anglesea Terrace, Cork**

Report No. PE24-905

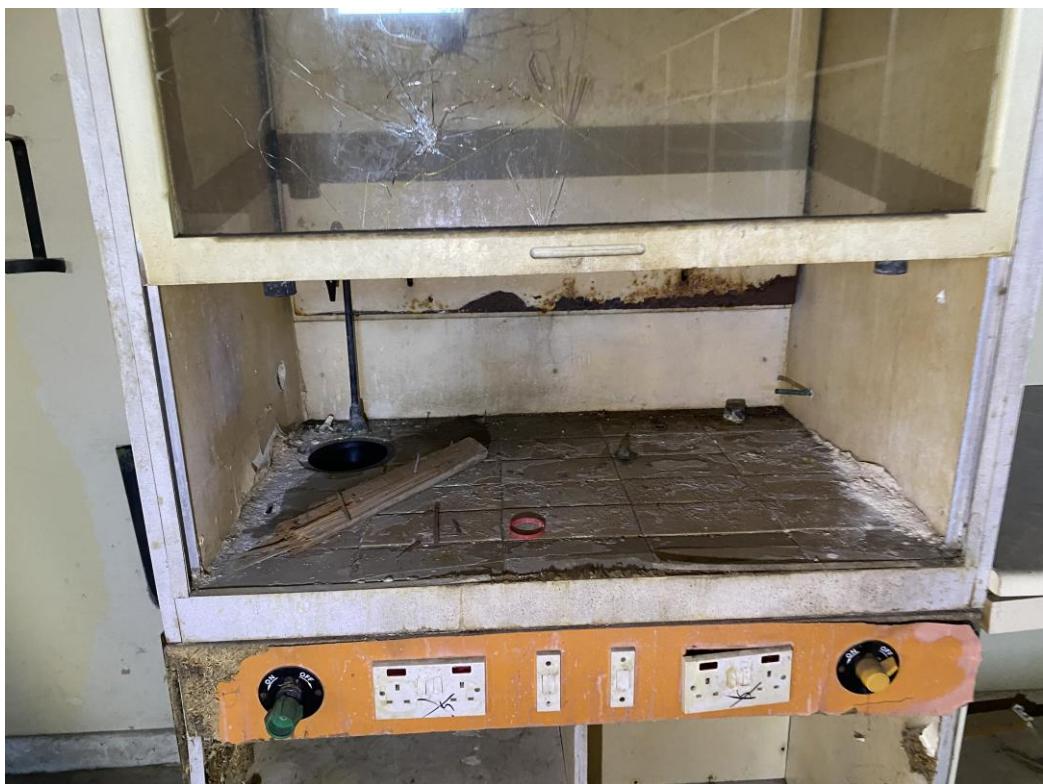
Insulation board sampled around flume hood in the lab

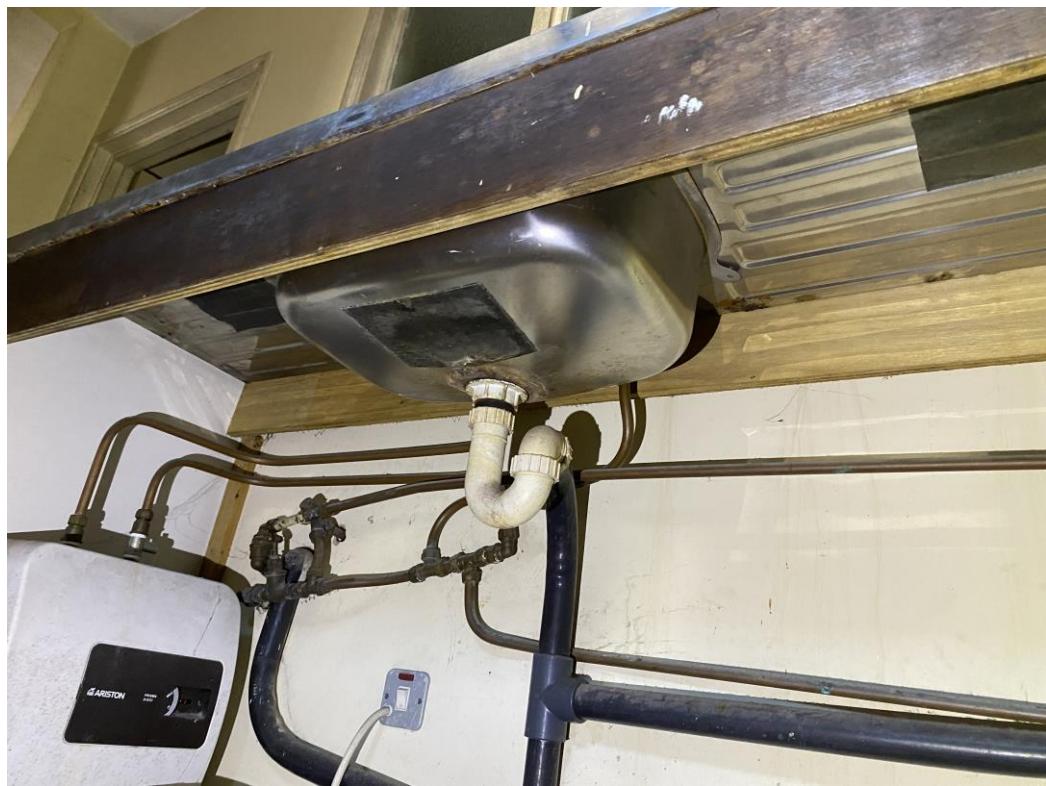
Felt pads sampled

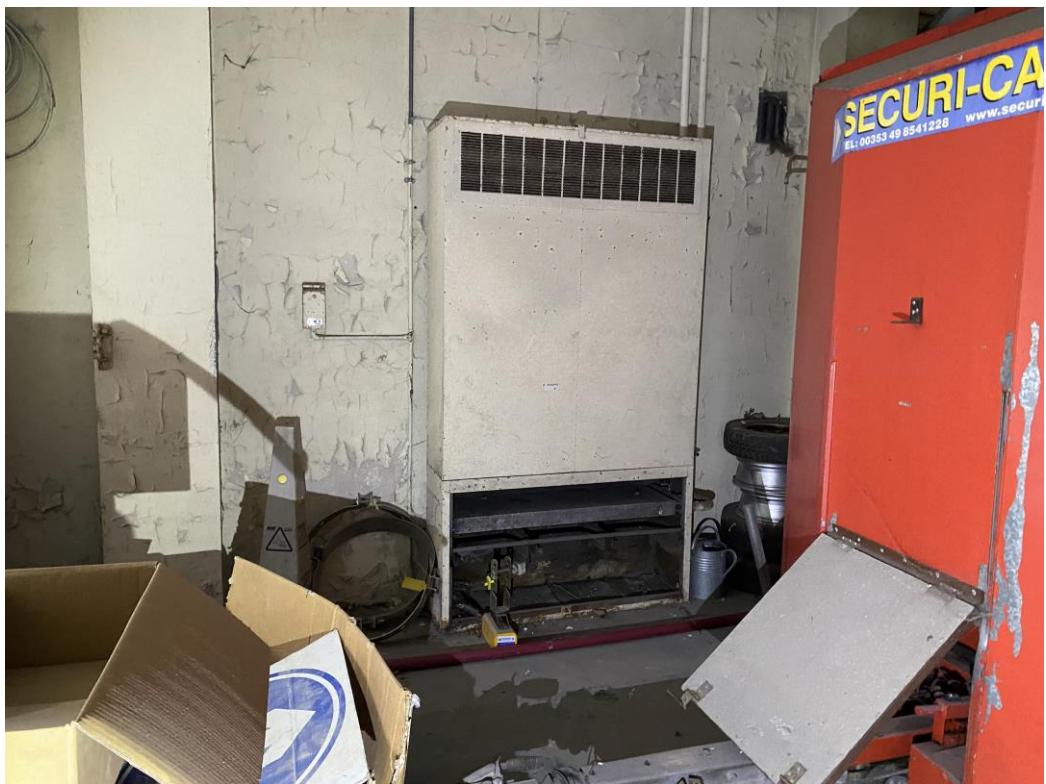
Timber insulation boards in the blow heaters

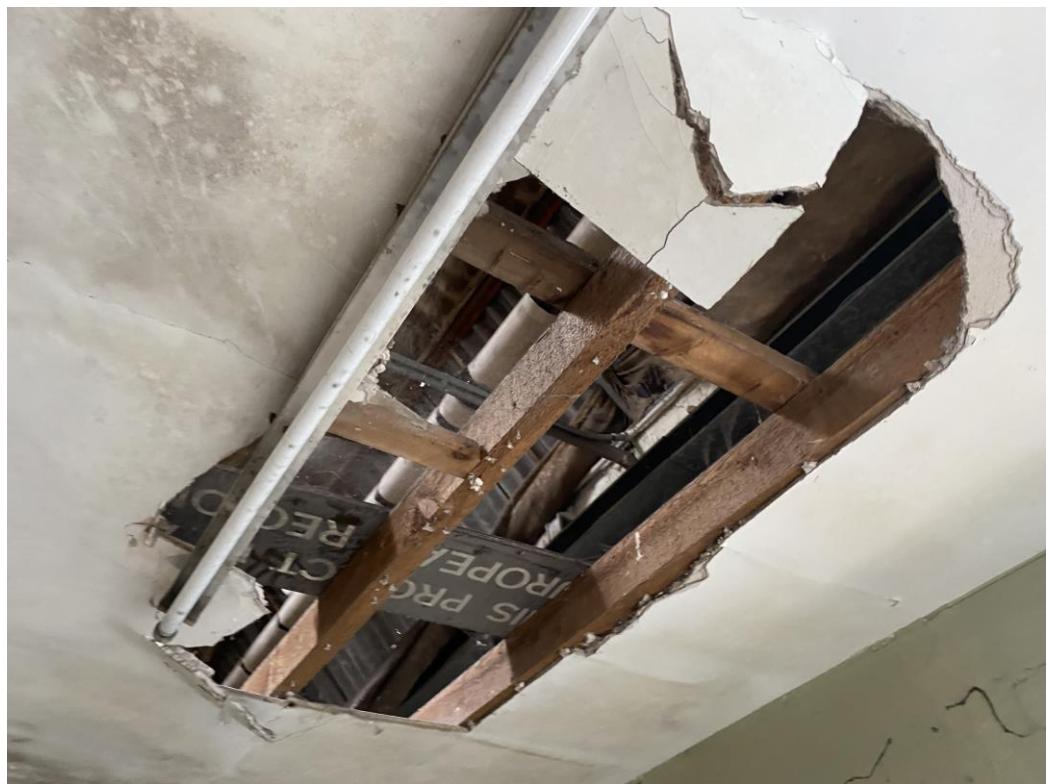
Plasterboard ceilings

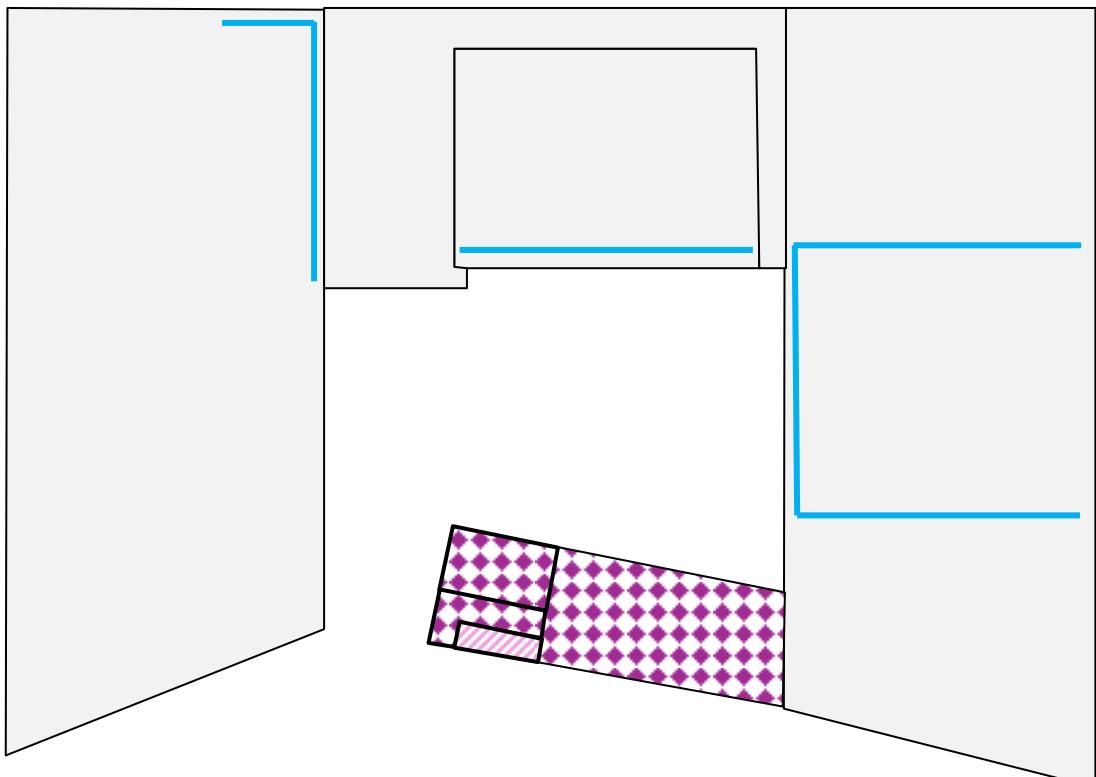
SITE 1st FLOOR / CEILING PLAN

Areas where asbestos paper and rope was identified on pipework
	Areas where asbestos containing resin step nosing were identified
	Areas where asbestos containing floor tiles & bitumen adhesive was identified
