Architectural Heritage Impact Assessment

Proposed residential development at Glyntown, Ballinglanna, Cork

March 2025

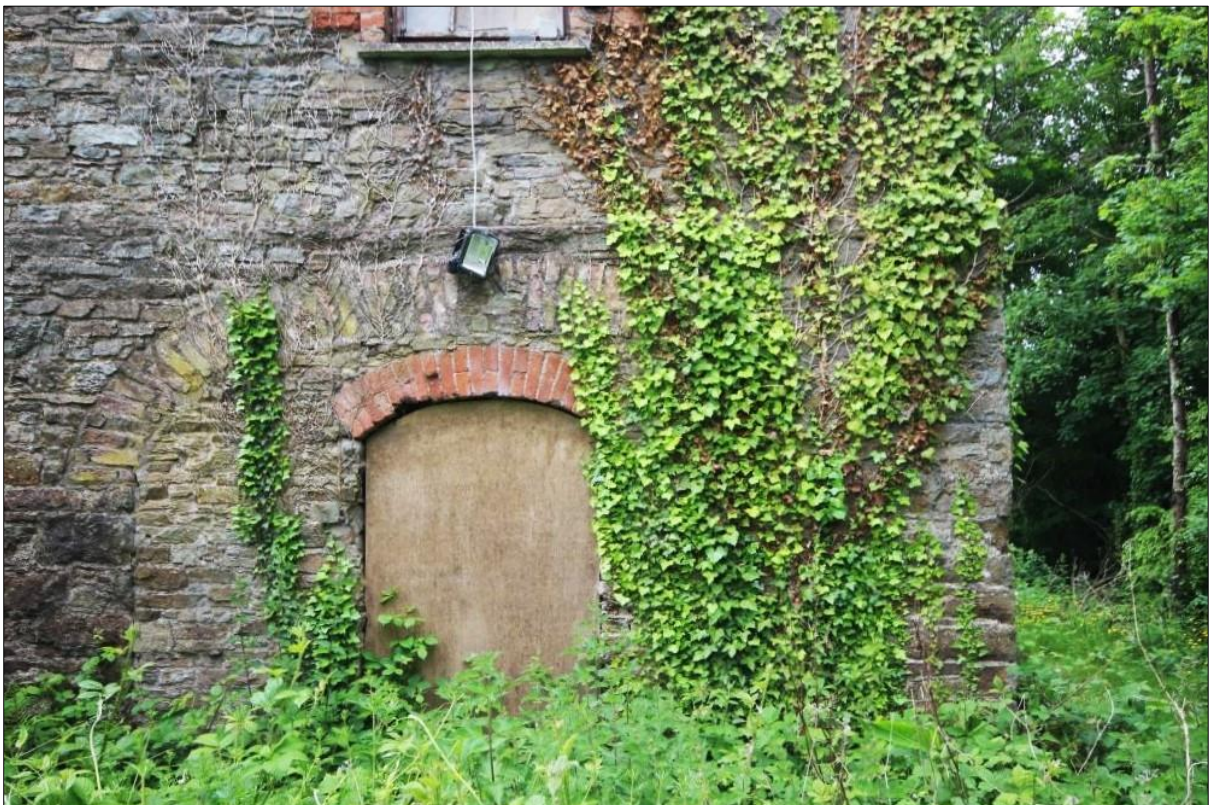
Plate 6: Opening in lower ground floor of eastern elevation

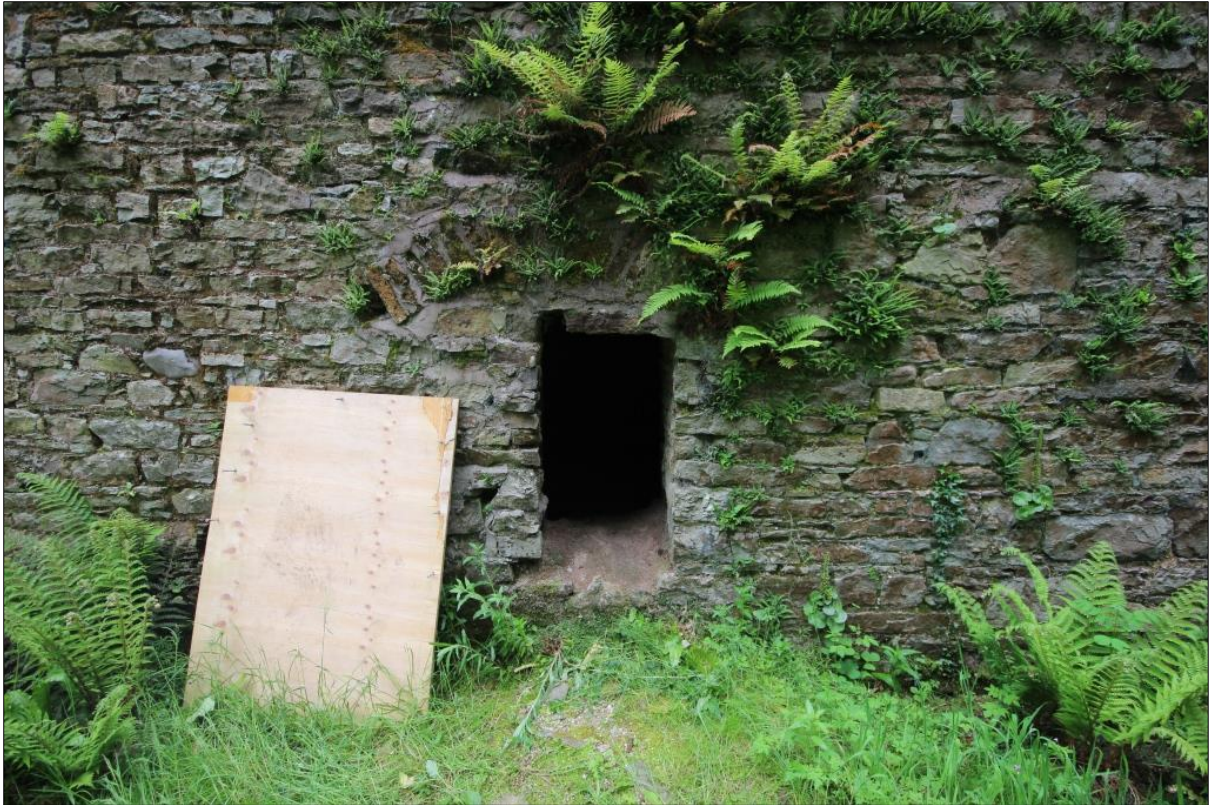
Plate 7: Opening in lower ground floor of northern elevation

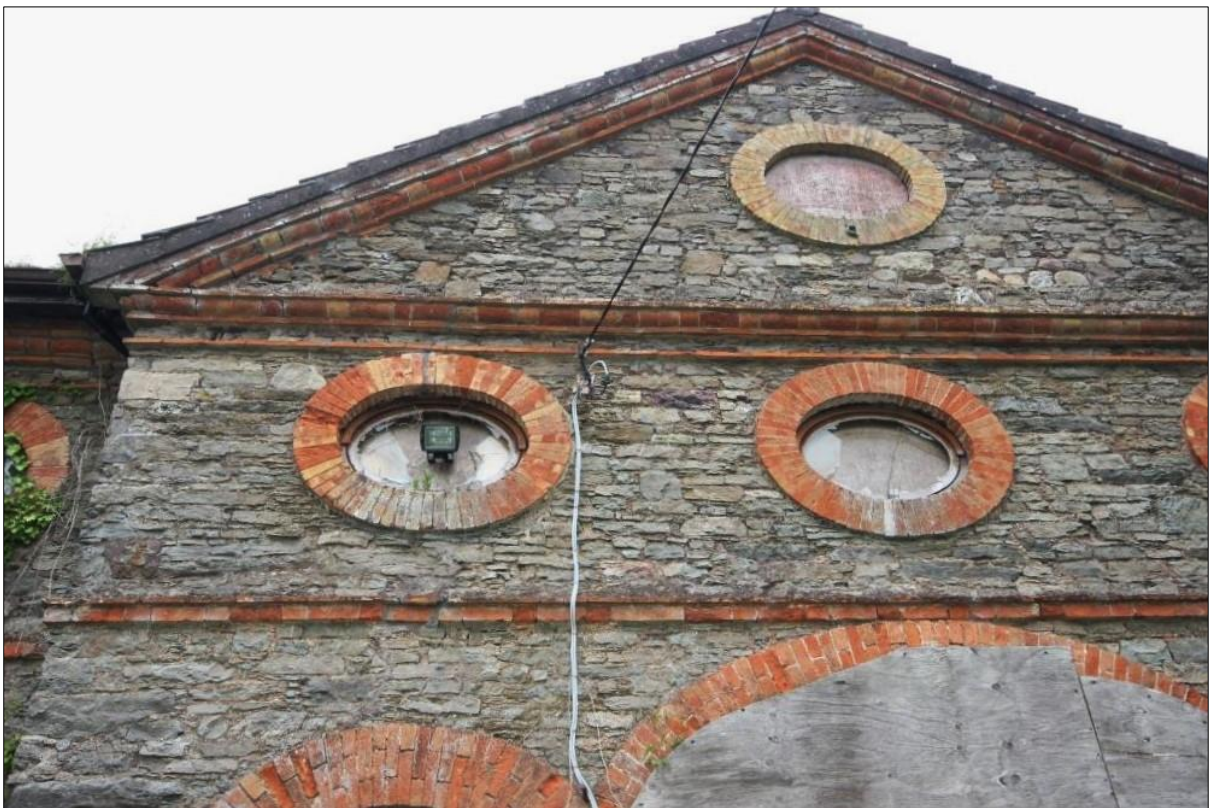
Plate 8: Detail of windows to first floor level on front elevation

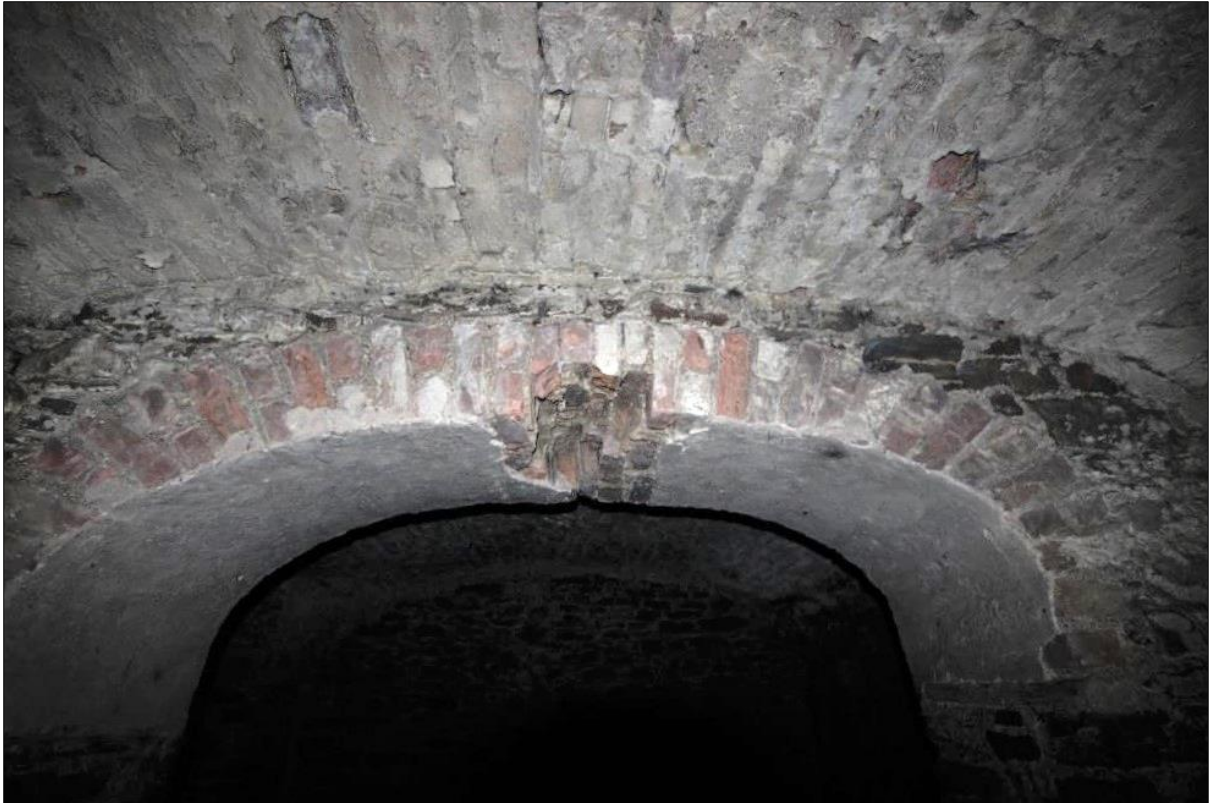
The lower ground floor level is occupied by a series of storerooms with low brick barrel vaulted roofs (see **Plates 10 – 13** in the **Appendix** to this report). The floor is generally of an earth surface but one room, LGF02, was noted to retain some cobbles. The arch between LGF01 and LGF05 has lost some bricks from its apex. The walls are of exposed stone and some sections of the brick barrel vaulting is lime rendered.

Plate 13: Missing bricks in arch on lower ground floor level LGF01

- A conservation consultant/architect will supervise the works to ensure that any required repairs/interventions to the original masonry and brick fabric is in accordance with conservation best practice.
- Any repointing or renewal of pointing or bedding mortar will be executed in a suitable lime mortar with a sand/grit mix that compliments the appearance of the building. The appointed conservation consultant/architect shall review and approve samples of any repointing works.
- Traditional-style painted timber windows and doors will be used on the elevations to respect the character of the building. The façade has been designed with suitable vertical battened doors which reflect the original use as a coach house/stable. The appointed conservation consultant/architect shall review and approve all joinery detail proposed for the exterior of the building.

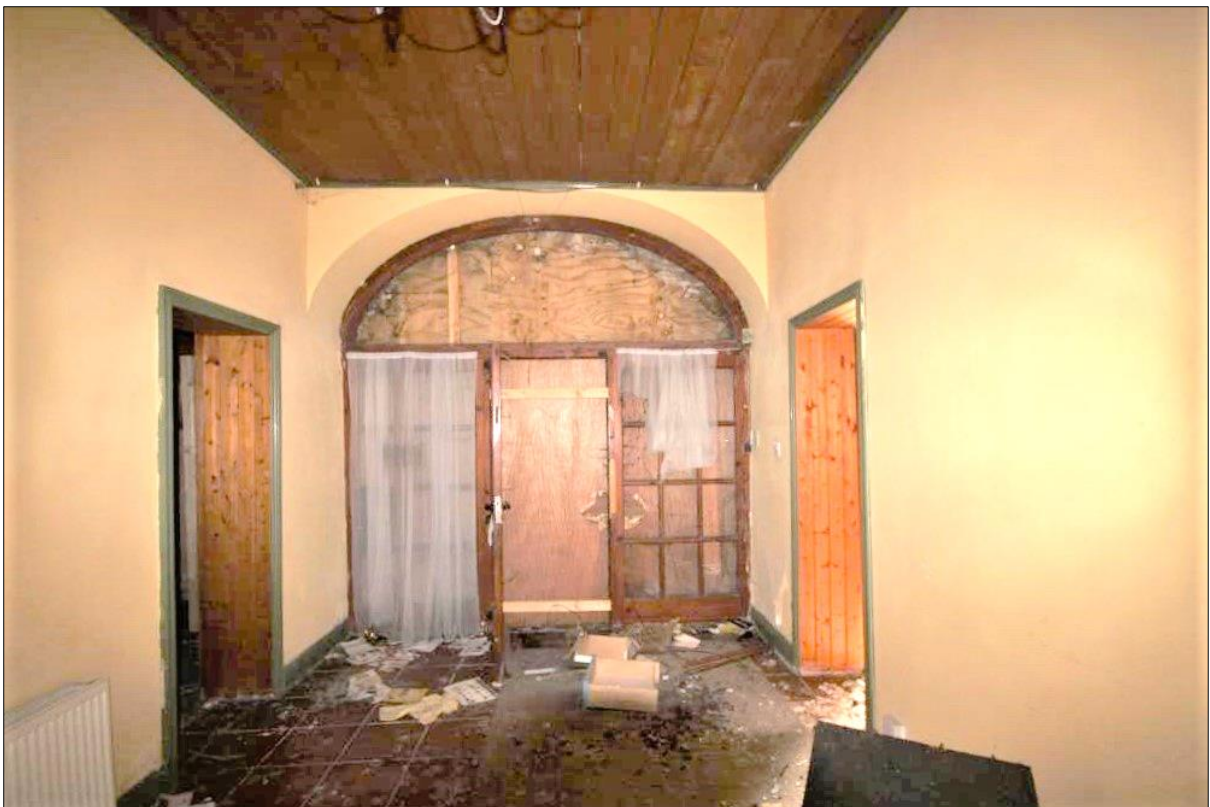
The ground floor is occupied by a hallway and three rooms. The floors have modern floor coverings over concrete and the joinery is a modern replacement. The ground floor carriage arch leads to a central hallway, GF01, which runs to the rear of the building and has a replacement timber staircase to the rear. The walls to the hallway are brick-built and original to the building. The walls are rendered and painted, the ceiling has modern timber cladding, and the floor has modern tiling. All joinery is a modern replacement (see **Plates 14-15**).

Plate 14: Ground floor entrance hall GF01 looking to front

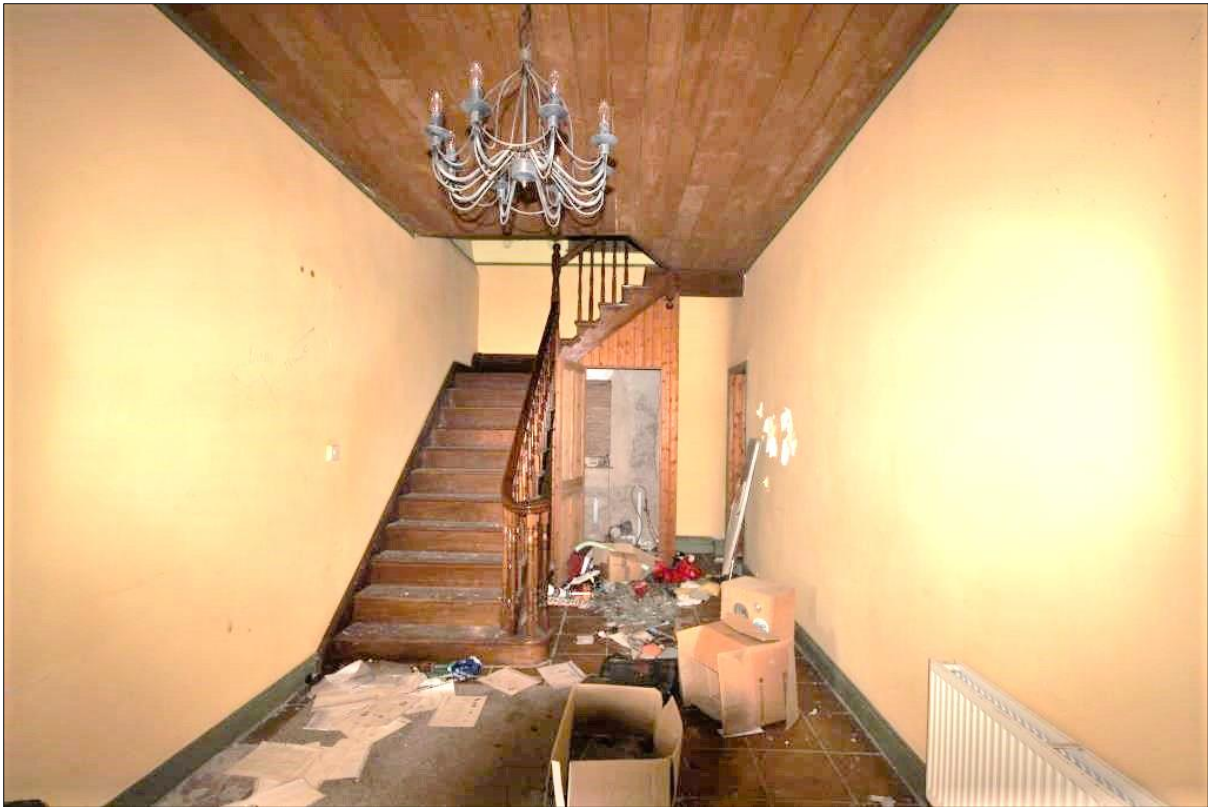
Plate 15: Ground floor entrance hall GF01 looking to rear

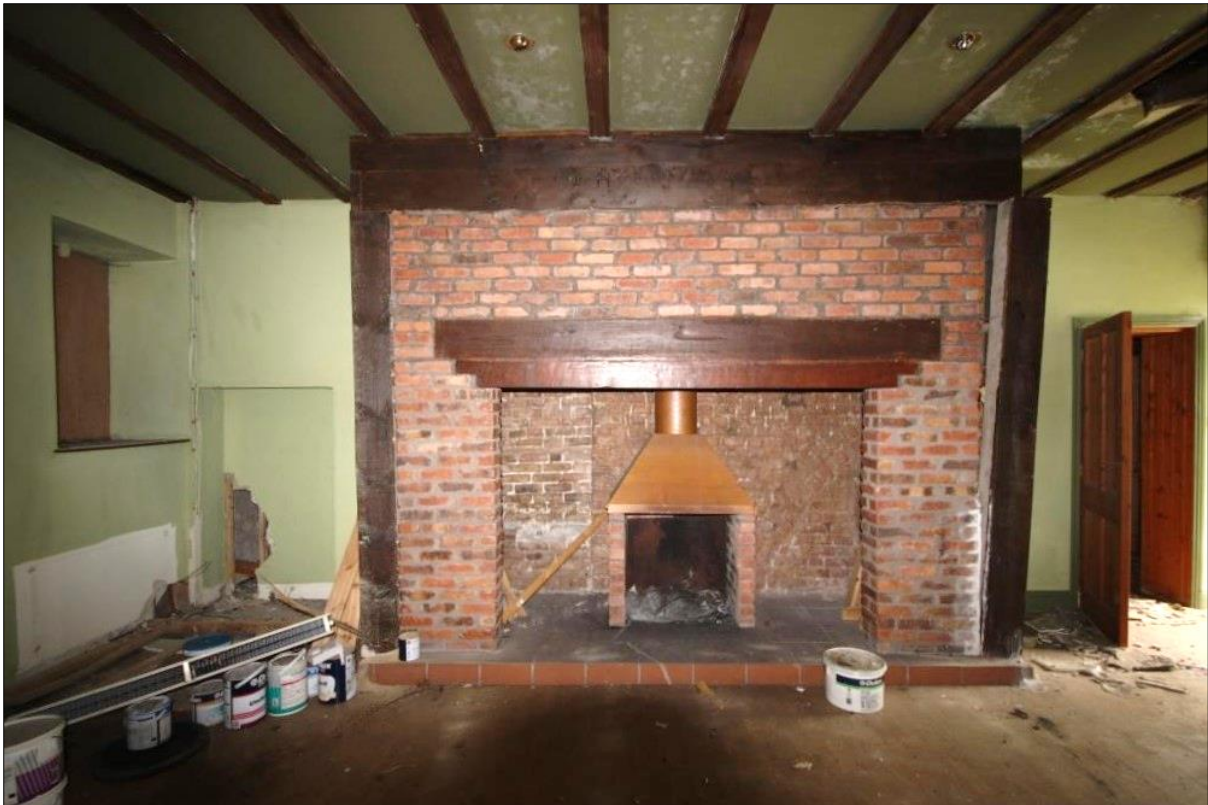
Some of the original brick wall is exposed but a large modern fireplace has been inserted into the room. The ceiling has exposed replacement joists and plasterboard (see **Plates 16-19**).

Plate 17: Modern brick fireplace built up against original brick wall in GF02

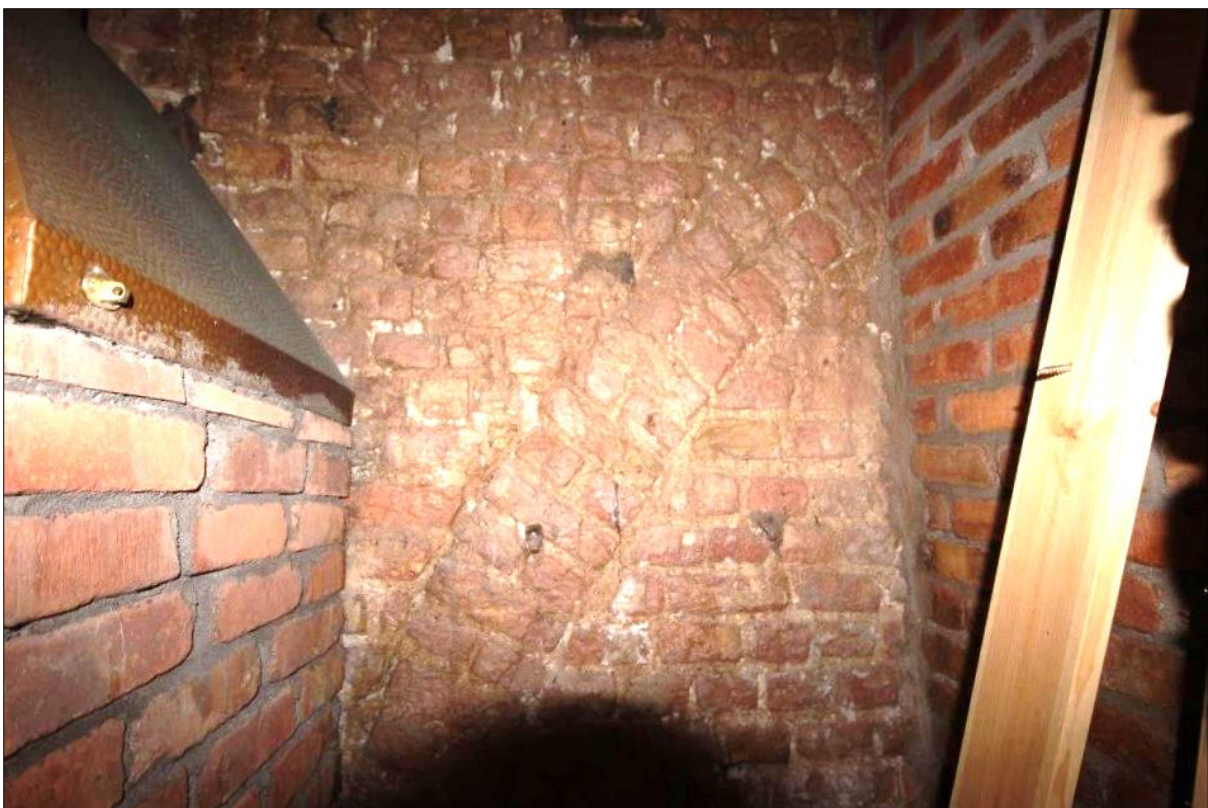
Plate 18: Relieving arch detail in original wall GF02

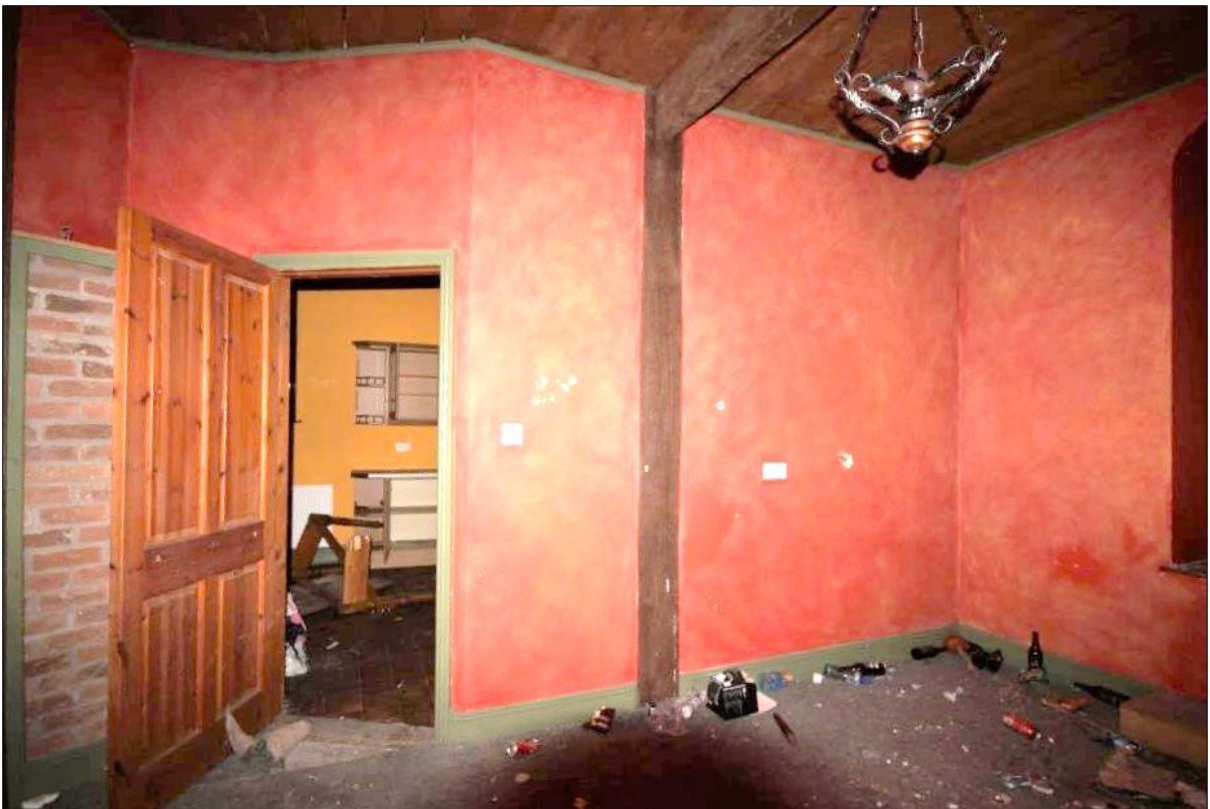
GF03 is located to the front and has a similar replacement entrance door in the front elevation; the room is lit by two original round-headed openings with modern replacement windows. A section of modern brick wall has been inserted into the room (see **Plate 20**).

Plate 20: Ground floor room GF03 looking to GF04

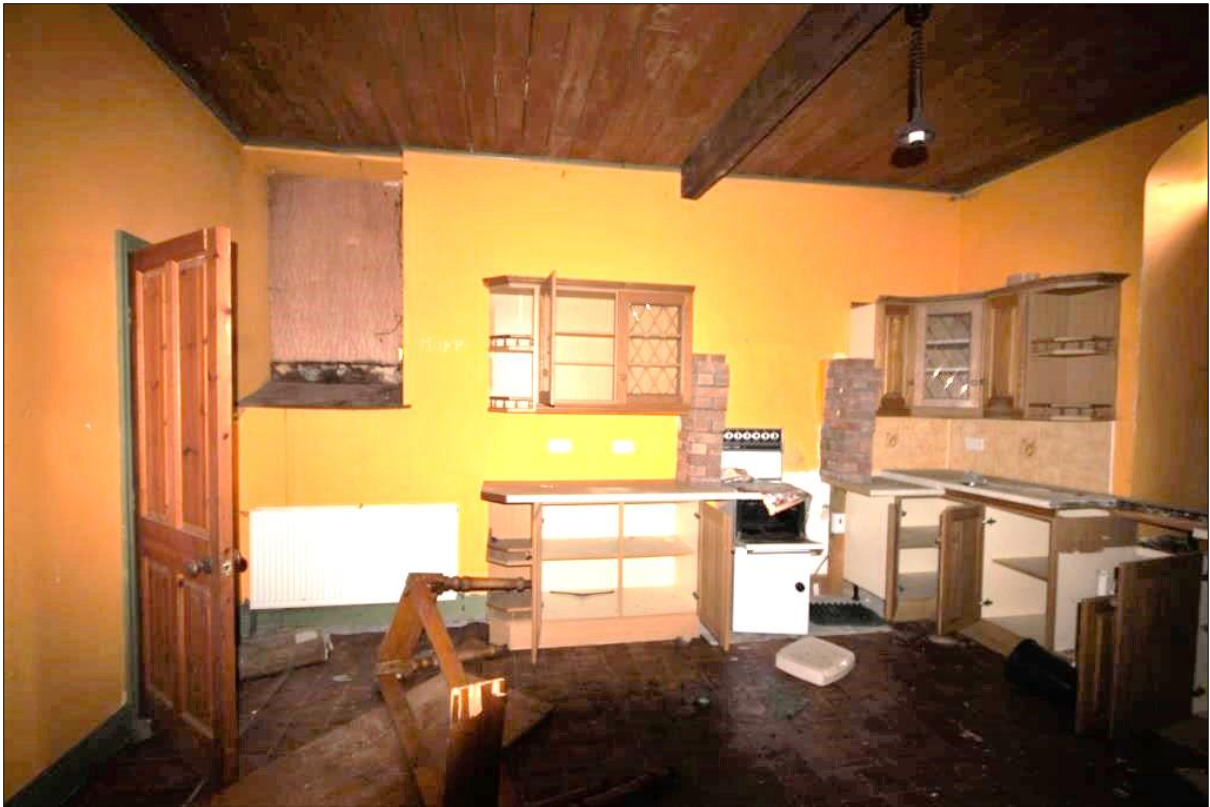
A modern doorway leads to a room to the rear GF04 which was previously in use as a kitchen. The room is lit by two original window openings with modern replacement frames. A modern

brick-built fireplace has been inserted into the corner of the room. A modern door leads to the central hallway (see **Plate 21**).

Plate 21: Ground floor room GF04

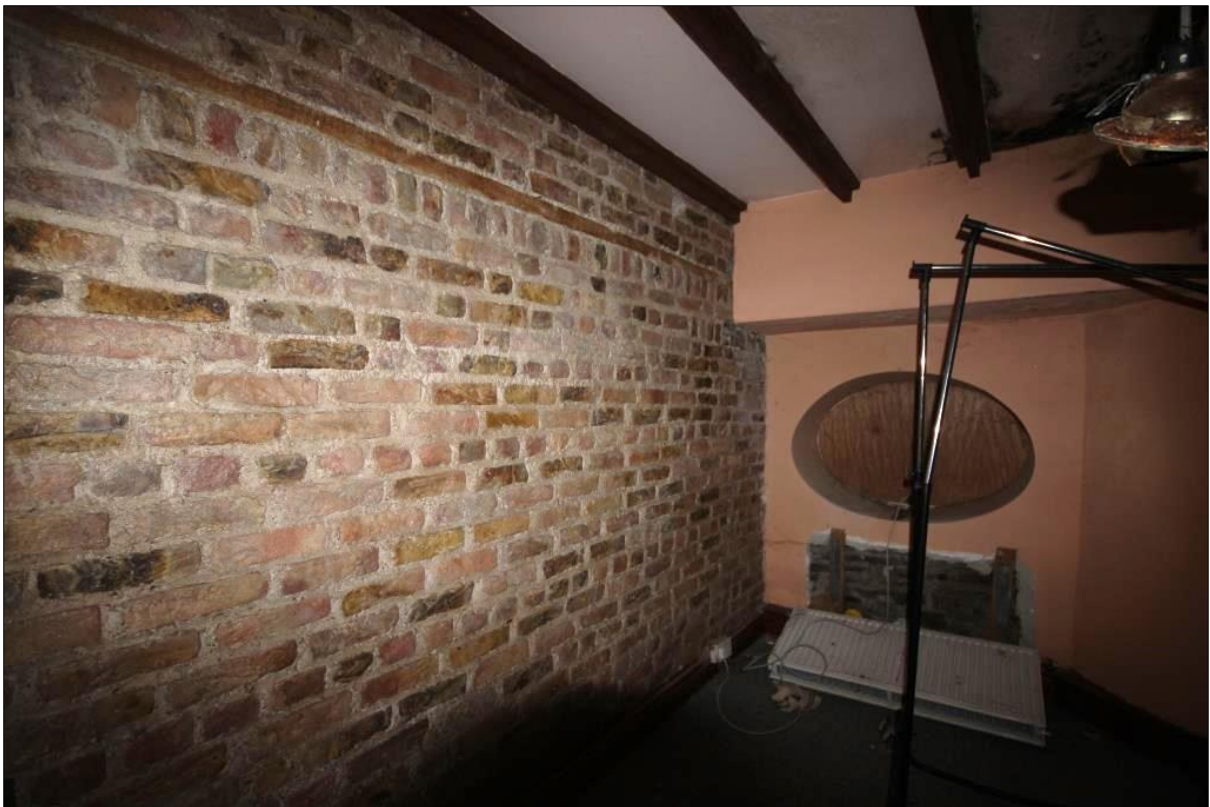
Plate 26: Original brick wall and oculus in FF06
