CHRIST THE KING PRESENTATION CONVENT, EVERGREEN ROAD, CORK CITY, CO. CORK

Architectural Heritage Impact Assessment

September 2025

Ref: 024021

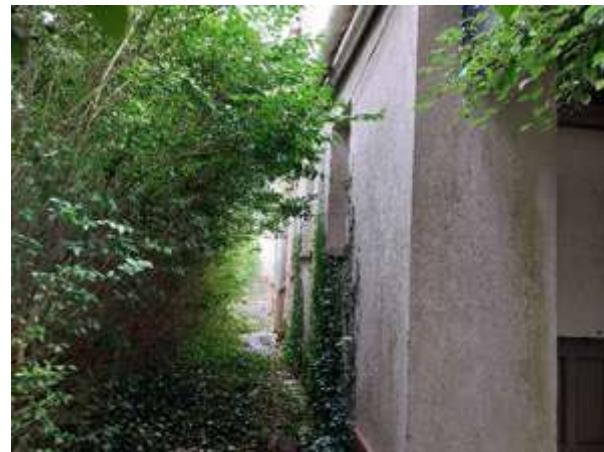
Fig.10: Vegetation overgrowth to north

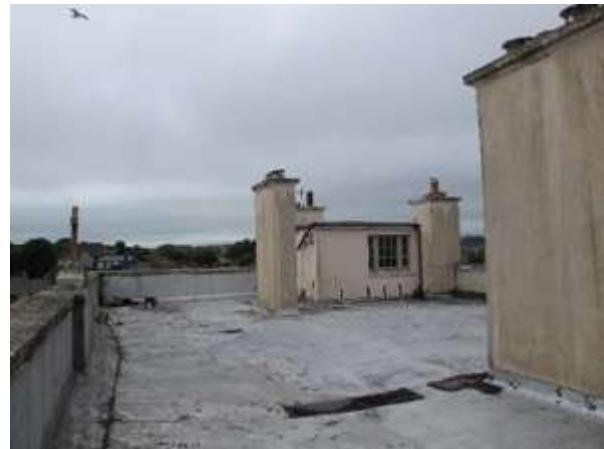
Fig.12: Looking west

Description	Flat roof with cement-rendered red brick parapets and concrete coping. Modern membrane roof covering. 4 no. chimney stacks with terracotta chimney pots. Access via staircase from second floor. Third floor of bell tower accessible on the roof.
Condition Class: Major symptoms

<ul style="list-style-type: none">Roof covering has failed. Overlay/ lining collapsed from parapets in north-east corner.Cracking and open joints to concrete coping.Cracked render to parapet.Blocked rainwater outlets. Water ponding in south-west corner, north-east corner, and on west annex.Biological growth (plant life, lichen, moss).
Probable causes	<ul style="list-style-type: none">Failed roof covering, flashing and linings.Obstructed rainwater goods.Ageing materials / weathering over time.Inadequate maintenance.
Probable Consequences	<ul style="list-style-type: none">Water ingress and consequent decay/ loss of historic fabric.Possible structural damage from long-term water ingress.

<ul style="list-style-type: none"> Interior damp with build-up of mould and/or insect infestations leading to potential structural decay and degradation of indoor air quality.
Assessment	<p>Comprehensive strategy required for repair and refurbishment to roof fabric and rainwater management system to address water ingress.</p> <p>Comprehensive strategy required to address the widespread open joints and cracking to the coping and cement render to include the removal of biological growth to address water ingress and water becoming trapped in the historic fabric and causing decay.</p> <p>Further investigation and structural assessment of roof area recommended to identify any remedial works required.</p>
Mitigation Measures	<p>Repairs to the external envelope and surface water management system to follow conservation best practice in accordance with the architectural heritage context and statutory status of the convent.</p> <p>Works to repair roof will help address the significant water ingress issues of the building thus prolonging its lifespan.</p>

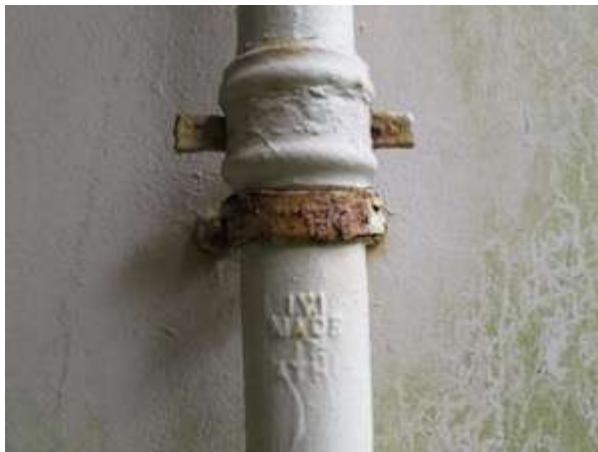
Description	Mix of original cast iron and modern replacement plastic rainwater goods, primarily painted to match elevations. Rectangular hoppers, round downpipes, plain brackets. The gutter to the west annex is plastic.
Condition Class: Moderately strong symptoms	<ul style="list-style-type: none">Rusting of the cast iron rainwater goodsVisible vegetation growth in hoppers.Algae growth on north elevation rainwater goods.
Probable causes	<ul style="list-style-type: none">Ageing, wear and inadequate maintenance.
Probable Consequences	<ul style="list-style-type: none">Poor drainage and water ponding/ retention.Rusted brackets may come away from walls.
Assessment	Rainwater goods should be cleared of plant life and debris. Modern plastic replacements should be replaced with appropriate cast iron. Refurbish rainwater goods complete. Repair and replace damaged sections only where necessary.

Fig.20: Down pipe on west elevation marked 'I.V.I
MADE IN ATHY'

<p>Ensure rainwater system is adequate for increased deluge rain events. Additional provision of capacity may be required.</p> <p>Drainage inspection recommended to ensure effective direction of water away from the historic fabric.</p>
Mitigation Measures	<p>Refurbishing the rainwater goods and replacing inappropriate modern elements will improve both the functionality and the historic character.</p> <p>If/where required, provision of additional capacity should follow conservation best practice.</p>

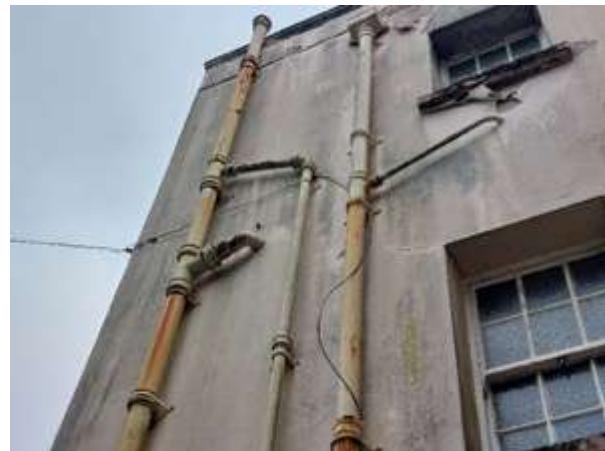
Fig.23: Rust to brackets and down pipe

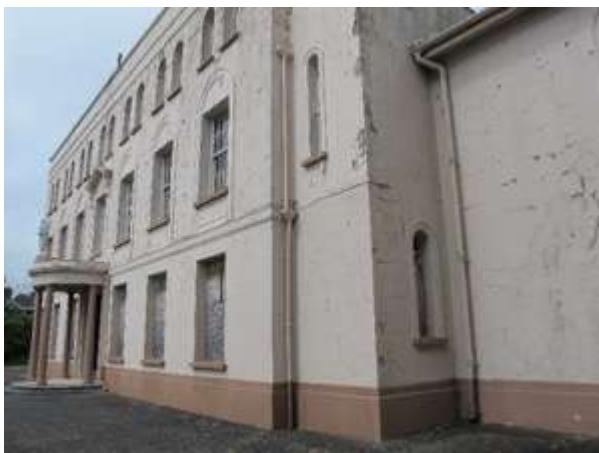
Fig.24: South elevation walls (looking west)

Description	Red brick walls with a painted cement render, investigated through opening up works. Decorative detailing to the render includes low relief moulded render plat bands and first floor window surrounds to south elevation of the principal building. There appears to have previously been a porch added and later removed to the north elevation (see Fig. 30).
Condition Class: Major symptoms	<ul style="list-style-type: none">Widespread, extensive, and significant cracking to cement render.Cracking, flaking, and peeling paintwork.Algae growth to north elevation.Ivy climbing walls.
Probable causes	<ul style="list-style-type: none">Cement render is non-porous and rigid, trapping water and cracking.Impermeable paint preventing water from exiting the building fabric.Ageing materials and inadequate maintenance.Water ingress from ponding on roof and through open joints and cracks exacerbating decay actions.Overgrowth of surrounding vegetation.

Probable Consequences	<ul style="list-style-type: none"> • Water ingress and consequent decay of historic fabric. • Continued deterioration of condition and structure. • Build-up of mould growth to interior.
Assessment	<p>Water ingress to the historic building fabric and to the interior is widespread and significant. The cracked render must be addressed to prevent further water ingress and damage. A comprehensive strategy is required to address the failed render in order to safeguard the building fabric and to allow the future use of the building. The removal and appropriate replacement of the cement render may be required to achieve this. To address the underlying causes of the failure of the render, a more flexible, vapour-permeable render mix and finish should be considered.</p> <p>Maintenance management works to surrounding vegetation.</p>
Mitigation Measures	<p>The strategy to address the failed render should be developed in collaboration with appropriately qualified specialists in order to ensure material compatibility as well as maintenance of character.</p> <p>The strategy to address the failed render must take into account conservation best practice and the architectural heritage context and statutory status of the convent. The existing render is a significant feature of the building, the decorative detail to the render is modest but forms an integral part of the character of the principal façade. Where it is considered necessary for the render to be removed, the existing decorative detail should be carefully recorded prior to removal and replaced to match by suitably qualified specialists.</p> <p>Any replacement render and finish should address the underlying causes of the failure of the existing render through its material properties in order to assure the effective functioning of the building envelope and to facilitate the ongoing use of the building.</p>

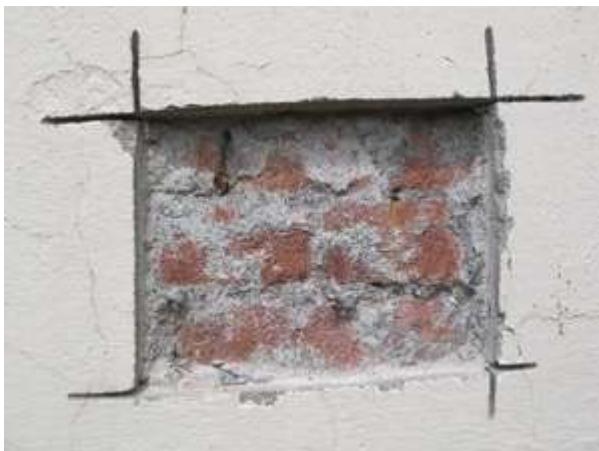
Fig.26: Incision of wall on south elevation

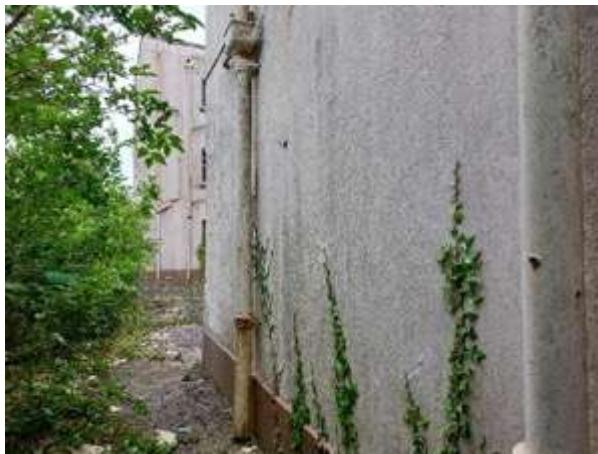
Fig.29: Ivy and algae growth on north elevation

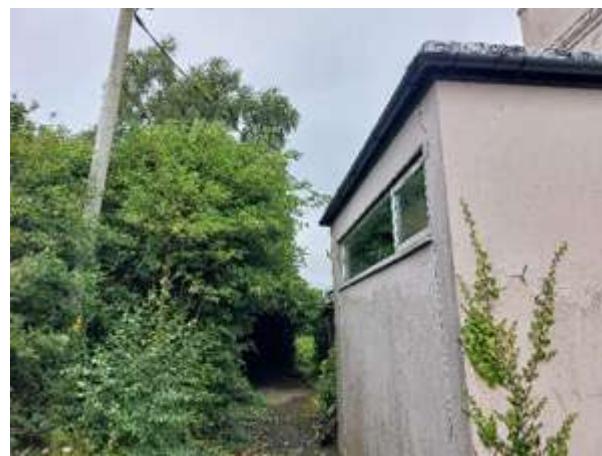
Fig.34: Windows of west elevation

Description	Windows throughout are generally square-headed multi-pane timber sliding sashes with ogee horns except for stained glass windows to chapel building (see separate sections on bell tower, chapel and sacristy annex below). Plywood affixed to exterior
--------------------	---

Probable causes	<ul style="list-style-type: none"> Water ingress causing swelling of timbers. Lost or inadequately maintained opening mechanisms. Damage and water ingress to surrounding walls. Ageing, wear, and inadequate maintenance.
Probable Consequences	<ul style="list-style-type: none"> Unopenable windows. Water ingress and consequent decay of historic fabric. Continued deterioration of condition and structure. Lack of ventilation. Build-up of mould growth to interior.
Assessment	<p>The bottom rails could not be assessed due to affixed plywood of ground floor windows.</p> <p>The windows appear to be in moderate condition, with no visible evidence of extreme timber decay despite the water ingress to the walls. A comprehensive strategy to address the issues to the external envelope in general is required as continued lack of maintenance, repair, and refurbishment will cause deterioration to the windows.</p> <p>Windows to be repaired and refurbished to working order throughout. Window reveals to be refinished in coordination with the external render strategy. Paint and biological growth to be removed from the sills and appropriate repairs carried out.</p> <p>Investigation and structural assessment of lintels is recommended particularly given the extensive water ingress to the external walls.</p>

Mitigation Measures	Window refurbishment should be carried out by suitably experienced operatives to maintain the historic character of the building and ensure its effective ongoing use.

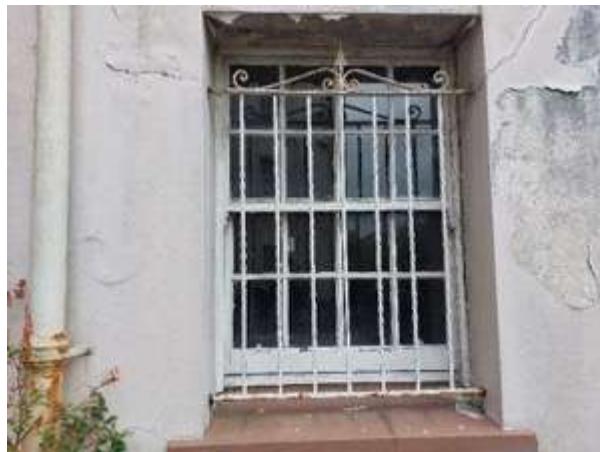
Fig.36: Paint flaking and cracking to north elevation window surround, note decoratively-detailed iron guarding

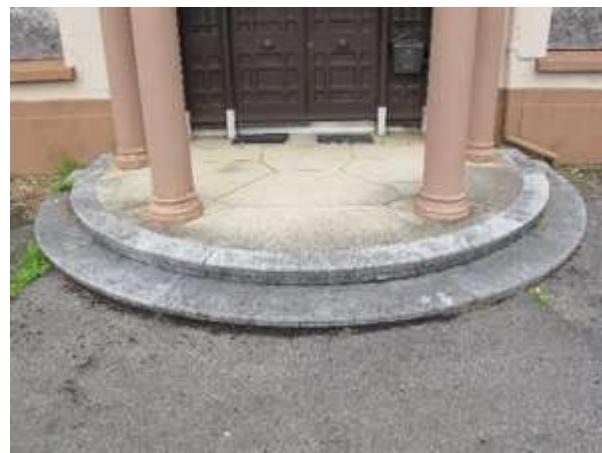
Fig.43: Entrance porch.

Description	Semi-circular projecting porch with 4 no. tapered doric columns. Moulded entablature supporting statue of the Virgin Mary and Child. Two stone steps up to the terrazzo floor.
Condition Class: Major symptoms

<ul style="list-style-type: none"> • Signs of water ingress and cracking to entablature and ceiling. • Cracking and crumbling to lintel/entablature over door, area currently secured with a mesh. • Biological growth. • Overpainting. Cracked, flaking, and peeling paint. • Impermeable paint trapping water. Large blister to paint on column. • Cracking and plant growth to the terrazzo.
Probable causes	<ul style="list-style-type: none"> • Water ingress. • Ageing, wear, and inadequate maintenance. • Use of inappropriate materials such as impermeable paint to columns.
Probable Consequences	<ul style="list-style-type: none"> • Possible structural damage to lintels. • Further loss of historic fabric. • Continued water ingress and consequent decay of historic fabric. • Continued plant life causing further cracking.

Assessment	<p>Access for close inspection of the roof was not possible. External survey was from ground level only with no high access.</p> <p>The roof of the porch is showing clear signs of water ingress and damage. Following removal of the paint further inspection and investigative works to be carried out to determine the extent of damage and repairs required.</p> <p>Investigation and structural assessment of the roof, entablature, lintel, and columns is recommended particularly given the extensive water ingress to the external walls and clear signs of decay.</p> <p>Removal of biological growth and any redundant modern services and fixings.</p> <p>Roof finish, flashings, and rainwater management system to be inspected and refurbished to direct water away from the historic fabric. Additional rainwater capacity may be required to cope with increased deluge events.</p>

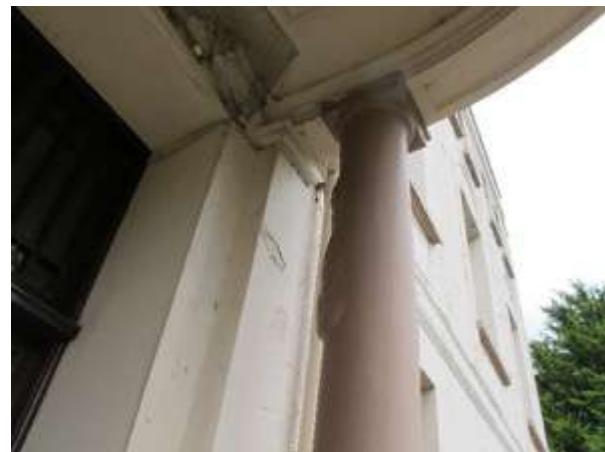
Fig.45: Bulging impermeable paint on column trapping water

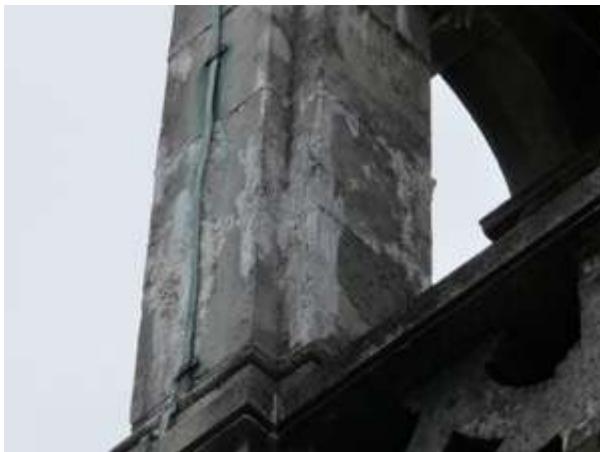
Fig.54: Leached deposits to final stage. Note lightning conductor

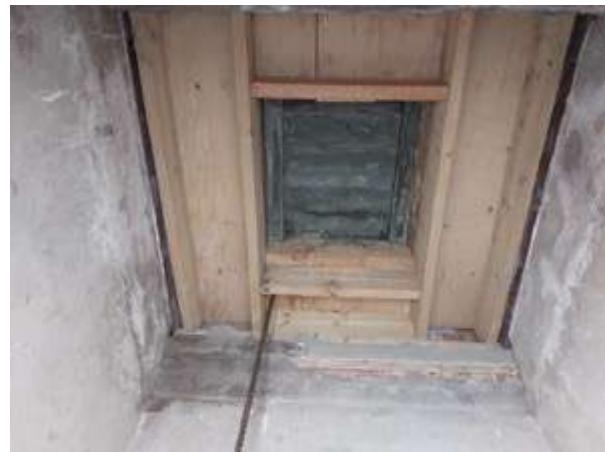
Fig.55: Repairs to platform to final stage. Bell rope remains in situ. Note leaching and efflorescence to walls at high level

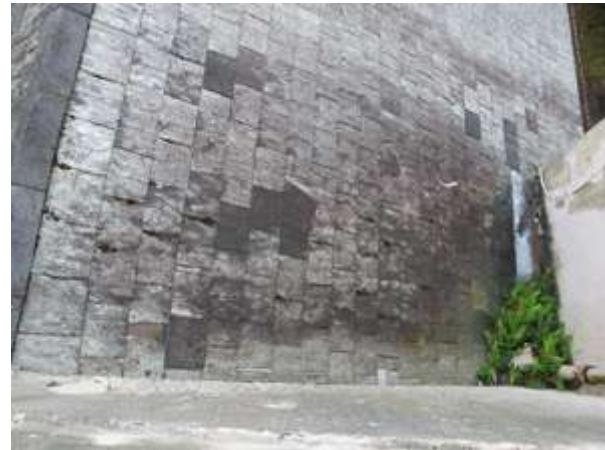
Fig.57: Blocked drainage at bell tower north wall

Description	Cast iron rainwater goods, painted to match walls. Gutters, down pipes, and simple brackets.
Condition Class: Moderately strong symptoms	<ul style="list-style-type: none"> Visible rusting of cast iron. Missing portions eg. down pipe from base of ashlar masonry upper stage. Plant life blocking drainage.
Probable causes	<ul style="list-style-type: none"> Ageing, wear, and inadequate maintenance.
Probable Consequences	<ul style="list-style-type: none"> Water ingress and consequent decay of fabrics. Blocked drainage can cause water ingress.
Assessment	Debris build up to roof gutters cannot be assessed due to lack of access.

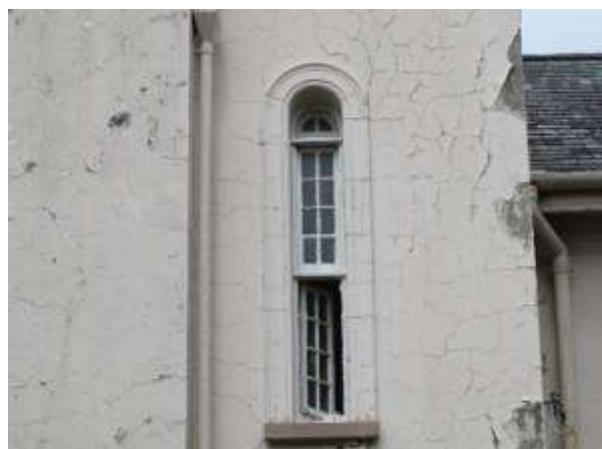
Fig.63: First floor window

Description	6 no. windows to the bell tower. 3 no. multi-pane round-headed timber casement windows with moulded render surrounds and concrete windowsills. 3 no. round windows to third floor with moulded render surrounds.
Condition Class: Minor symptoms	<ul style="list-style-type: none"> Windows are in situ but generally not fully operational. Plywood affixed to ground floor window. Visible glass appears intact. Cracking and flaking to moulded render surrounds.
Probable causes	<ul style="list-style-type: none"> Ageing, wear, and inadequate maintenance.

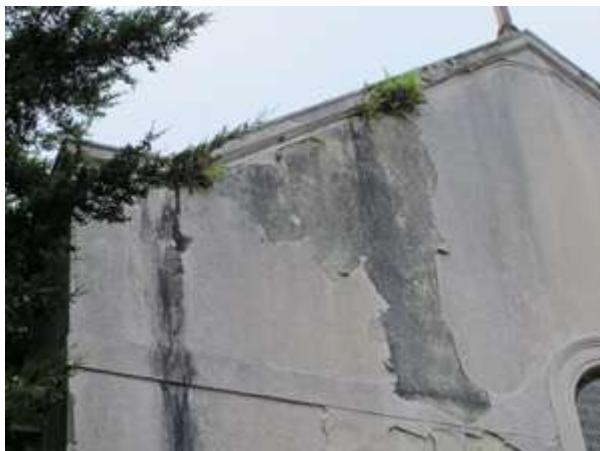
Fig.69: East elevation, damage to exterior wall and plant growth along mouldings

Mitigation Measures	Maintenance of vegetation on property will improve surrounds and prevent damage to historic fabrics, improving its historic character.

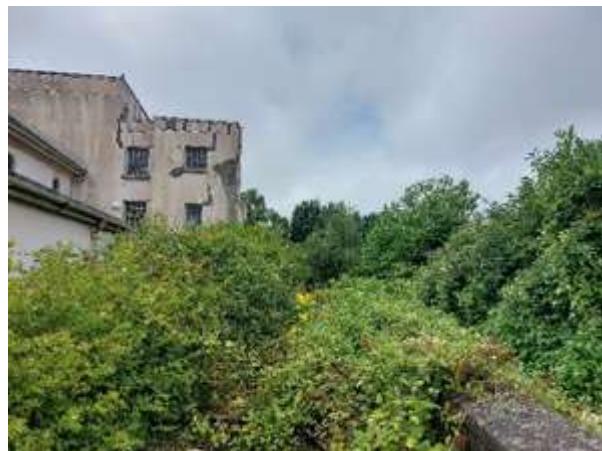
Fig.70: Overgrown vegetation to north

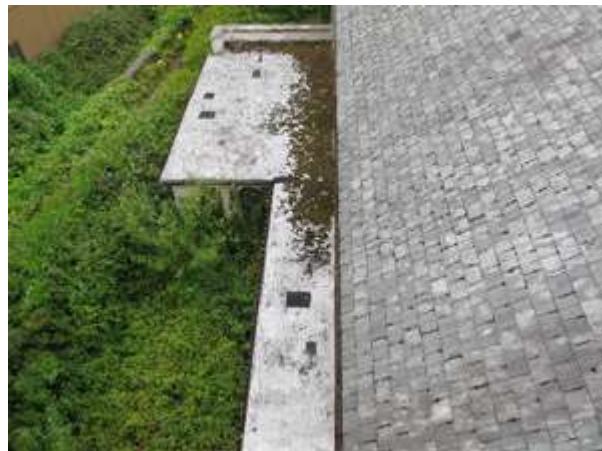
Fig.72: Roof of sacristy annex with moss growth

Description	Chapel: pitched natural slate roof. Terracotta ridge tiles. Parapet at east gable with concrete coping having cross to apex. Sacristy annex: flat roof. Partial parapet at east with concrete coping.
Condition Class: Moderately strong symptoms	Chapel: <ul style="list-style-type: none">• Biological growth on and between slates, to gutters and to cracks to coping.• Cracking to slates, loose slate.• Replacement slates inappropriately fixed. Sacristy annex: <ul style="list-style-type: none">• Ponding and biological growth to flat roof.• Cracking to concrete coping to flat roof.
Probable causes	<ul style="list-style-type: none">• Poor drainage and/ or blocked rainwater goods.• Age and inappropriate repairs.• Note also large tree at southwest overhanging pitched roof.
Probable Consequences	<ul style="list-style-type: none">• Water ingress and consequent decay of interior and exterior fabrics.• Water ponding.• Water ingress to fabric underlying slates.

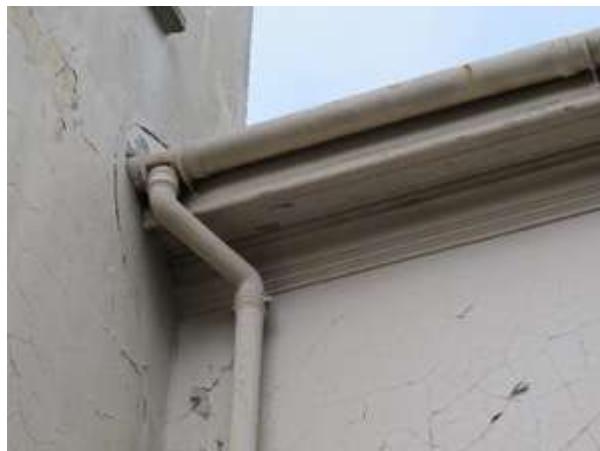
Fig.75: Gutter and down pipe on south elevation

Description	Cast iron rainwater goods painted to match walls. Gutters, down pipes, and simple brackets.
Condition Class: Moderately strong symptoms	<ul style="list-style-type: none"> Rusting of cast iron. Debris and plant life creating blockages. Visible algae growth.
Probable causes	<ul style="list-style-type: none"> Age and lack of maintenance.
Probable Consequences	<ul style="list-style-type: none"> Poor drainage and water ingress. Rusted brackets may come away from walls.
Assessment	Rainwater goods should be cleared of plant life and debris. Repair/ replace damaged sections.

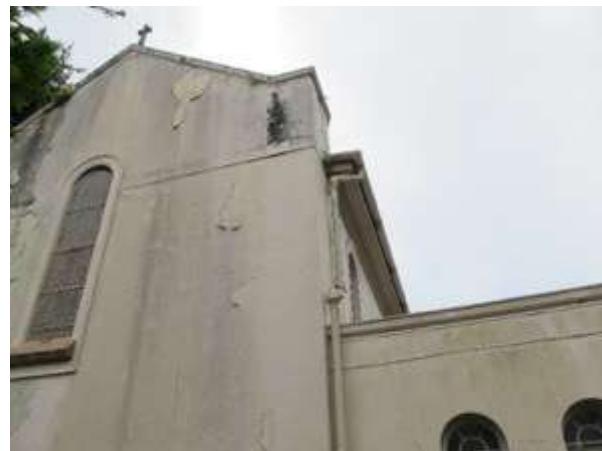
Fig.76: Gutter and down pipe on east elevation

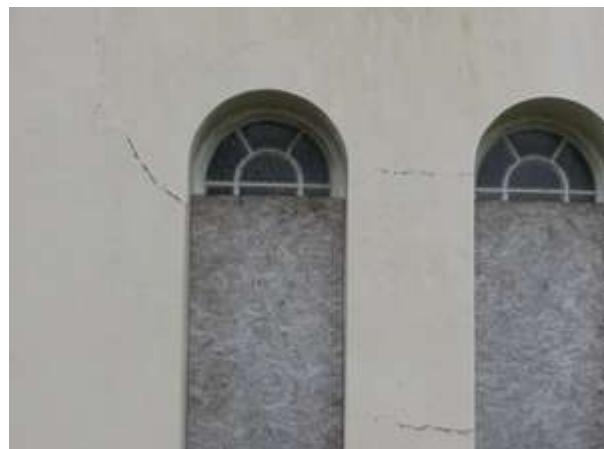
Fig.82: Cracks to render on east elevation

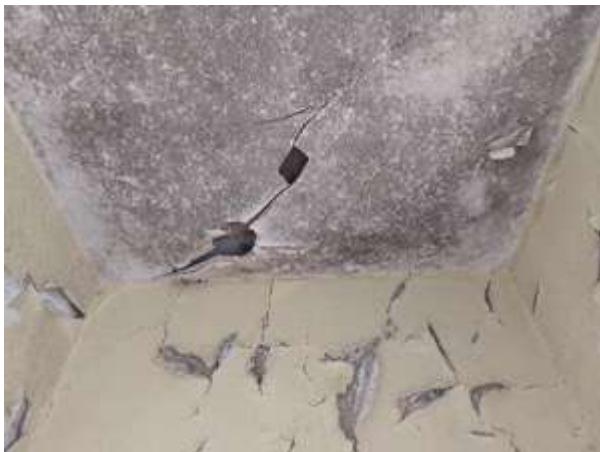
Assessment	<p>Ceilings, particularly to the upper floors, are showing significant signs of water ingress with consequent damage, decay, and mould growth. The risk of insect infestation, toxic mould build up, structural damage and fabric degradation is considerable. There are possible structural implications from the long-term water ingress and lack of adequate drainage which may be causing structural damage to the historic fabric. Further investigation and structural assessment of ceilings recommended to identify extent of remedial works required.</p> <p>Sources of water ingress (roof, exterior render, etc) to be investigated and resolved.</p> <p>Areas affected by damp, mould, efflorescence, and water ingress will require repair to plaster and paint.</p>
Mitigation Measures	Repairs to be carried out in compatible materials. Where decorative detailing exists this should be retained and repaired where necessary to match the existing.

Fig.94: Mould build up and consequent damage to ceiling (EX1-03)

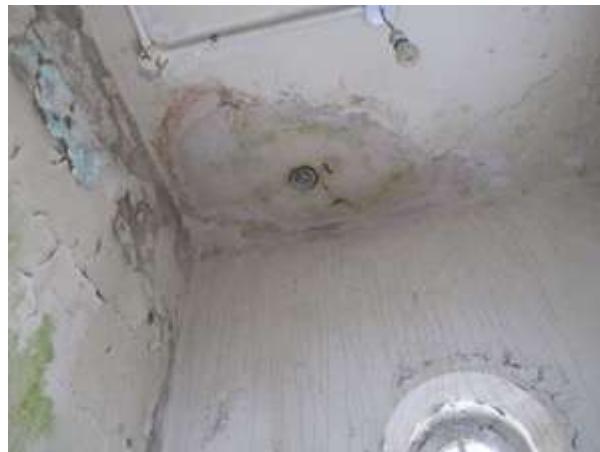
Fig.95: Bell tower ceiling showing signs of water ingress and previous repair (EX2-16)

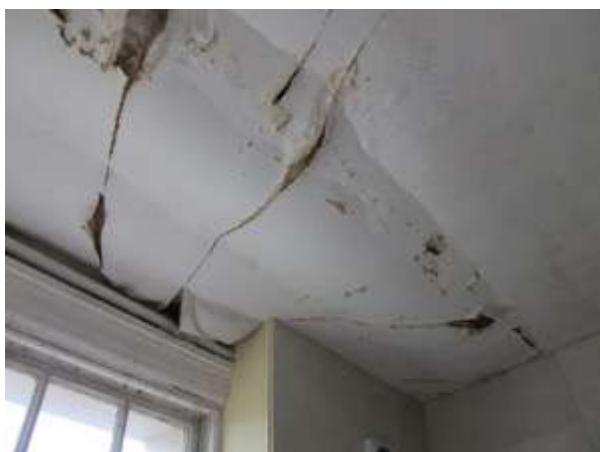
Fig.96: Ceiling sagging and cracking (EX2-10)

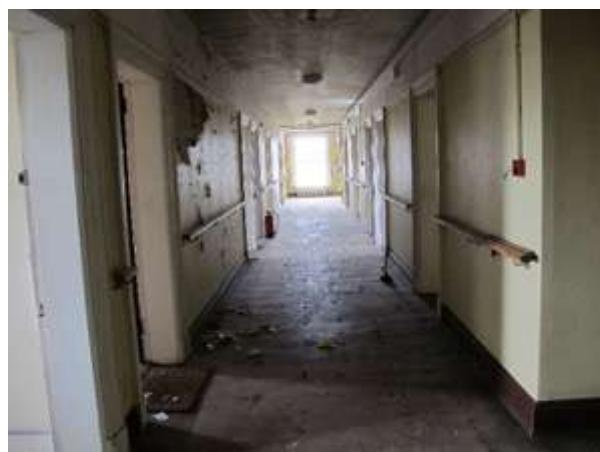
Fig.97: Second floor corridor ceiling is sagging (EX2-01)

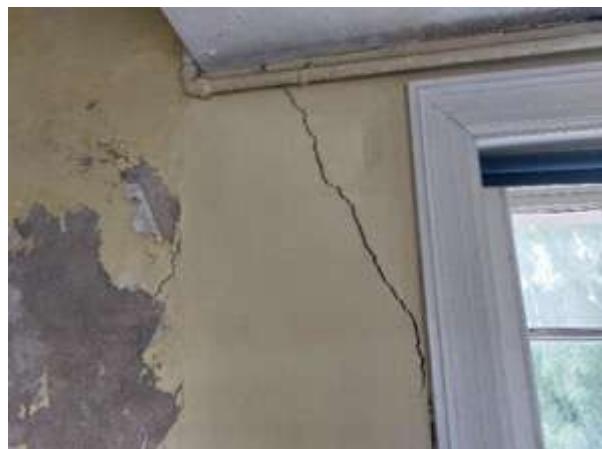
Fig.105: Crack in wall on west staircase to second floor (EX2-01)

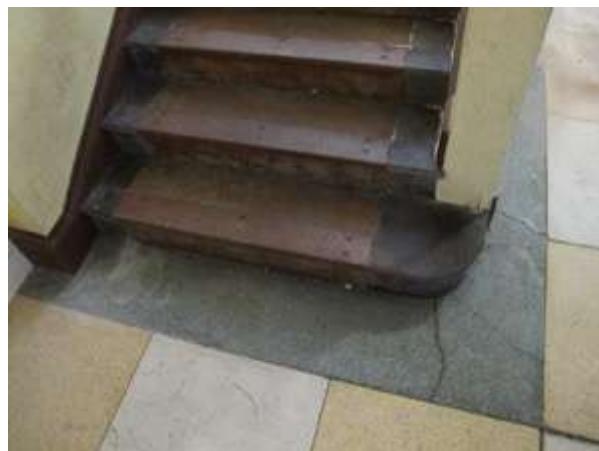
Fig.110: Cracking to ground floor flooring at east staircase (EXG-13)

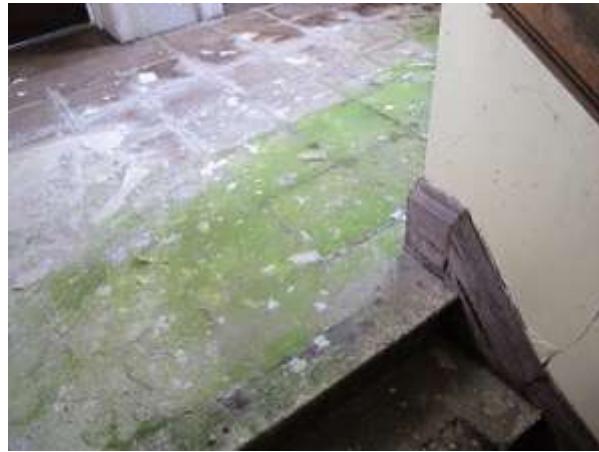
Fig.112: Damage to cork tiles under previously leaking water tank at second floor east staircase (EX2-12)

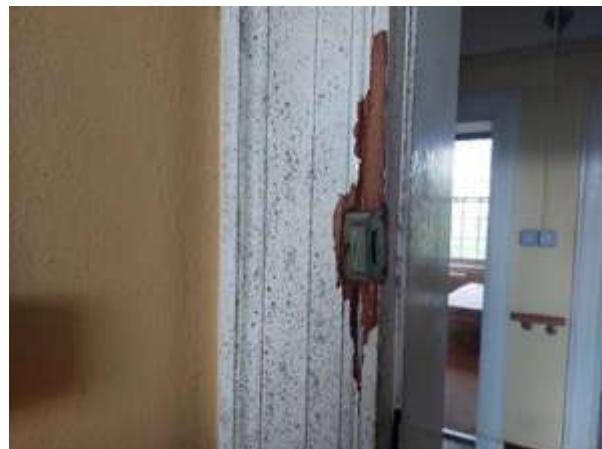
Fig.122: Damage and mould build up to timber frame (room EX1-22)

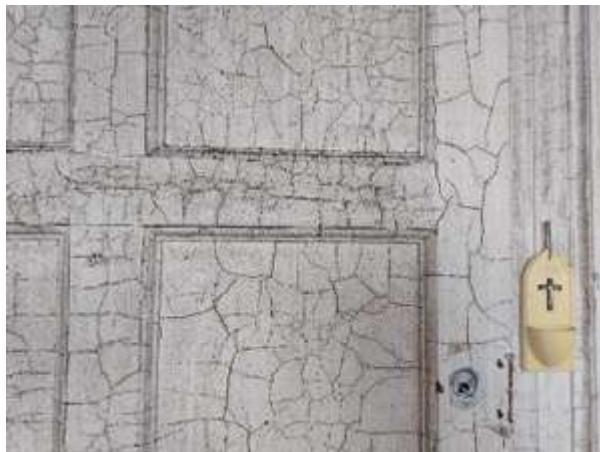
Fig.123: Damaged paint of timber six-panelled door (room EX1-20)

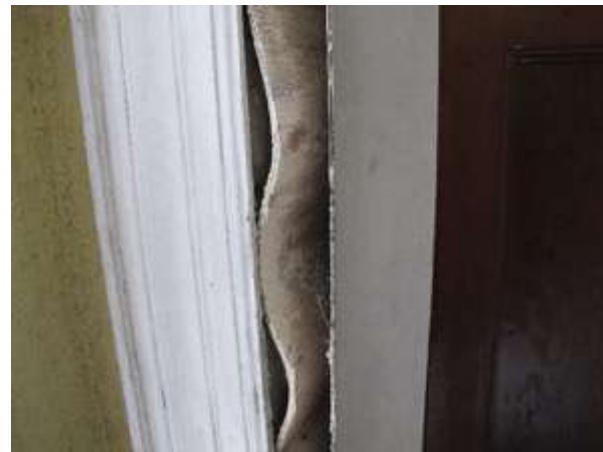
Fig.124: Disintegration of timber door frame (EXG-10)

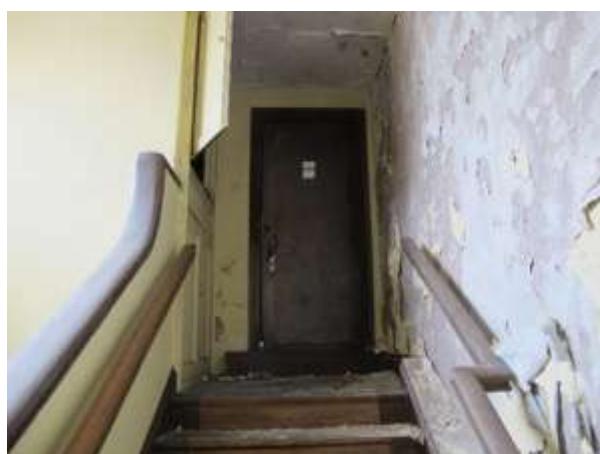
Fig.125: Broken door leading to roof on west staircase of third floor

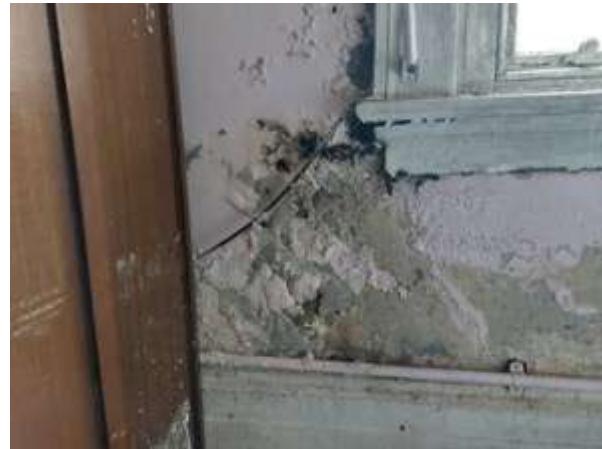
Fig.139: Mould build up around timber sill (EXG-05)

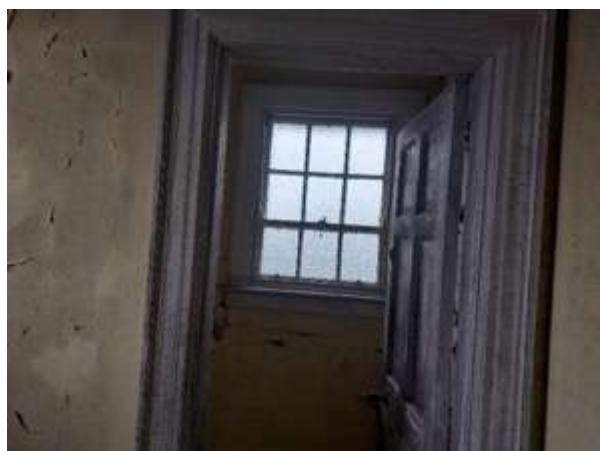
Fig.146: Mould build up and paint damage to timber architrave (EX2-03)

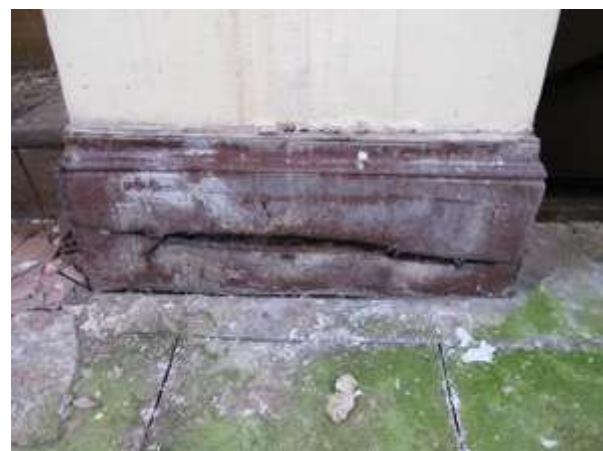
Fig.147: Water ingress and timber decay in skirting (EX2-12)

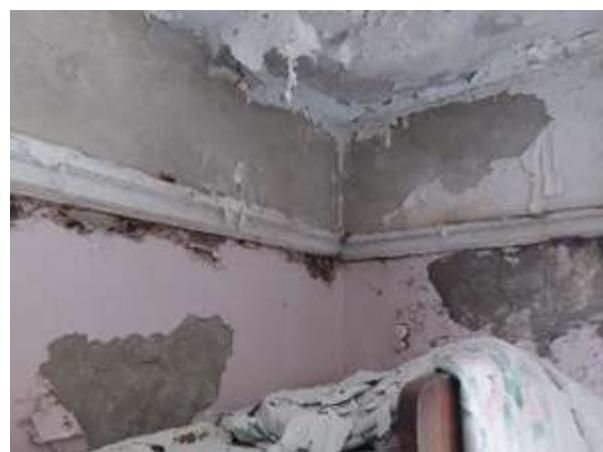
Fig.149: Damaged timber picture rail (EXG-05)

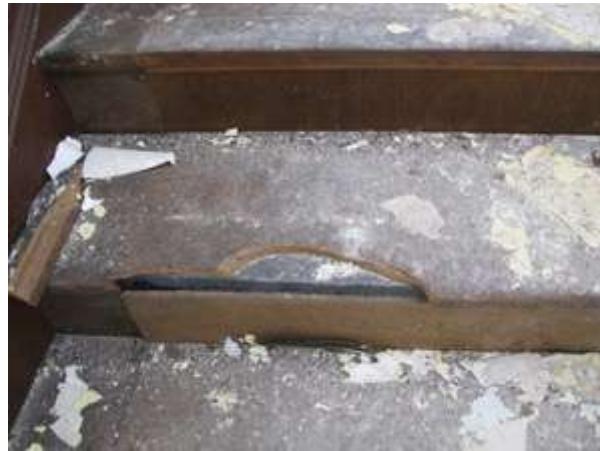
Fig.155: Damage to cork tile on west staircase to roof (EX2-01)

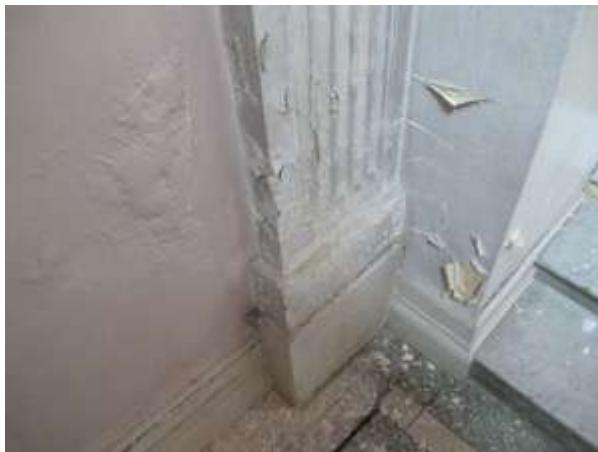
Fig.163: Bubbling to rendered plaster wall and surround

Mitigation Measures	Resolving water ingress will allow better conservation of plasterwork.

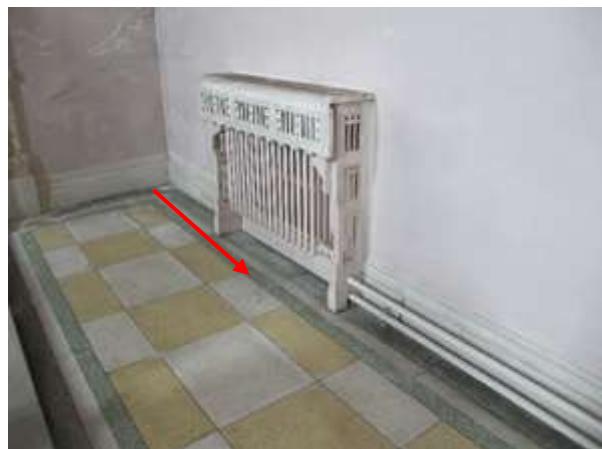
Fig.172: Slight crack to terrazzo indicated with red arrow (south side of altar)

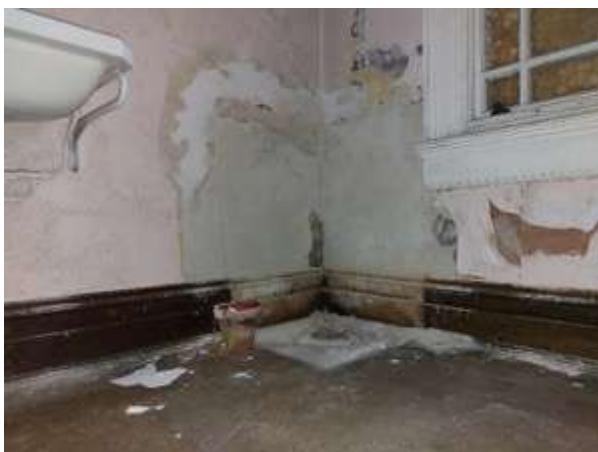
Condition Class: Minor symptoms	<ul style="list-style-type: none">• Mould build up to some parts of timber.• Timbers appears in relatively sound condition despite signs of significant water ingress to walls.• All glass panes intact.
Probable causes	<ul style="list-style-type: none">• Water ingress.• Age, use, and lack of maintenance.
Probable Consequences	<ul style="list-style-type: none">• Water ingress and consequent deterioration of fabrics.
Assessment	Sources of water ingress to be investigated and resolved. Windows require refurbishment to good working order.
Mitigation Measures	Window refurbishment would have a positive impact on the historic character of the building.

Fig.183: Signs of water ingress and previous repair to wall adjacent to timber frame (EXG-29)

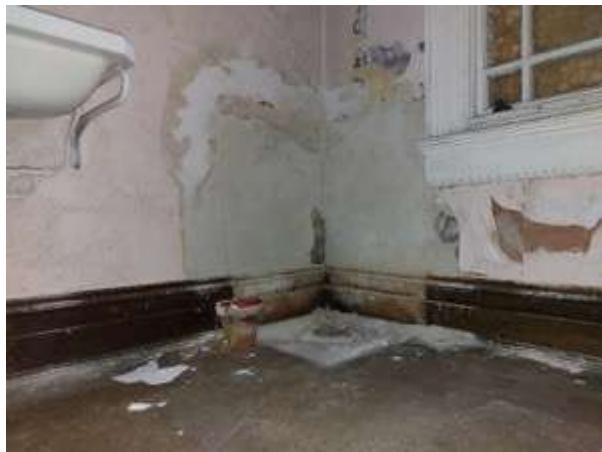
Description	Timber architraves and skirtings. Moulded fluted architraves to doors in chapel. Simple timber architraves, window surrounds, and skirtings in the sacristy annex.
Condition Class: Moderately strong symptoms	<ul style="list-style-type: none">• Mould build up.• Cracking, peeling, and flaking paint.• Bubbling to walls around skirtings.
Probable causes	<ul style="list-style-type: none">• Water ingress.• Damp atmosphere of interior.• Age and lack of maintenance.
Probable Consequences	<ul style="list-style-type: none">• Continued water ingress could lead to decay of historic fabrics.• Increased mould build up.
Assessment	Sources of water ingress to be investigated and resolved. The timber architraves, surrounds, and skirtings are a decorative element of the chapel and sacristy. Following solving the water ingress issues, damaged timber elements should be refurbished.
Mitigation Measures	Refurbishing damaged areas of timber architraves, surrounds, and skirting would have a positive impact on the historic character of the building.

Fig.187: Stained and damaged timber skirting (EXG-29)

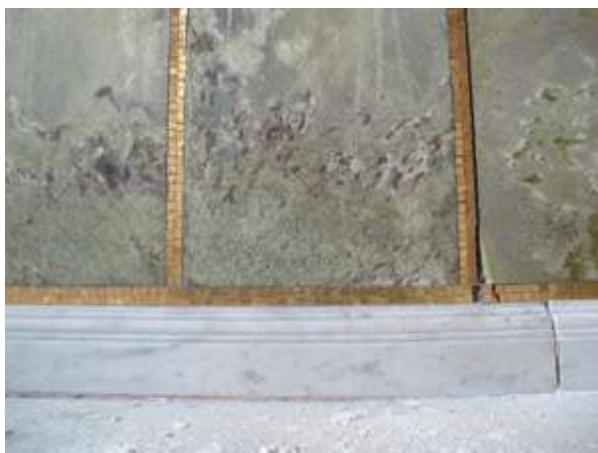
Probable causes	<ul style="list-style-type: none">• Water ingress.• Damp atmosphere of interior.• Age, use, and lack of maintenance.
Probable Consequences	<ul style="list-style-type: none">• Damage, decay, and possible loss of historic and religious features.• Continued mould build up.
Assessment	The chapel and sacristy annex have several features associated with the original function of this space. They appear in relatively good condition, but the issue of water ingress remains. This should be investigated and resolved at the source (exterior render and roof) to ensure longevity of historic fabrics.
Mitigation Measures	Resolving water ingress issue to conserve features.

Fig.197: Slight damage to reredos
