Stage 1 Quality Audit Response Document

Proposed Residential Development at Anglesea Terrace,  
Old Station Road, Cork

H105-CSC-ZZ-XX-RP-C-0006

## Stage 1 Quality Audit

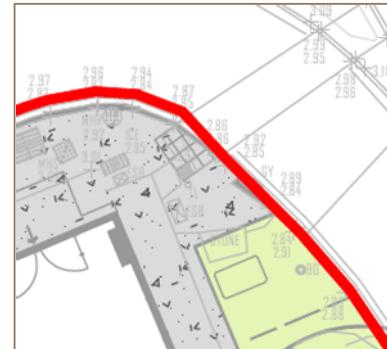
#### A.1.1 Tactile Paving Stem

The stem of the tactile paving at the existing signalised pedestrian crossing on the western side of South City Link Road does not extend to the back of the footpath. This may lead to visually-impaired pedestrians travelling at the back of the footpath being unable to detect the tactile paving and subsequently the crossings resulting in them being unable to safely and independently navigate the road layout.

The stem of the tactile paving has been extended to the back of the footpath at the location of the crossing as recommended. Please refer to CS drawing no. **H105-CSC-XX-XX-DR-C-0013**.

The stem of the tactile paving should extend to the back of the footpath at the location of the crossing.

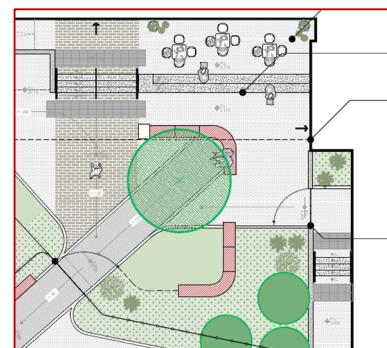
*A tree is located in the middle of the pedestrian footway, which may represent an obstacle for visually impaired pedestrians.*

The pathway shall stop before the secondary plaza area and shall have a kerb delineation between the pathway and plaza area.

The tree should be relocated outside the path where it will not present an obstacle to visually impaired pedestrians.

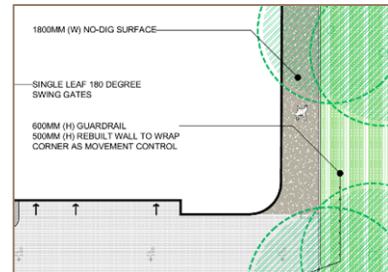
The footpath on the eastern side of the proposed development is indicated as 'no dig surface'. It is unclear if this is a bound material. If the surface is not composed of a bound material, it may be more susceptible to rutting and a resulting increased risk of ponding, leading to slips and falls for pedestrians, particularly during wet and icy weather conditions.

The no dig surface shall be composed of a bound material.

The proposed 'no dig surface' should be composed of a bound material.

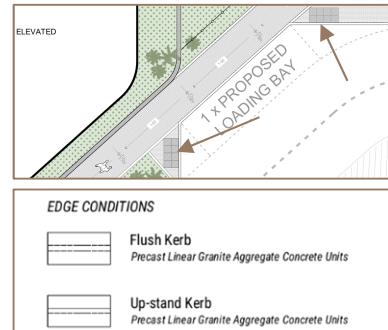
#### A.1.5 Absence of Dropped Kerbs

*Dropped kerbs, where tactile paving arrangement is proposed, has not been indicated at the loading bay on the western side of Anglesea Terrace, so it is unclear how mobility impaired vehicle occupants will travel between the parking space and the adjacent footpath.*

Dropped kerb shall be provided at the locations of tactile paving to ensure that the mobility impaired users can safely travel between the parking spaces and the adjacent footpath.

Ensure mobility impaired users can safely travel between the parking spaces and the adjacent footpath.

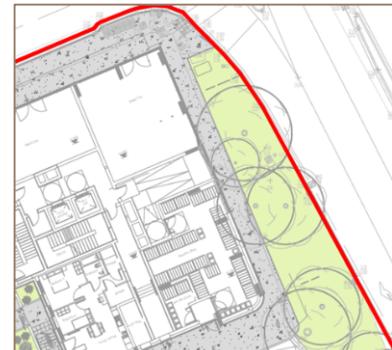
*Trees are indicated as overhanging the footway located on the eastern side of the development. The specification of tree is unclear, but low hanging canopies may increase the risk of head strikes, leading to personal injury.*

These canopies are of existing trees, and will be subject to BS5837 trees in relation to design, demolition and construction. It is understood that the existing canopy is notably above head clearance height, and any local pruning shall be coordinated and conducted by trained arboriculture specialist.

Ensure tree canopies are at least 2.3m above the footway, or 2.5m if cyclists are expected to use the pavement.

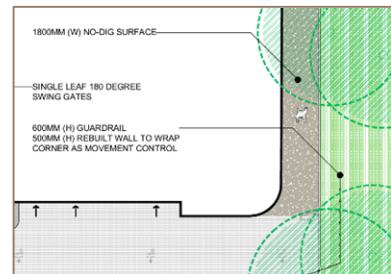
#### C.1.1 Surface of Footpath

The footpath on the eastern side of the proposed development is indicated as 'no dig surface'. It is unclear if this is a bound material. If the surface is not composed of a bound material, it may be more susceptible to rutting and a resulting increased risk of ponding, leading to slips and falls for pedestrians, particularly during wet and icy weather conditions.

The no dig surface shall be composed of a bound material.

The proposed 'no dig surface' should be composed of a bound material.

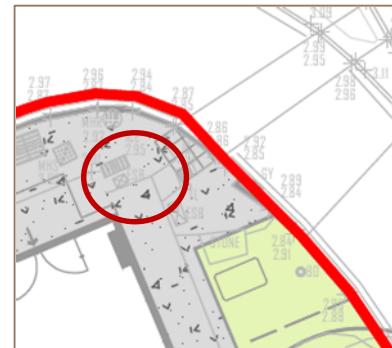
Summary: *The stem of the tactile paving at the signalised pedestrian crossing on South City Link Road at its junction with Old Station Road does not extend to the rear of the footpath.*

The stem of the tactile paving at the existing signalised pedestrian crossing on the western side of South City Link Road does not extend to the back of the footpath. This may lead to visually-impaired pedestrians travelling at the back of the footpath being unable to detect the tactile paving and subsequently the crossings resulting in them being unable to safely and independently navigate the road layout.

*The stem of the tactile paving has been extended to the back of the footpath at the location of the crossing as recommended. Please refer to CS drawing no. **H105-CSC-XX-XX-DR-C-0013**.*

The stem of the tactile paving should extend to the back of the footpath at the location of the crossing.

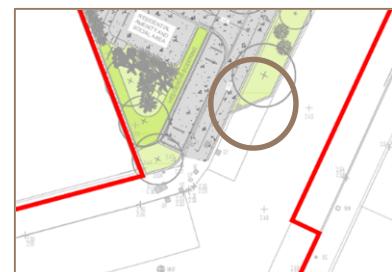
Summary: *The location of a build-out after the horizontal curve may lead to wheel strikes.*

A new build-out has been indicated on Anglesea Terrace, to the south of the proposed development. The build-out commences shortly after a horizontal curve, so may not be clearly visible to drivers on Anglesea Terrace. This may increase the risk of wheel strikes and material damage collisions.

*The build out has been extended to smoothly tie-in with the kerb line at the corner of Anglesea Terrace. Please refer to CS drawing no. **H105-CSC-XX-XX-DR-C-0013**.*

The build-out should be extended to smoothly tie-in with the kerb line at the corner of Anglesea Terrace.

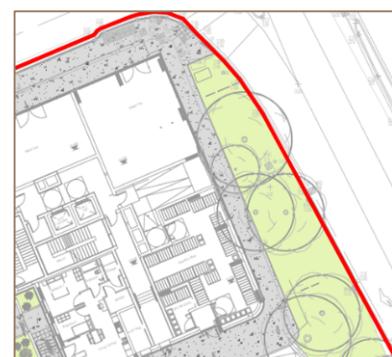
Summary: *Overhanging trees may increase the risk of head strikes*

Trees are indicated as overhanging the footway located on the eastern side of the development. The specification of tree is unclear, but low hanging canopies may increase the risk of head strikes, leading to personal injury.

These canopies are of existing trees, and will be subject to BS5837 trees in relation to design, demolition and construction. It is understood that the existing canopy is notably above head clearance height, and any local pruning shall be coordinated and conducted by trained arboriculture specialist.

Ensure tree canopies are at least 2.3m above the footway, or 2.5m if cyclists are expected to use the pavement.

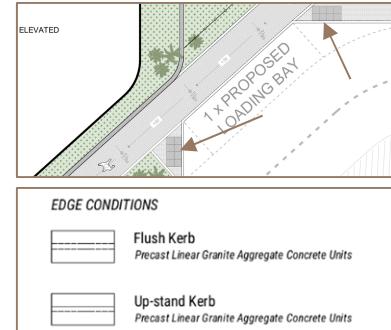
Dropped kerbs, where tactile paving arrangement is proposed, has not been indicated at the loading bay on the western side of Anglesea Terrace, so it is unclear how mobility impaired vehicle occupants will travel between the parking space and the adjacent footpath.

Dropped kerbs have been proposed on both sides of the loading bays to ensure that mobility-impaired users can safely travel between the parking spaces and the adjacent footpath.

Ensure mobility impaired users can safely travel between the parking spaces and the adjacent footpath.

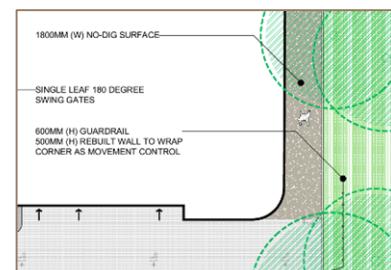
The footpath on the eastern side of the proposed development is indicated as 'no dig surface'. It is unclear if this is a bound material. If the surface is not composed of a bound material, it may be more susceptible to rutting and a resulting increased risk of ponding, leading to slips and falls for pedestrians, particularly during wet and icy weather conditions.

The no dig surface shall be composed of a bound material.

The proposed 'no dig surface' should be composed of a bound material.
