C1019-OCSC-XX-XX-RP-S-0001

Condition Survey Report for
Glanmire to Dunkettle roundabout
R639 Road Boundary Wall

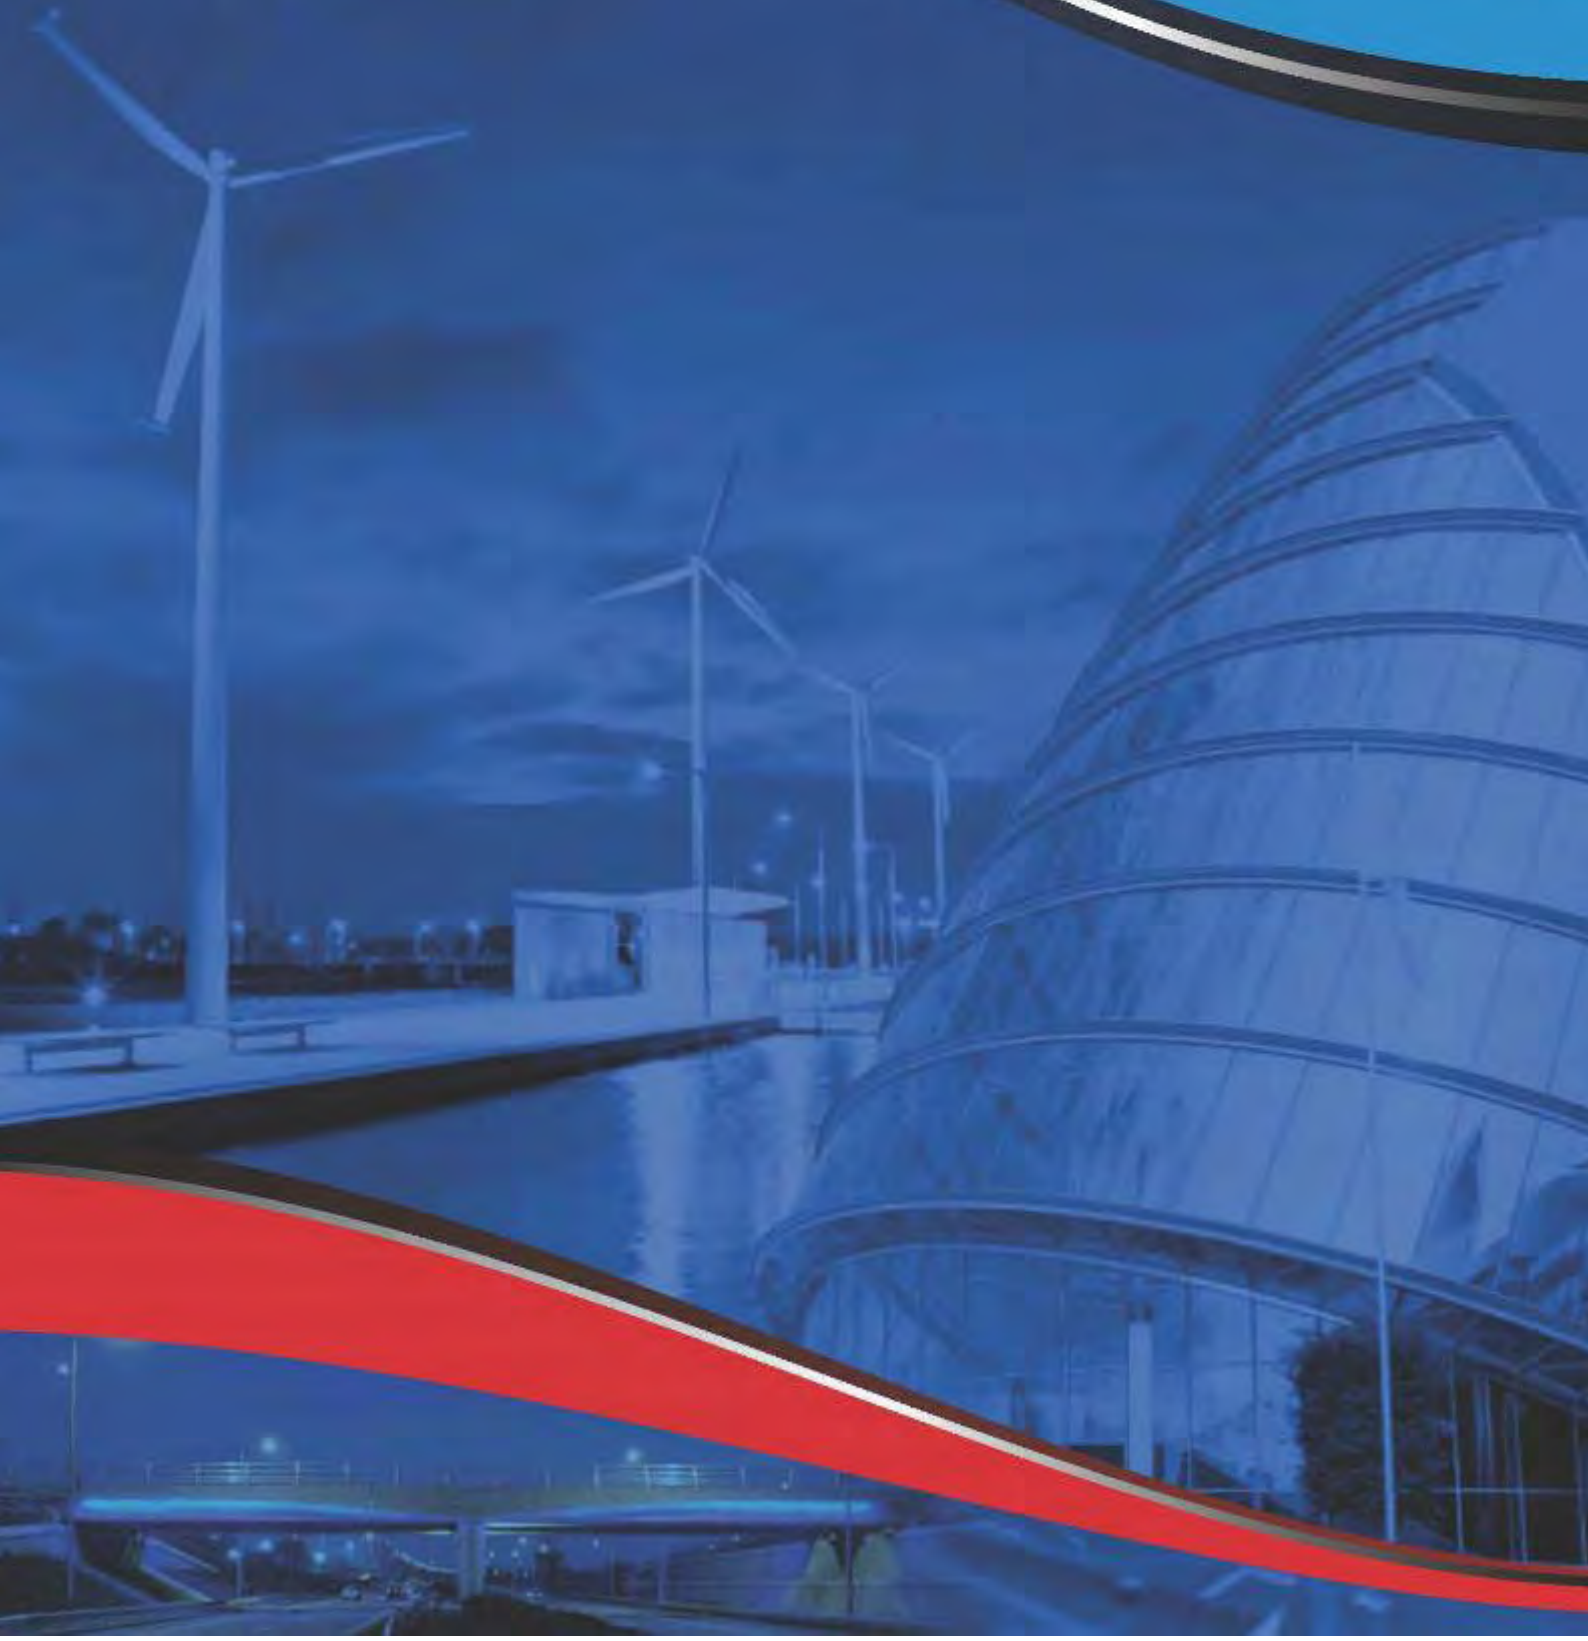
Condition Survey Report for Glanmire to Dunkettle Roundabout Road Boundary Wall

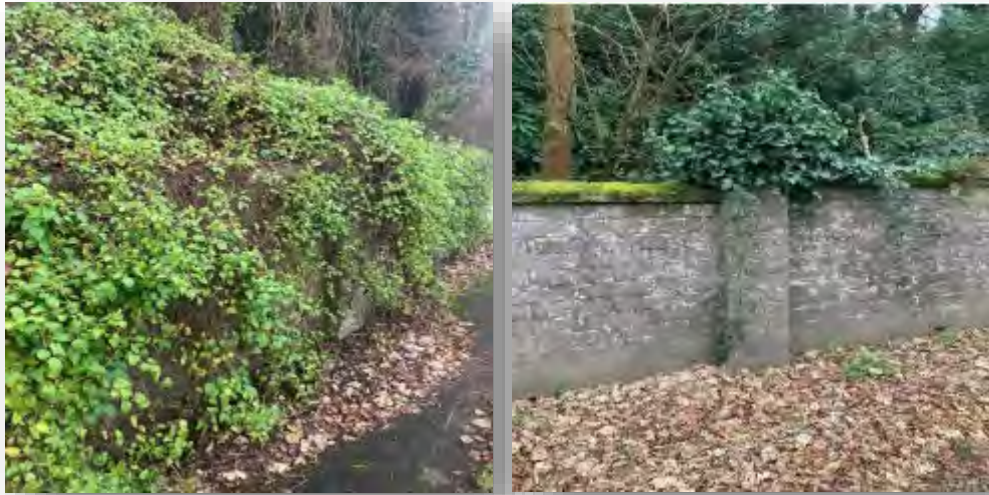
Figure 2 & 3: Wall overgrown by vegetation (Refer to Appendix A&B for locations)

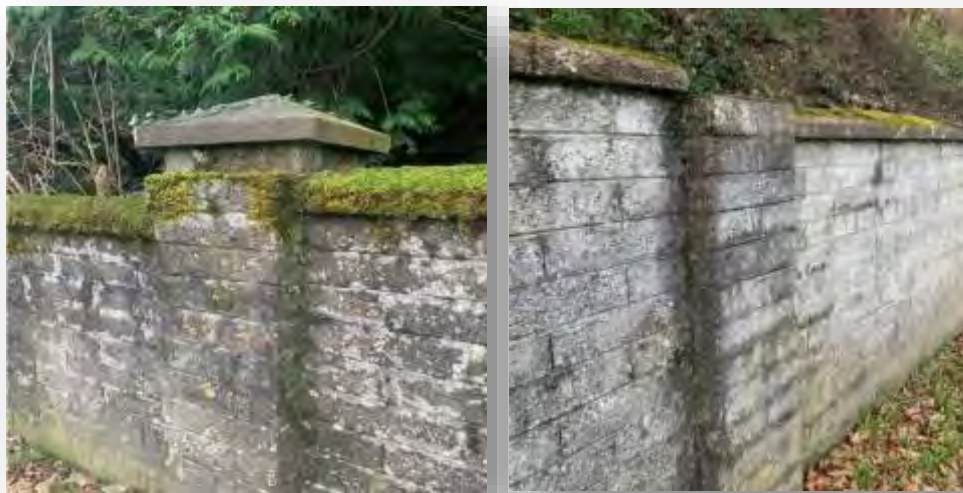
Figure 4 & 5: Damage to piers (Refer to Appendix A&B for locations)

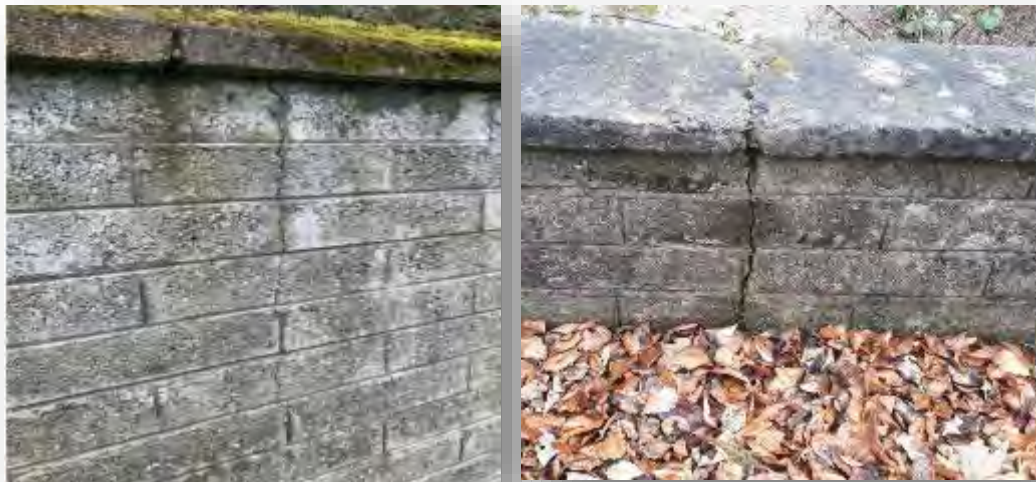
Figure 6 & 7: Vertical cracks (Refer to Appendix A&B for locations)

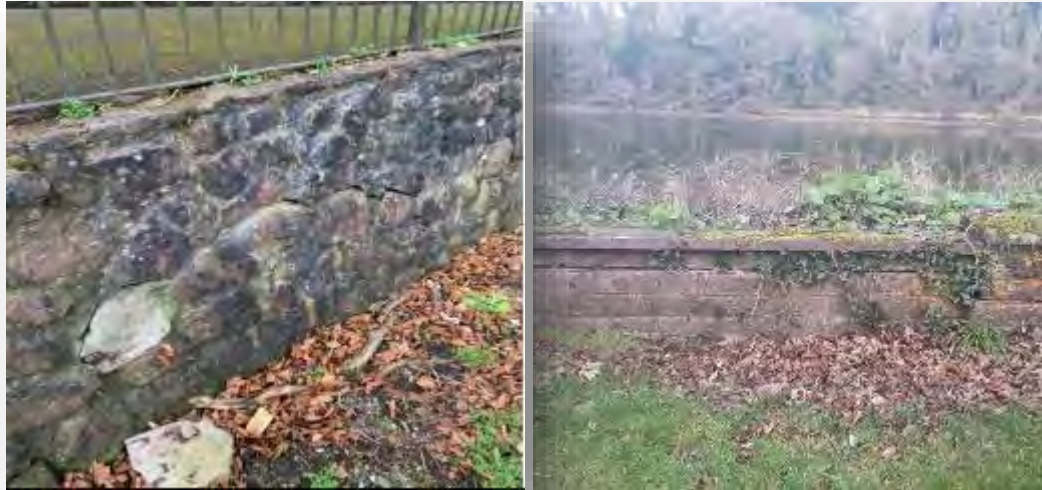
Figure 8 & 9: Horizontal cracks (Refer to Appendix A&B for locations)

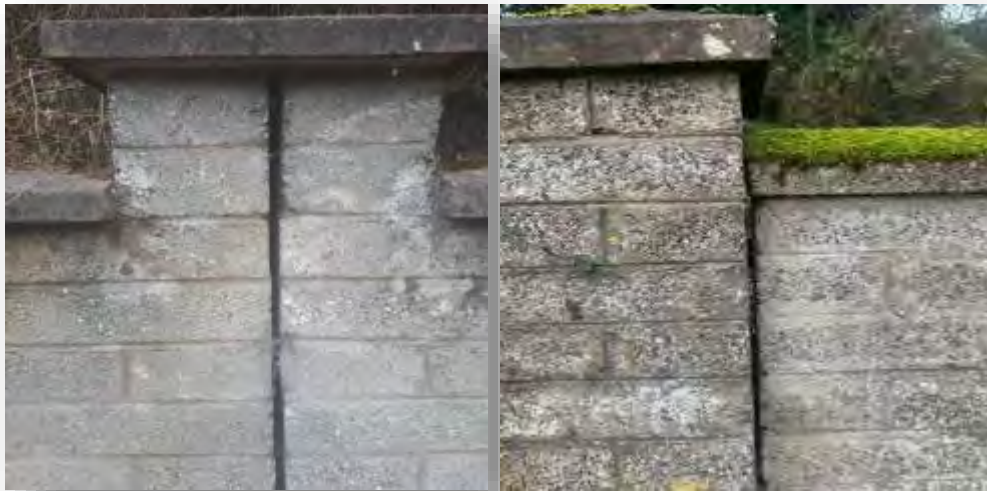
Figure 10 & 11: Separated joints (Refer to Appendix A&B for locations)

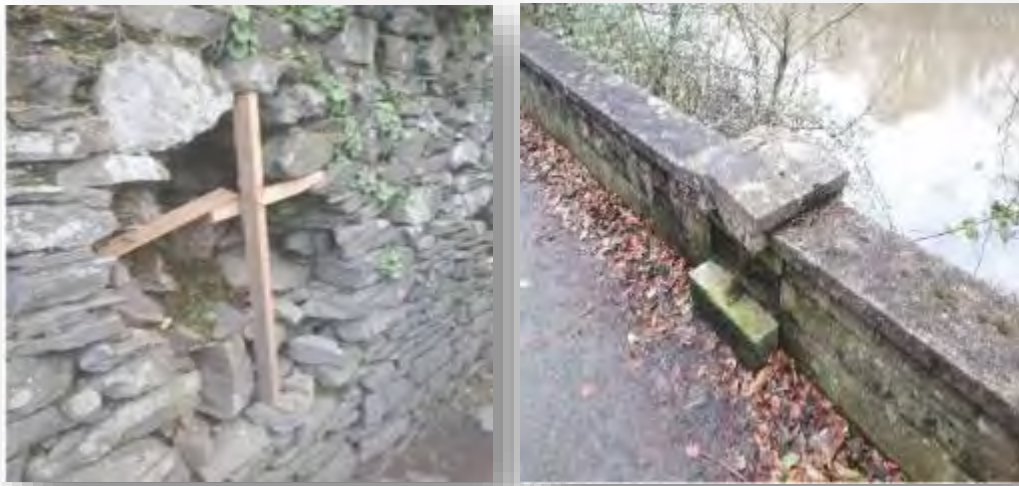
Figure 14 & 15: Loss of masonry (Refer to Appendix A&B for locations)

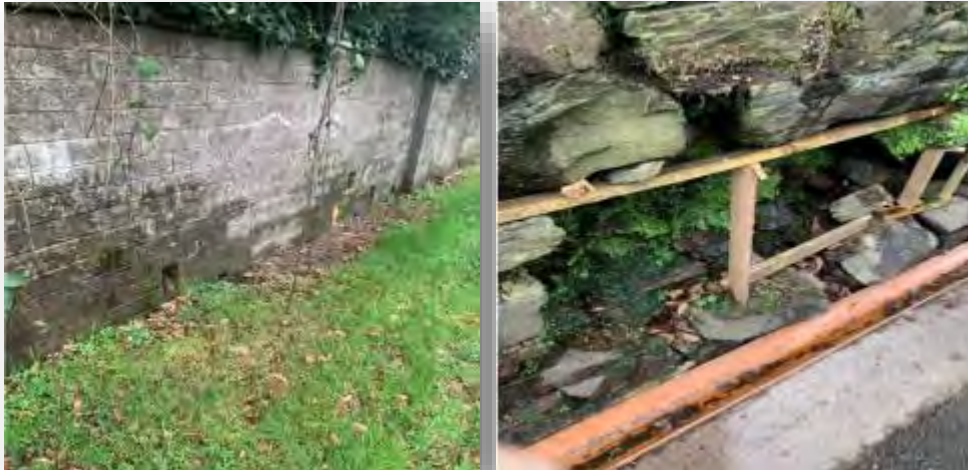
Figure 16 & 17: Loss of masonry & Collapsed wall (Refer to Appendix A&B for locations)

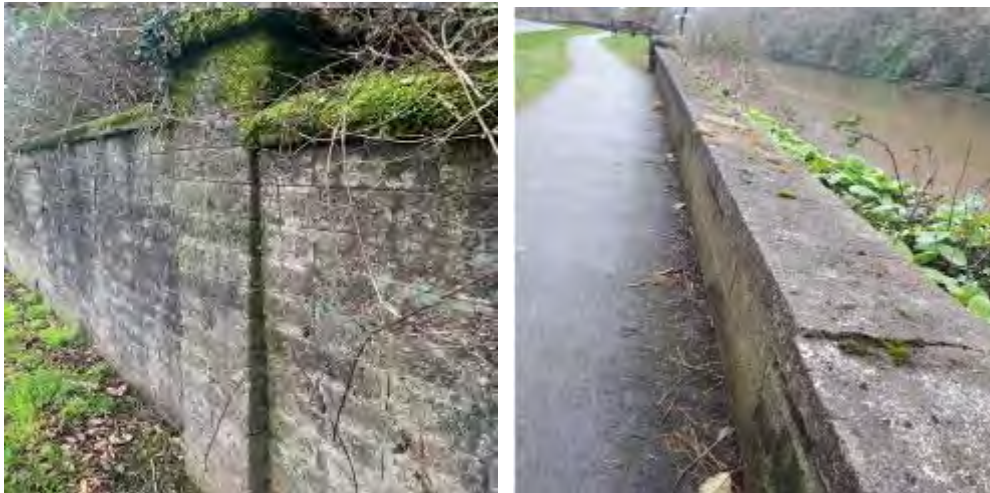
Figure 18 & 19: Wall leaning (Refer to Appendix A&B for locations)

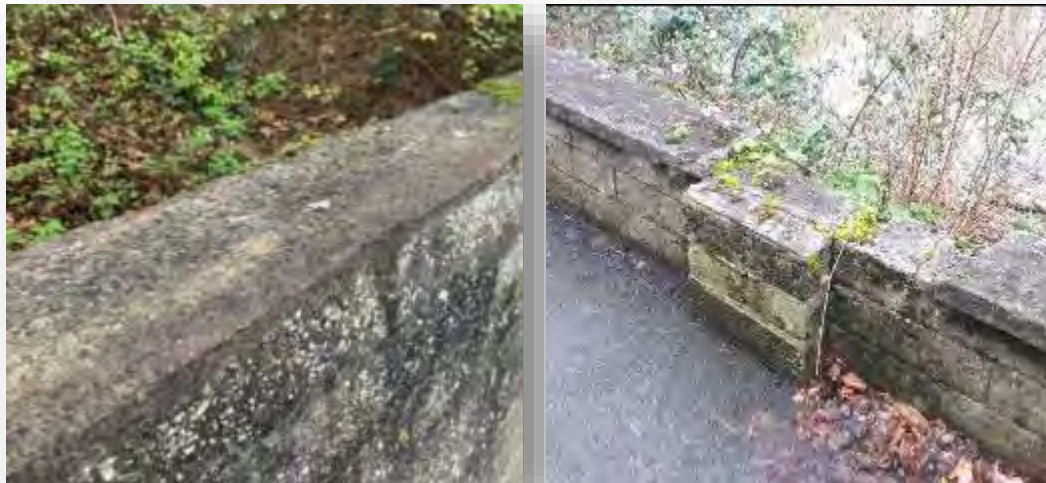
Figure 21 & 22: Collapsed structure (Refer to Appendix A&B for locations)

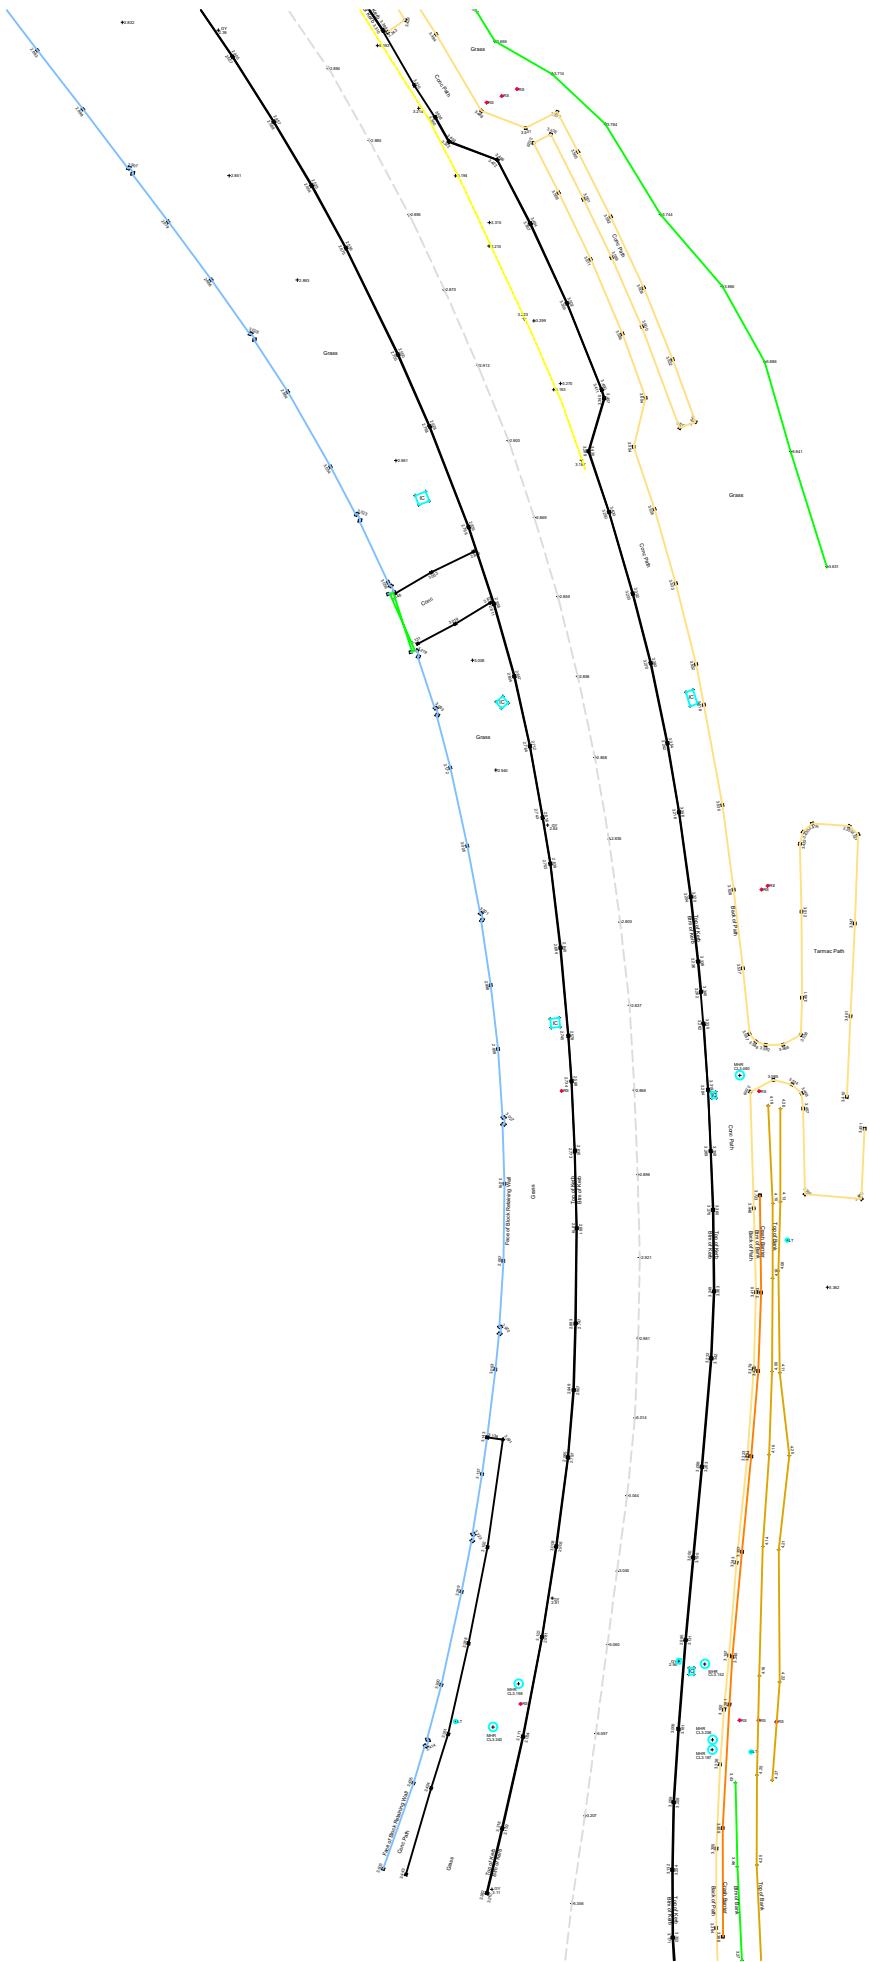
APPENDIX A. SITE INSPECTION RECORD OF DEFECTS

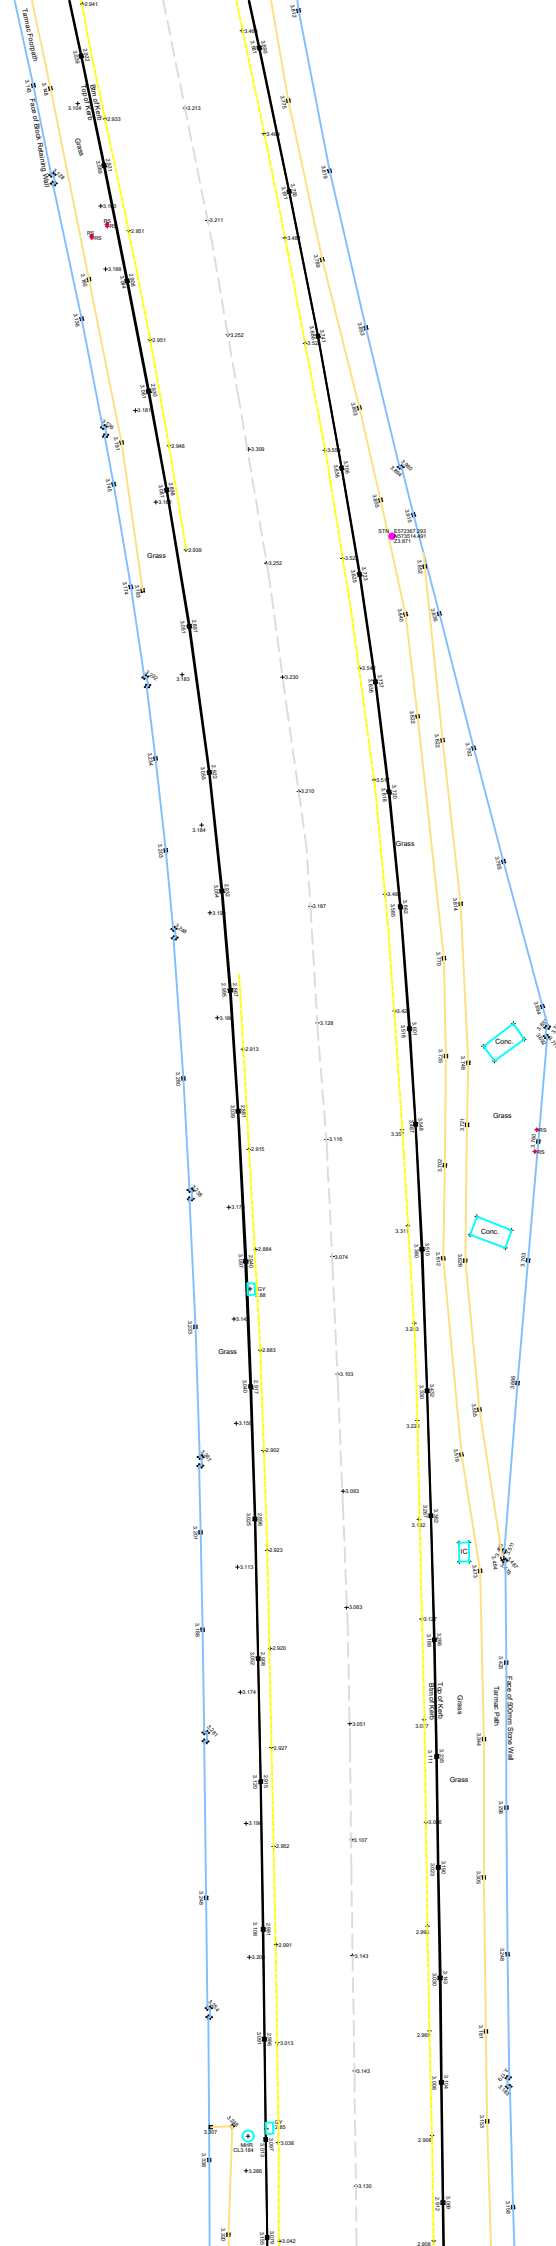
OCSC <small>ORCONORR / BURTOM / O'CONNOR</small> <small>Multidisciplinary Consulting Engineers</small>	C1019-OCSC-XX-XX-SK-S-0004-P01-S3 R639 GLANMIRE TO DUNKETTLE ROUNDAABOUT WALL CONDITION ASSESSMENT		
	REV: P01	BY: AN	DATE: 11.02.2022

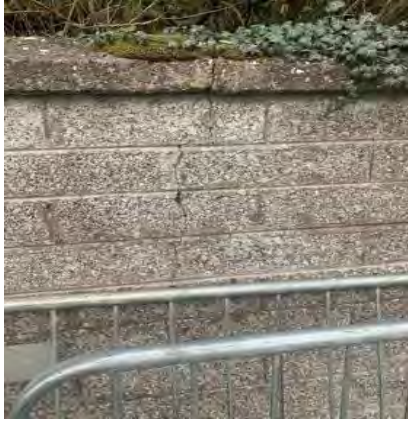
1. Vertical crack through wall

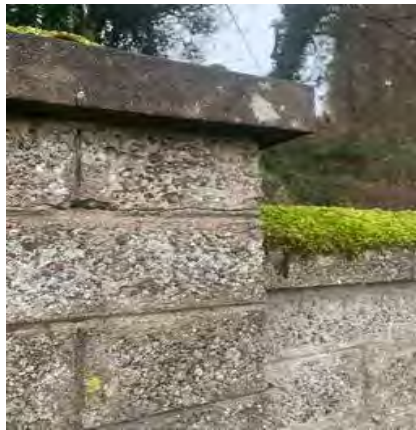
2. Horizontal crack through mortar under the top course of blockwork at top of pier

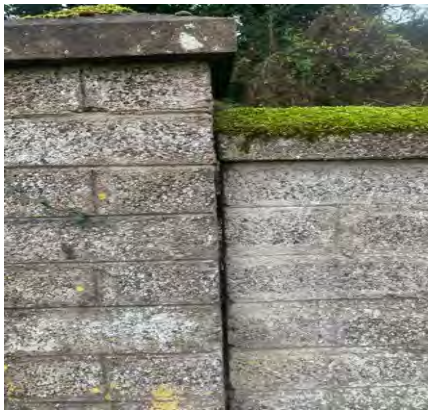
3. Separated joint between wall and pier
Minor vegetation growth to coping

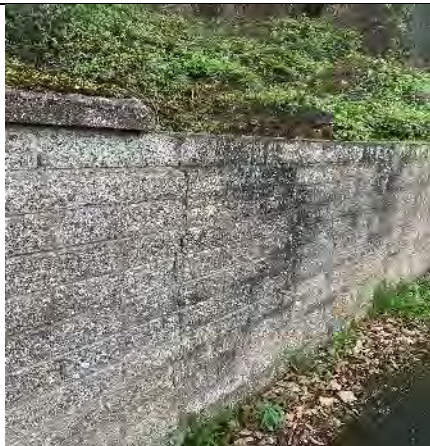
4. Vertical crack through wall & missing coping

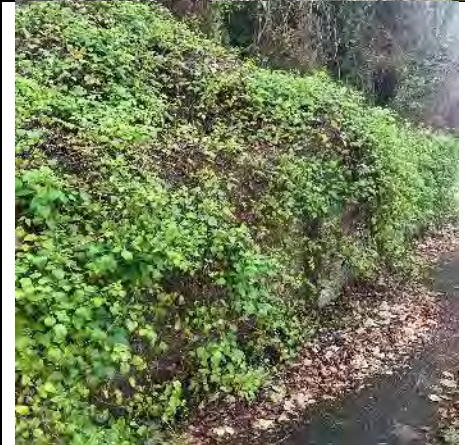
6. Wall heavily overgrown by vegetation

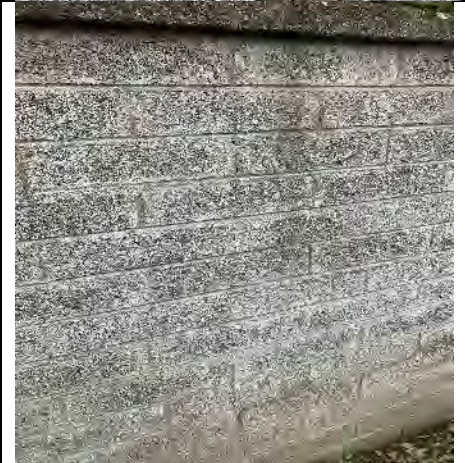
7. Separated joint between wall and pier

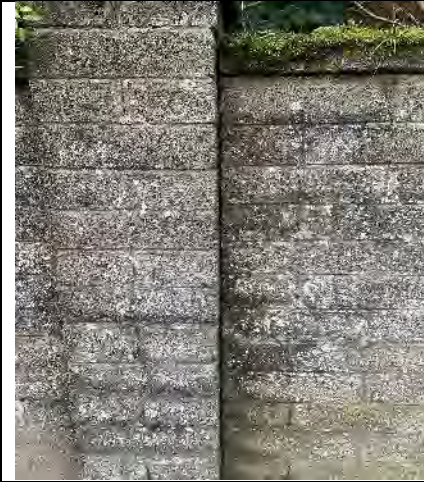
9. Gap between coping and top of wall

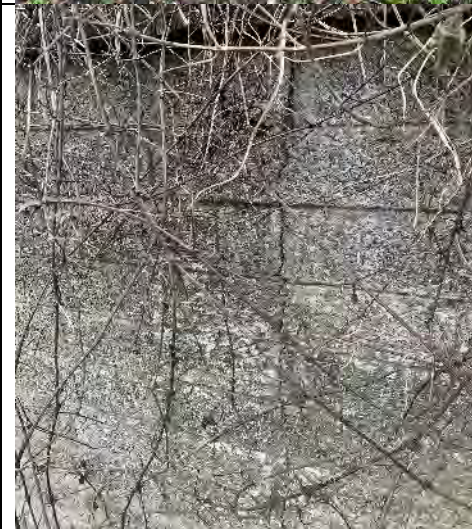
14. Vertical crack through wall

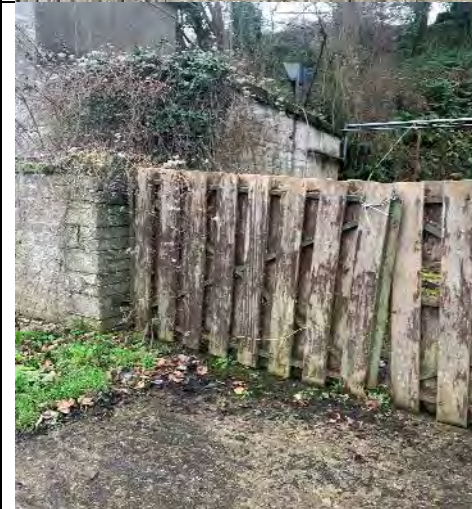
15. Top of pier collapsed

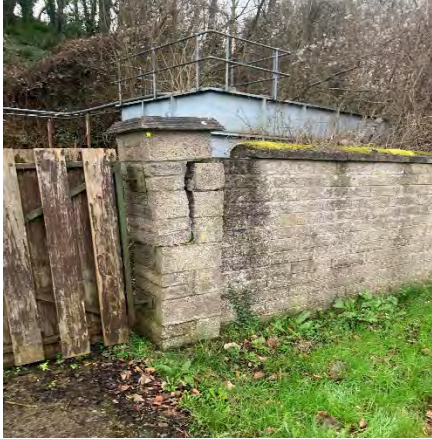
16. Serious deterioration of pier

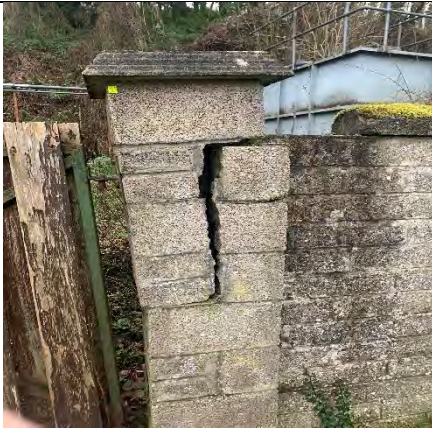
17. Cracked top part of pier tilting out & missing coping

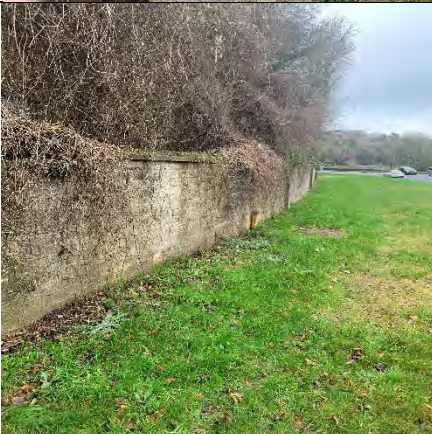
18. Wall overgrown by vegetation

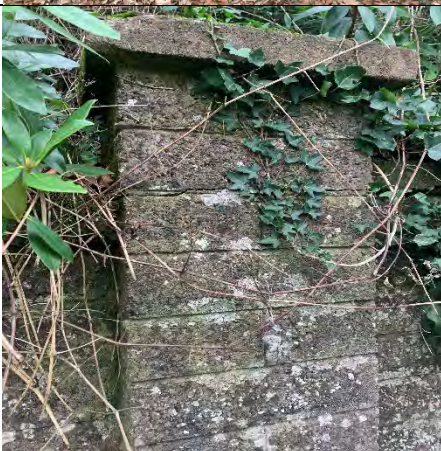
22. Horizontal crack through mortar at top of pier & vegetation growth

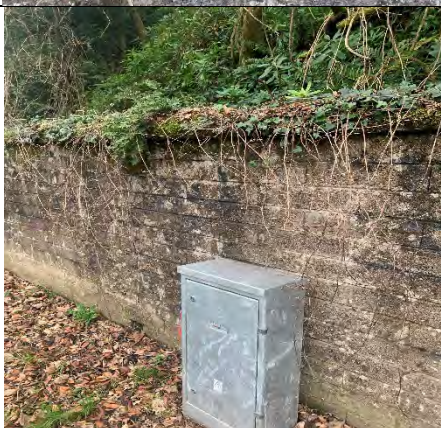
23. Gap between coping and top of wall & vegetation growth to wall

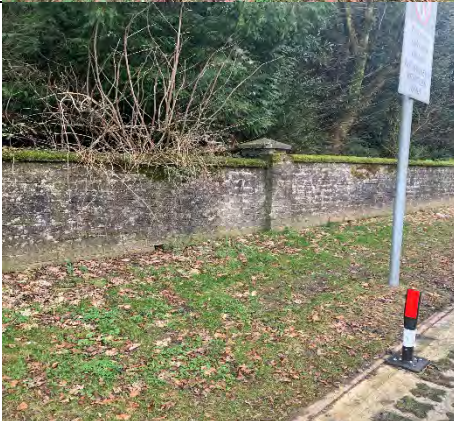
25. General view to the wall & vegetation growth to the coping & sign of stain on wall

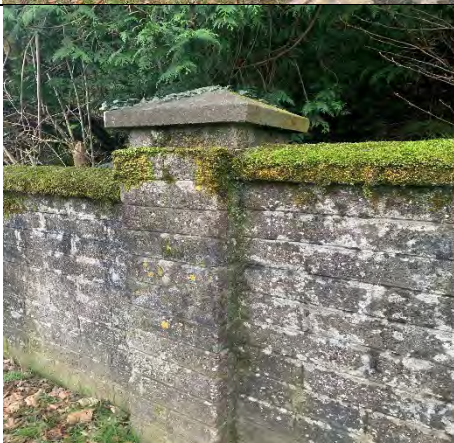
26. Structural division of top course of block of the pier separated and moved

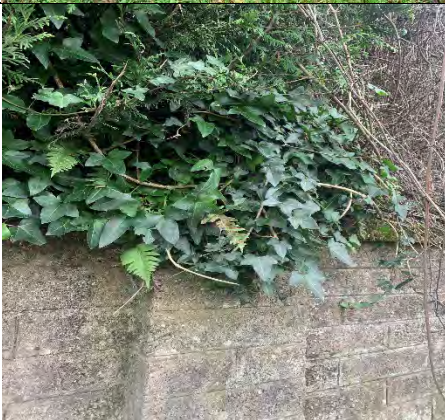
30. Top of pier is overgrown by vegetation & stain present on the face of the wall

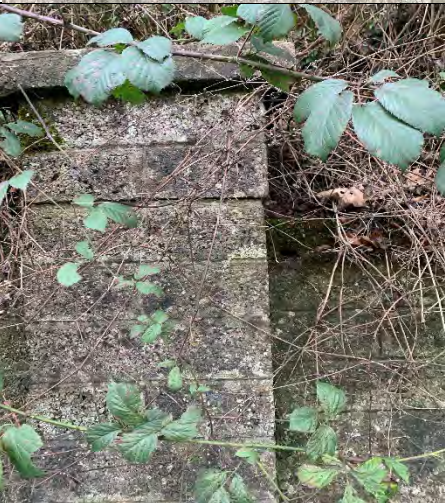
31. Top of pier separated under the top course of block and moved

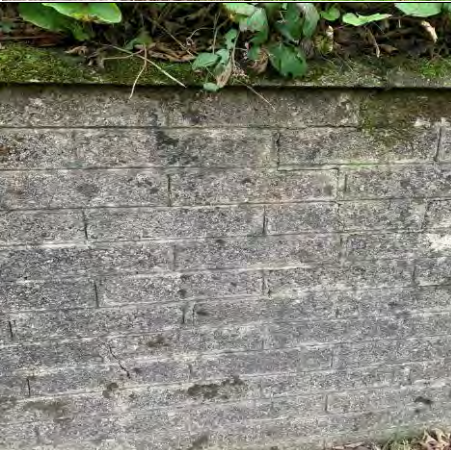
36. Vertical crack through wall

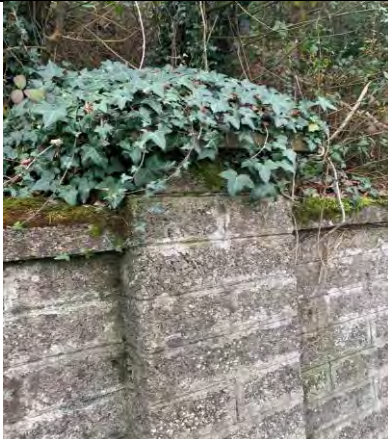
37. Division of top part of pier under first course of blockwork & top of pier covered with vegetation

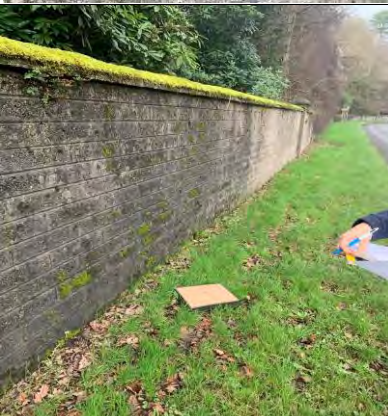
39. Stain present on the face of the wall

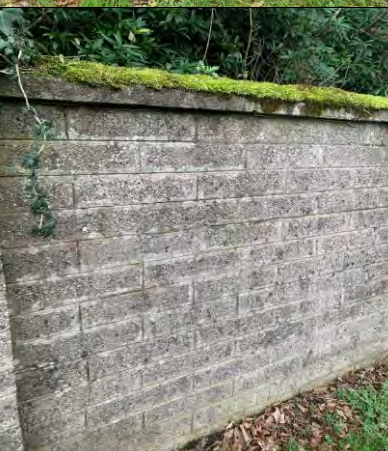
40. General view to the wall

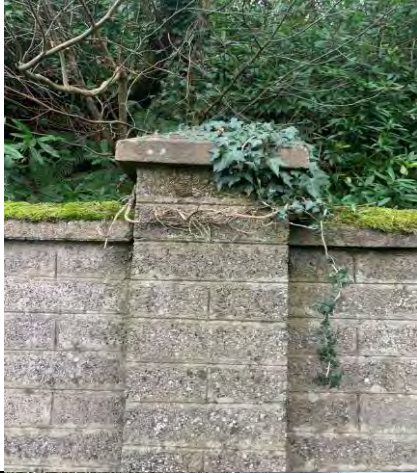
41. Horizontal crack through mortar at top of pier

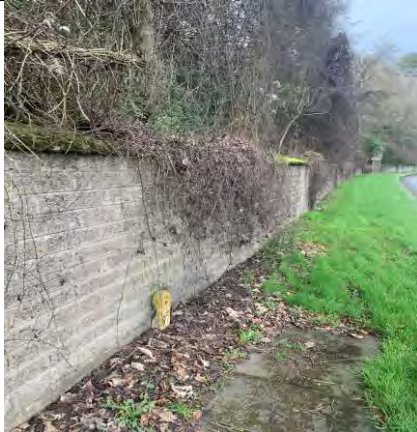
42. Vegetation growth to the wall

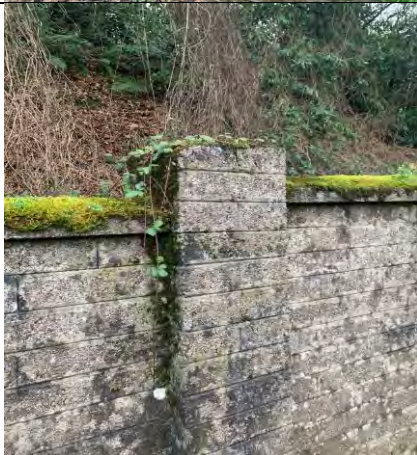
43. Missing coping on pier & stain present on the face of wall throughout

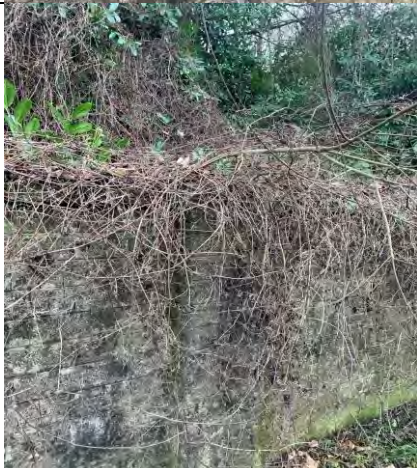
44. Top of pier collapsed & vegetation growth onto it & stain present on the face of the wall throughout

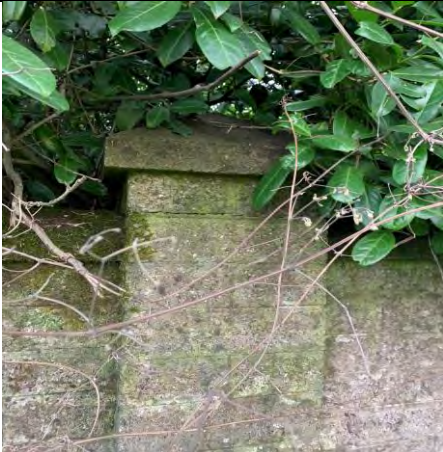
45. Top block course of pier separated and moved & vegetation growth onto it

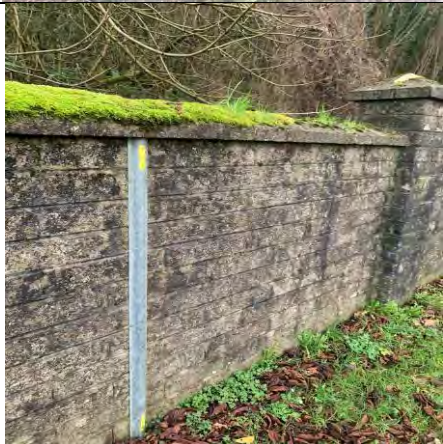
46. Electrical cable fixed to wall & evidence of stain present throughout

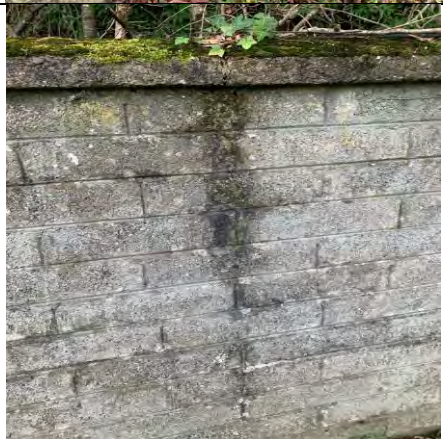
47. Water seeping through wall

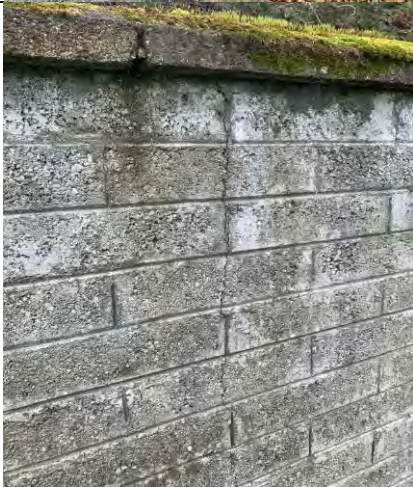
51. Vertical crack through wall

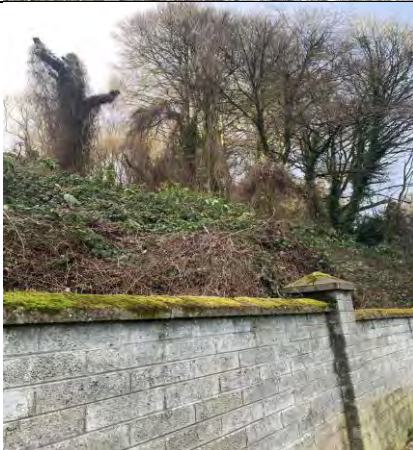
52. Gap between coping and wall

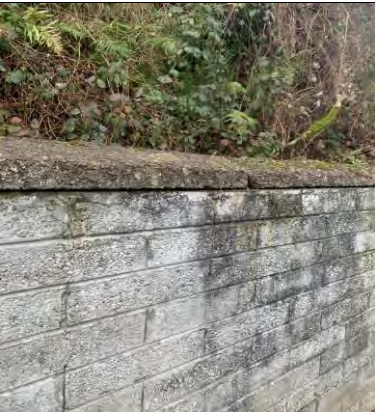
<p>53. Gap between coping and wall & vertical crack through wall</p>

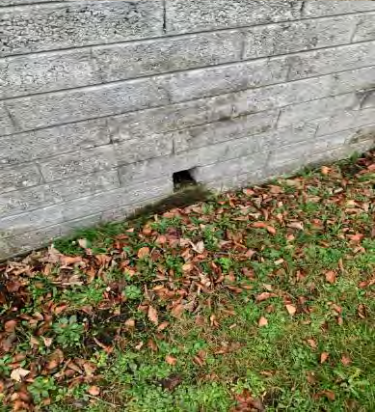
<p>54. Weep hole</p>

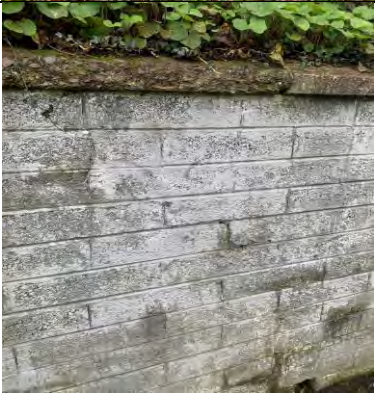
<p>56. Stepped crack through wall</p>

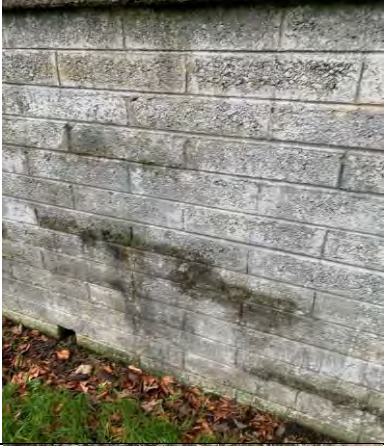
57. Evidence of weephole & Water seeping through wall

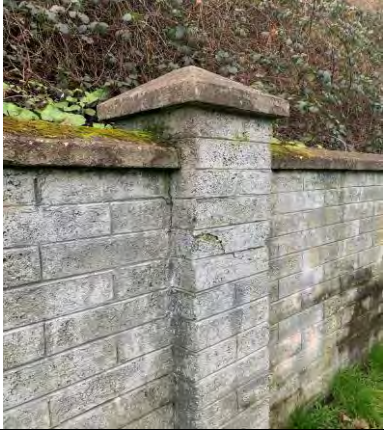
58. Horizontal crack through pier & evidence of stain on face of wall

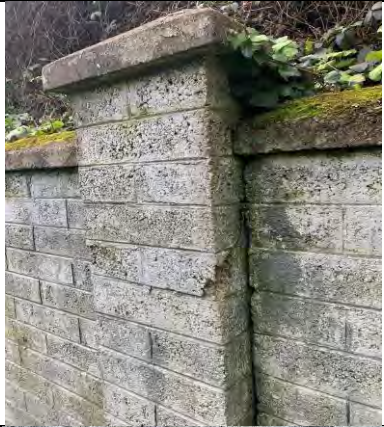
59. Separated vertical joint between the pier and the wall

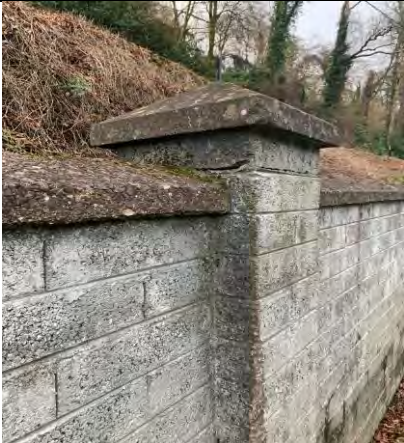
60. Horizontal crack at top of pier

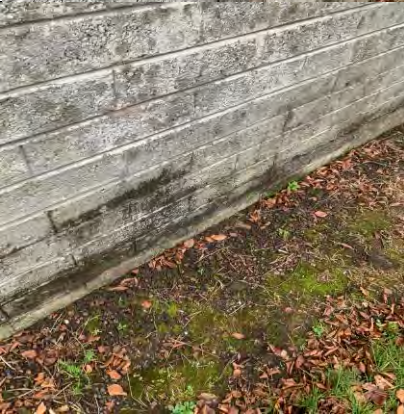
61. Evidence of stain on bottom face of the wall

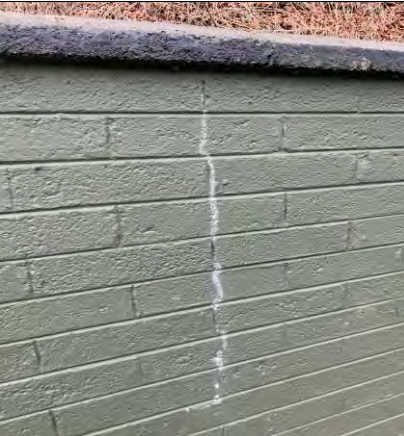
62. Vertical crack through wall

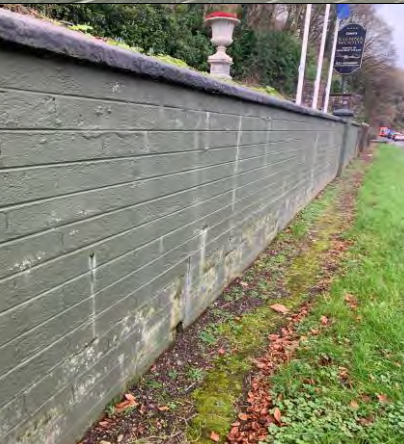
63. Water seeping through the bottom of the wall throughout

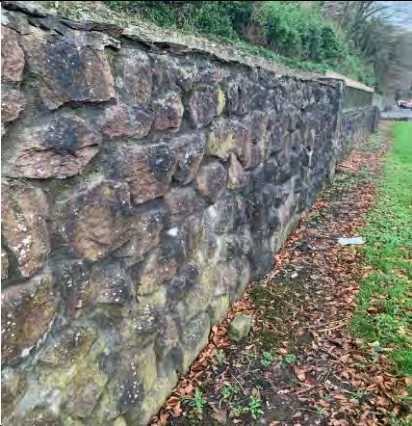
64. Horizontal crack through wall at entrance junction to the Cork's Vienna Hotel

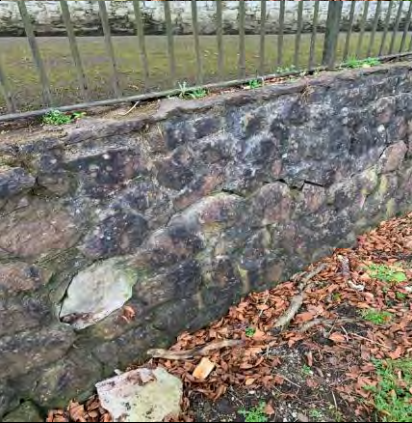
65. Horizontal crack through wall at entrance junction to the Cork's Vienna Hotel

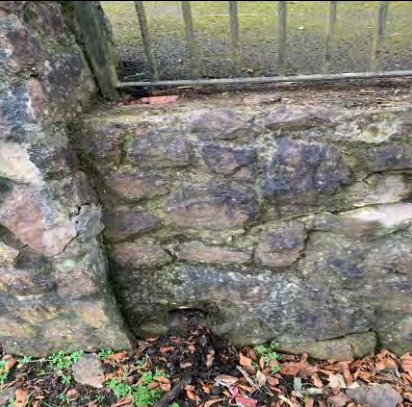
66. Horizontal crack through wall at entrance junction to the Cork's Vienna Hotel

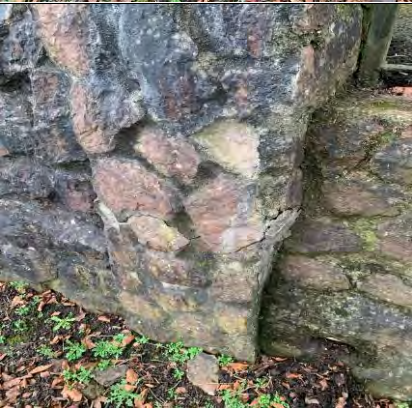
67. Horizontal crack through wall at entrance junction to the Cork's Vienna Hotel

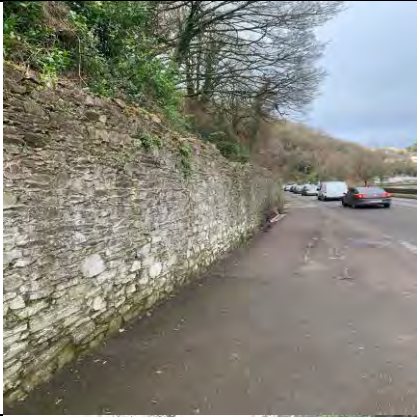
68. Entrance road to Cork's Vienna Hotel

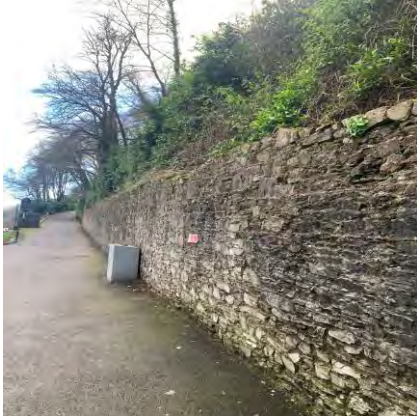
69. Entrance road to Cork's Vienna hotel & loss of mortar and loose stones evident

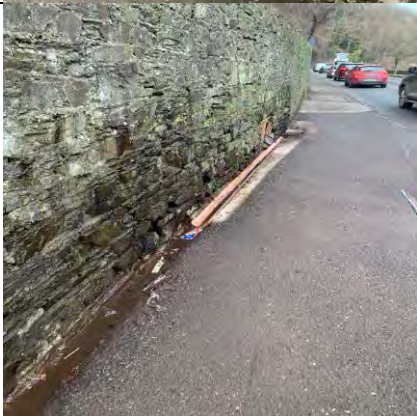
70. Water broke through wall & bottom of wall soaked

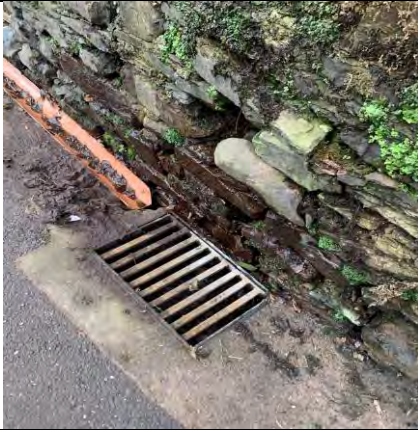
72. Loss of mortar, loose stones & water running through the bottom of the wall

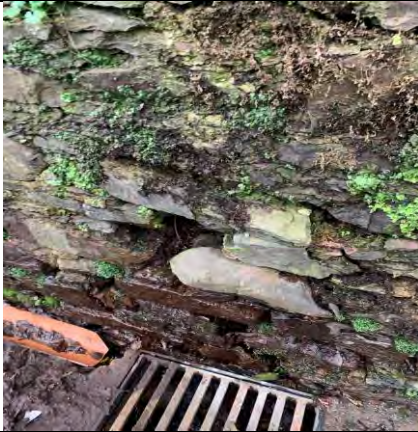
73. Loss of mortar and loss of stones & water running through the bottom of the wall

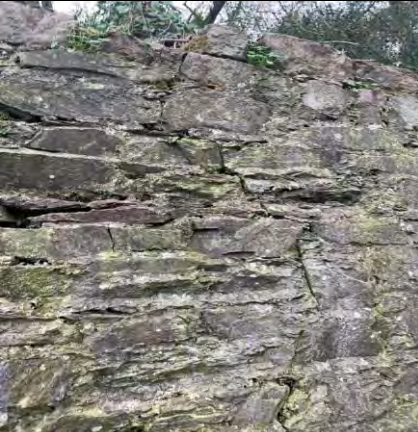
74. Vertical crack through wall

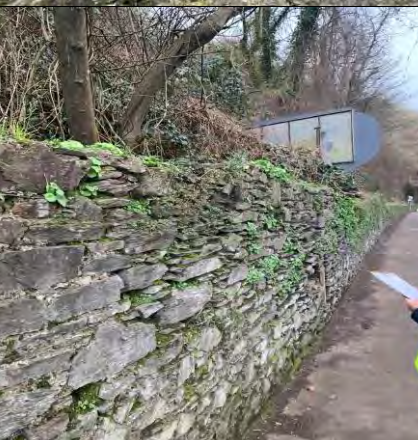
75. General view to the wall & minor vegetation growth present

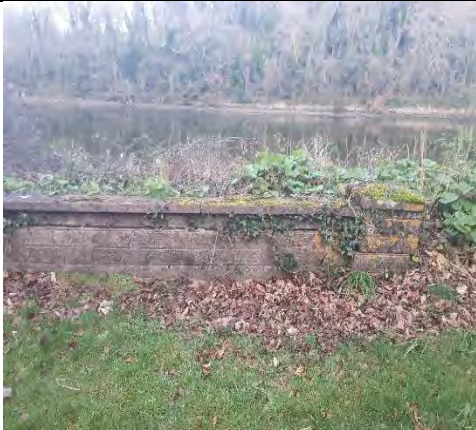
95. Crack through & deterioration of pier and adjacent wall

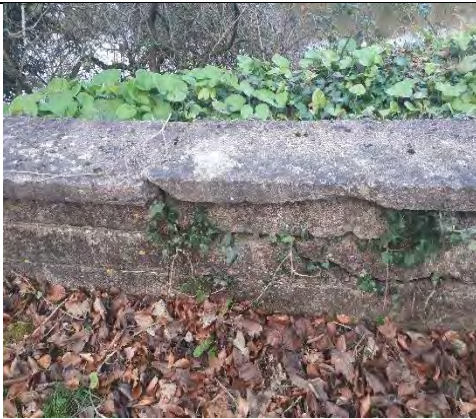
96. Crack through wall & coping
Spalling of concrete on coping

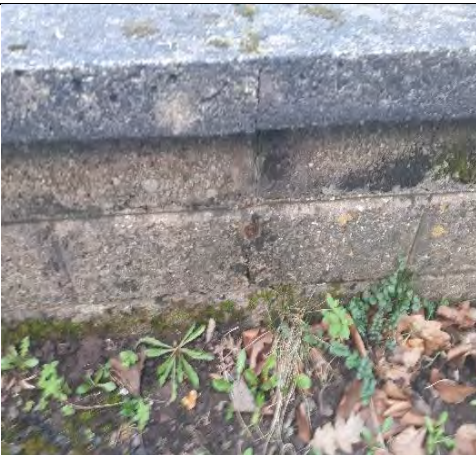
97. Vertical crack through wall & coping

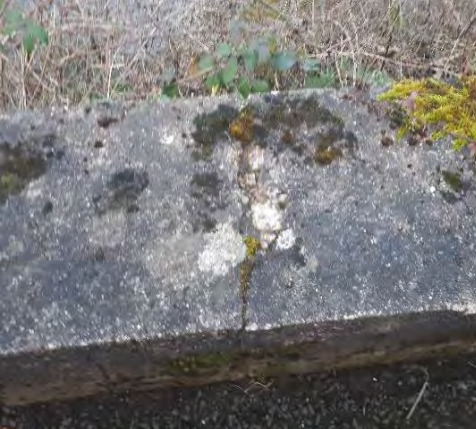
98. Crack & minor vegetation on coping

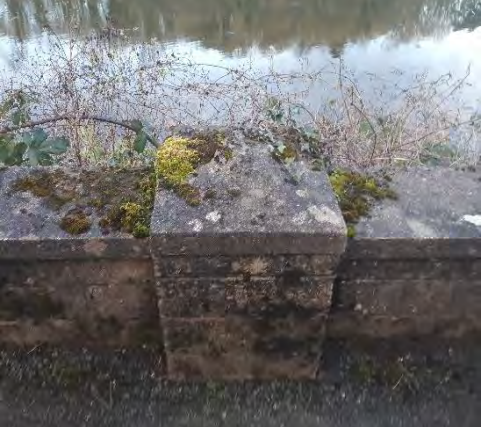
<p>99. Minor vegetation on coping of pier</p>

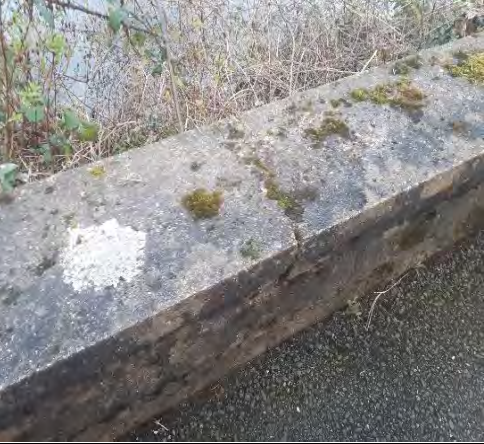
<p>100. Crack on coping</p>

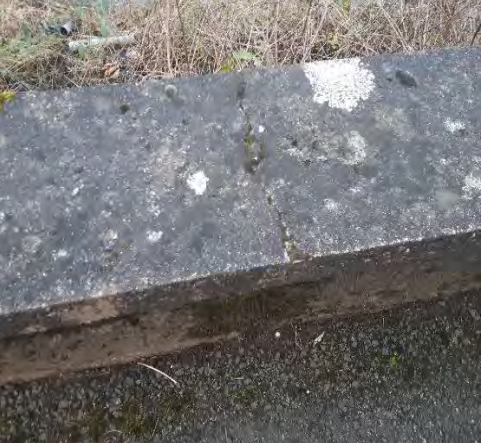
<p>101. Crack on coping</p>

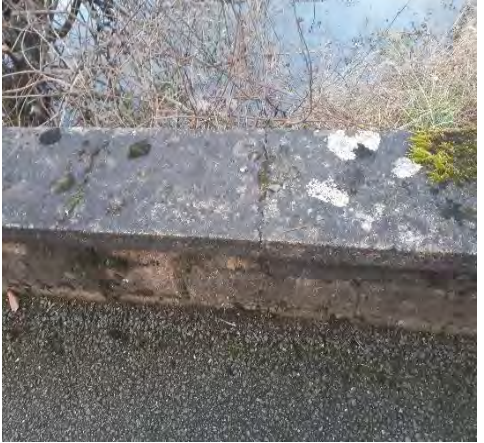
<p>102. Crack on coping</p>

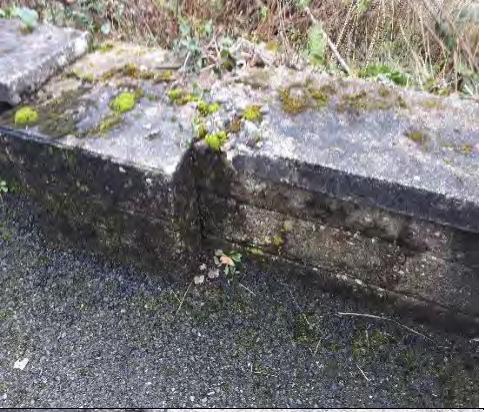
A close-up photograph of a stone pier. The top surface is a flat, grey stone slab. A significant portion of the masonry has been lost, creating a jagged, uneven edge. The remaining stone is dark and appears weathered. Some green moss is visible on the top surface.	<p>103. Loss of masonry at pier</p>

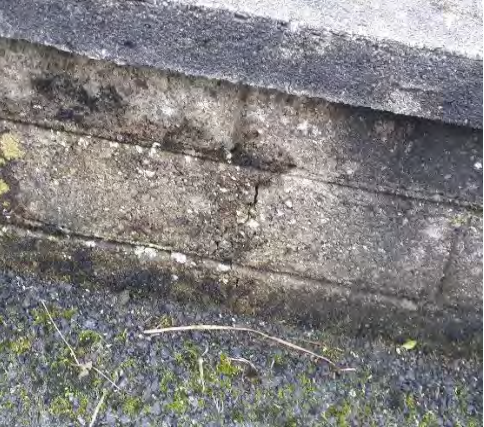
A close-up photograph of a stone wall. The wall is constructed from several courses of large, rectangular stone blocks. A prominent vertical crack runs through the mortar joints between the blocks, extending from the top to the bottom of the visible section. The stone is dark and shows signs of weathering.	<p>104. Vertical crack through wall</p>
