C1019-OCSC-XX-XX-RP-S-0001

Condition Survey Report for
Glanmire to Dunkettle roundabout
R639 Road Boundary Wall

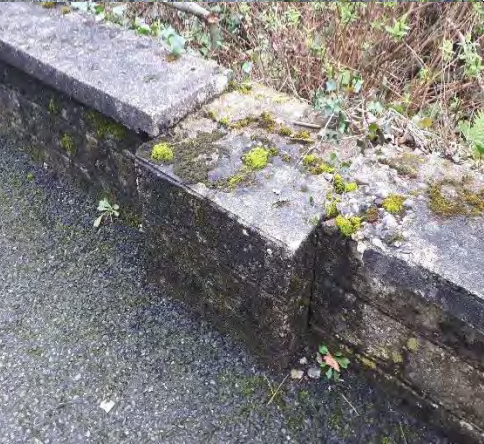
A close-up photograph of a stone pier, similar to the one in image 103. The top surface is a flat, grey stone slab. A significant portion of the masonry has been lost, creating a jagged, uneven edge. The remaining stone is dark and appears weathered. Some green moss is visible on the top surface.	<p>105. Loss of masonry at pier</p>

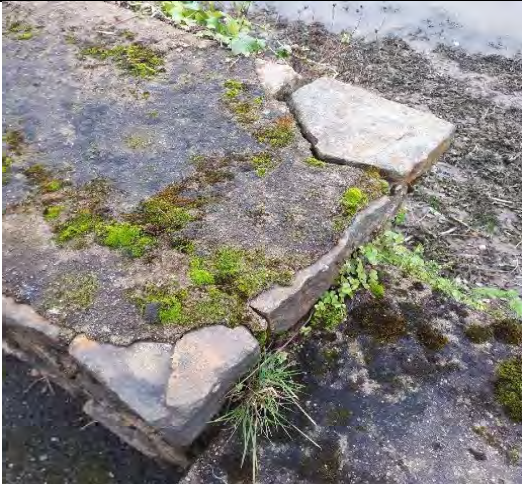
111. Loss of mortar & loose masonry at the edge of stone wall

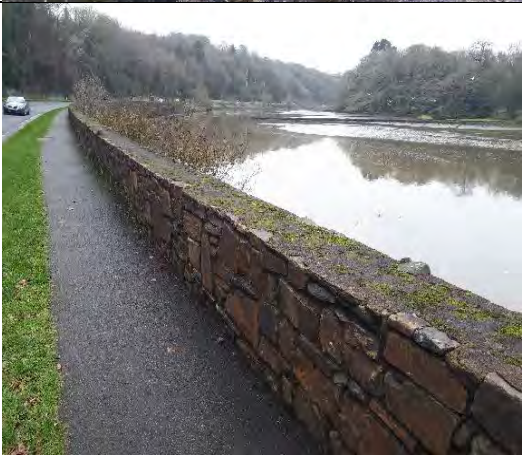
112. General view to the stone wall

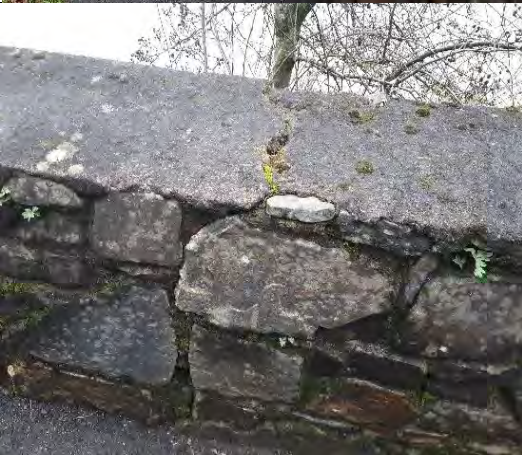
113. Crack on render

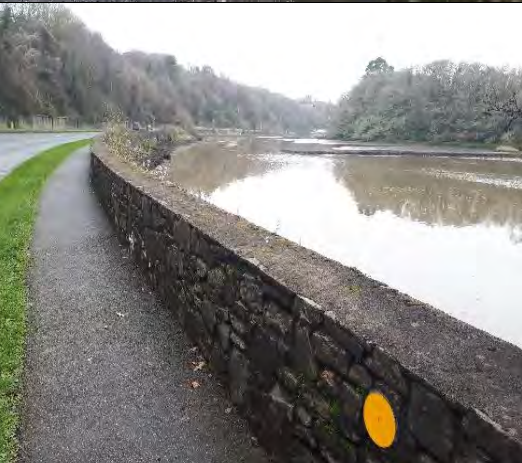
114. General view to the stone wall

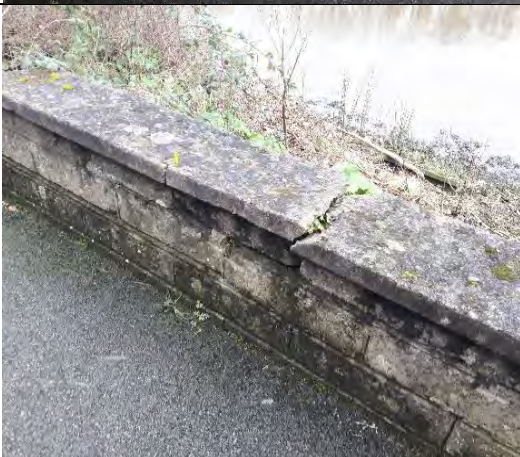
118. Crack through wall & tilting wall

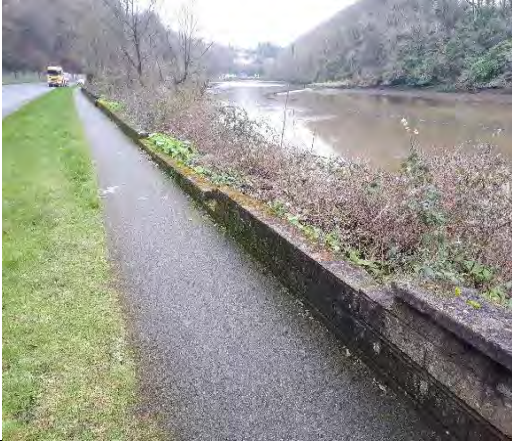
119. Collapsed wall section

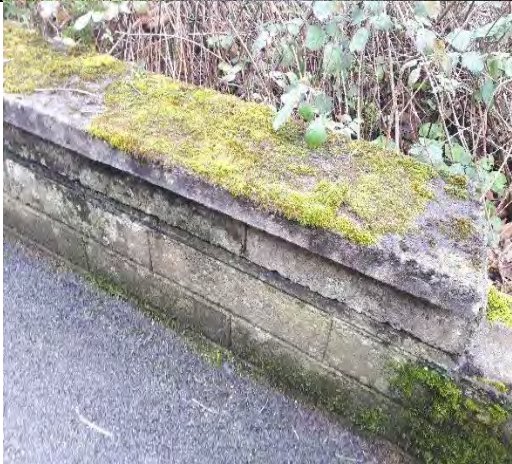
120. Crack through wall

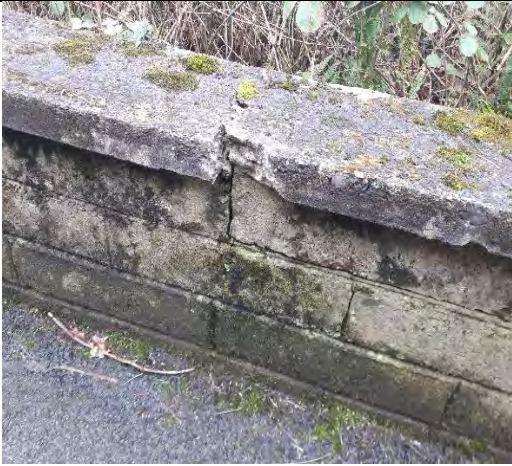
121. Crack through wall

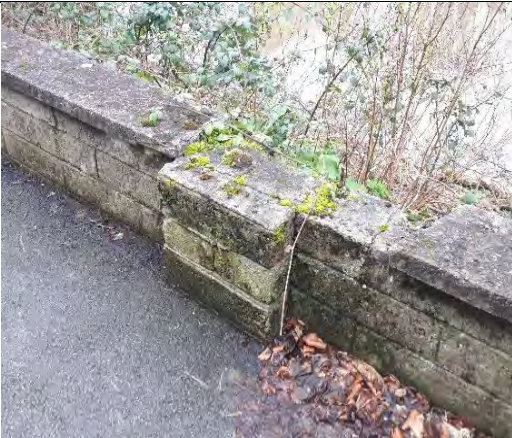
122. Top of pier collapsed

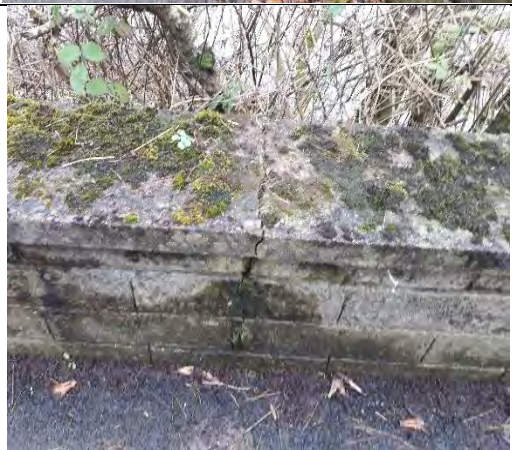
124. Vertical crack through wall

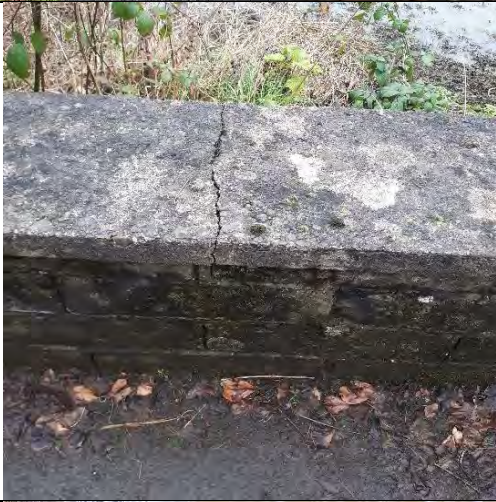
125. Vertical crack through wall

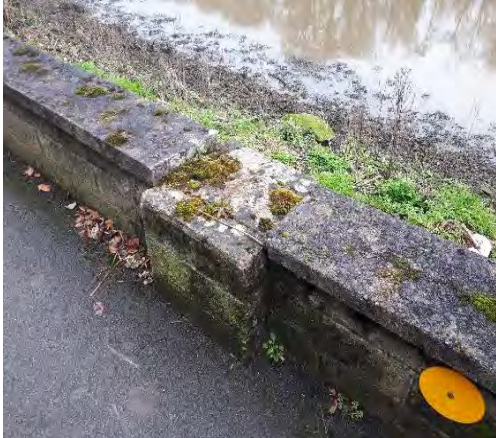
126. Loss of masonry & coping to pier

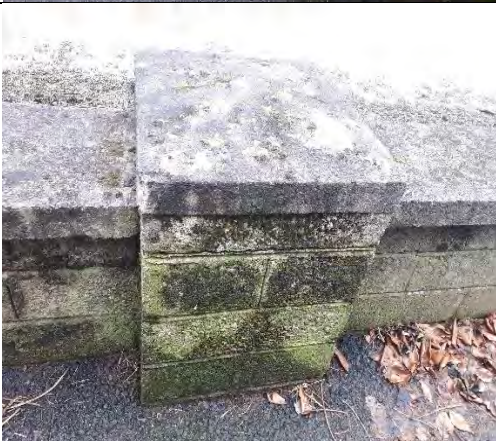
127. Horizontal crack on pier

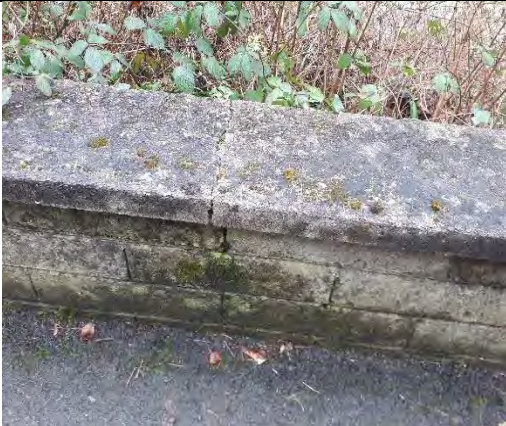
128. Vertical crack through wall

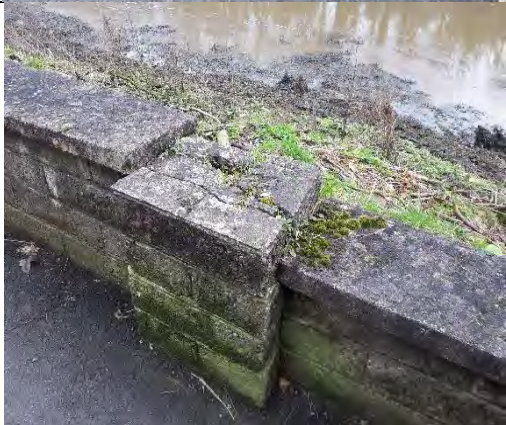
129. Top of pier collapsed & cracked

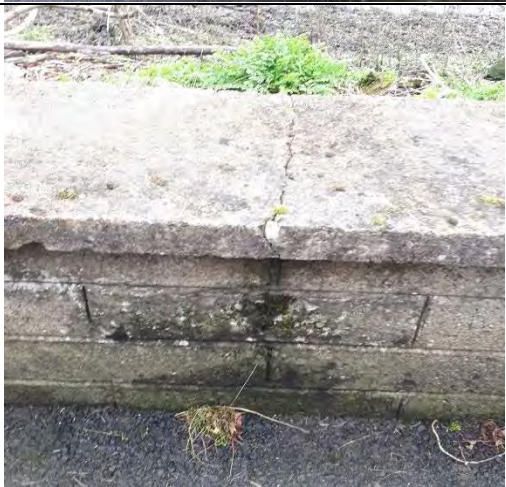
130. Vertical crack through wall

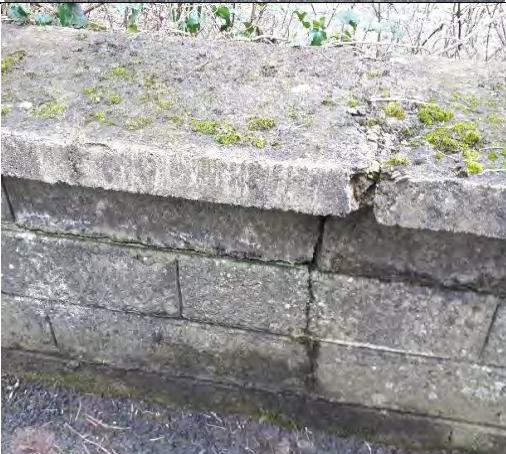
131. Vertical crack through wall

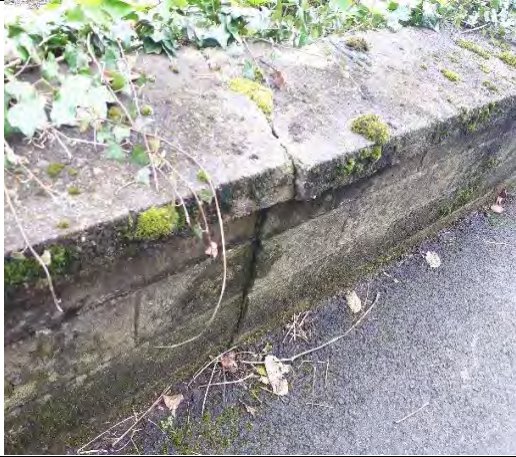
132. Crack&Deterioration of wall

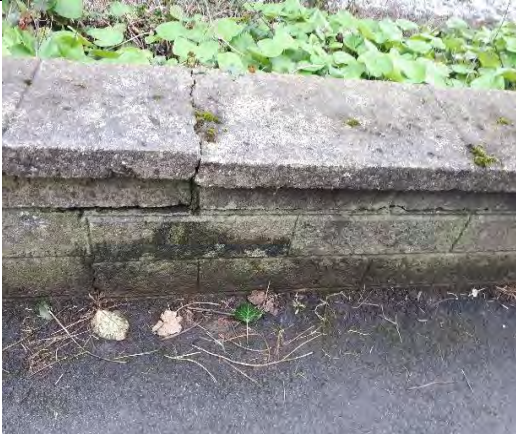
133. Crack&Deterioration of wall

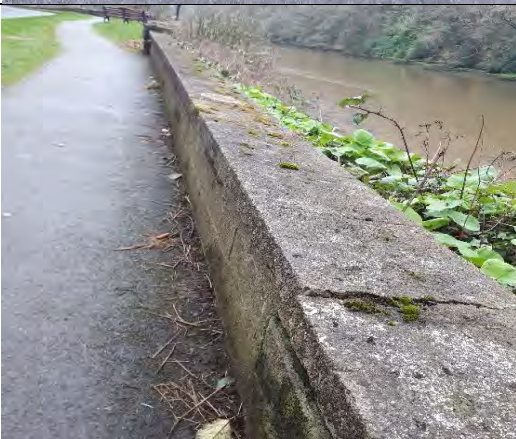
134. Crack&Deterioration of wall

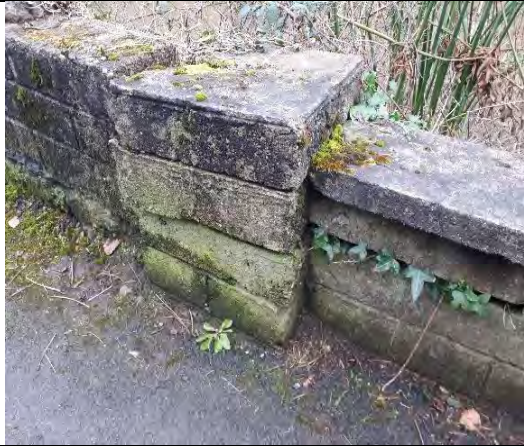
135. Crack&Deterioration of pier & missing coping

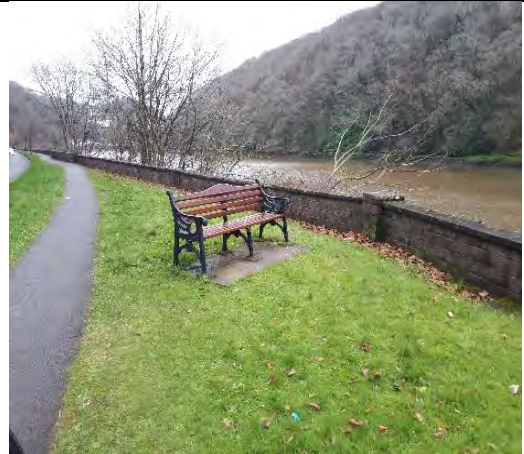
136. General view to wall

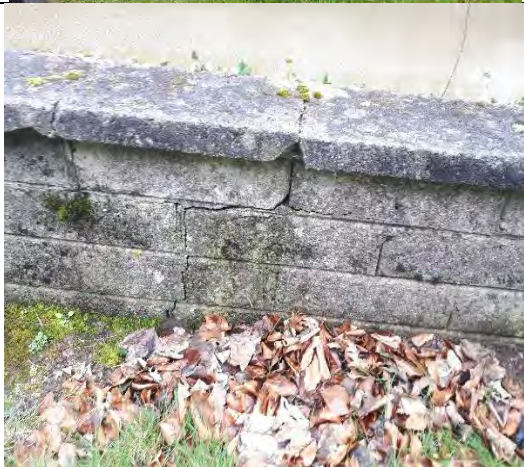
137. Vertical crack through wall

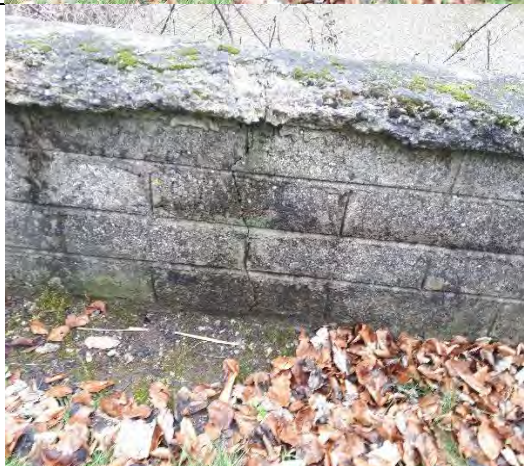
138. Vertical crack through wall & spalling of concrete on coping

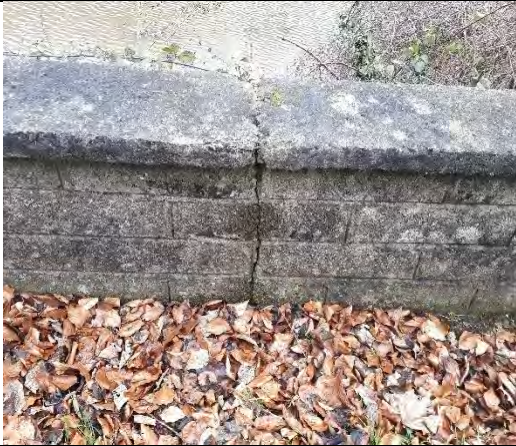
139. Vertical crack through wall

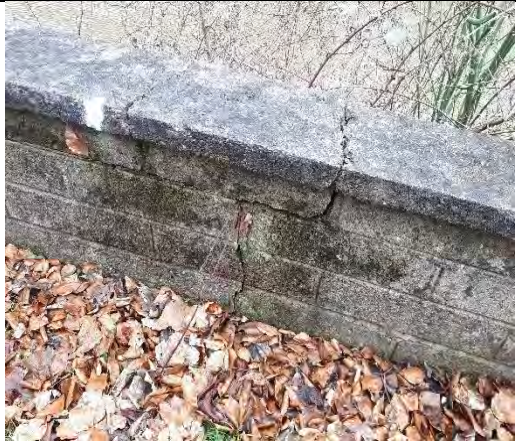
140. Vertical crack through wall

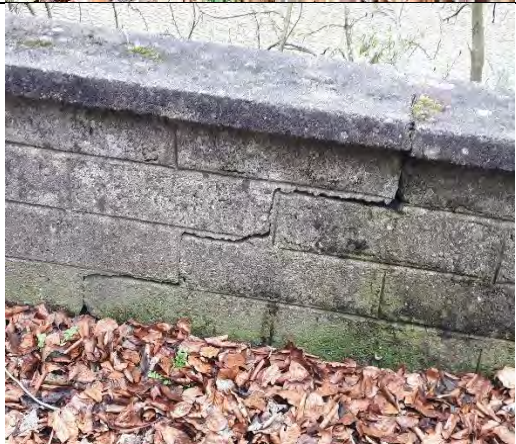
141. Vertical crack through wall

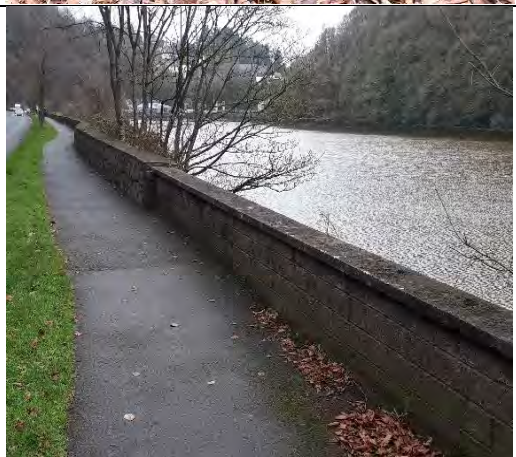
142. General view to wall
