**Arboricultural Impact Assessment and Tree Protection
Plan (BS5837:2012)**

Blarney Residential Scheme

Blarney, Co. Cork

10-03-2026

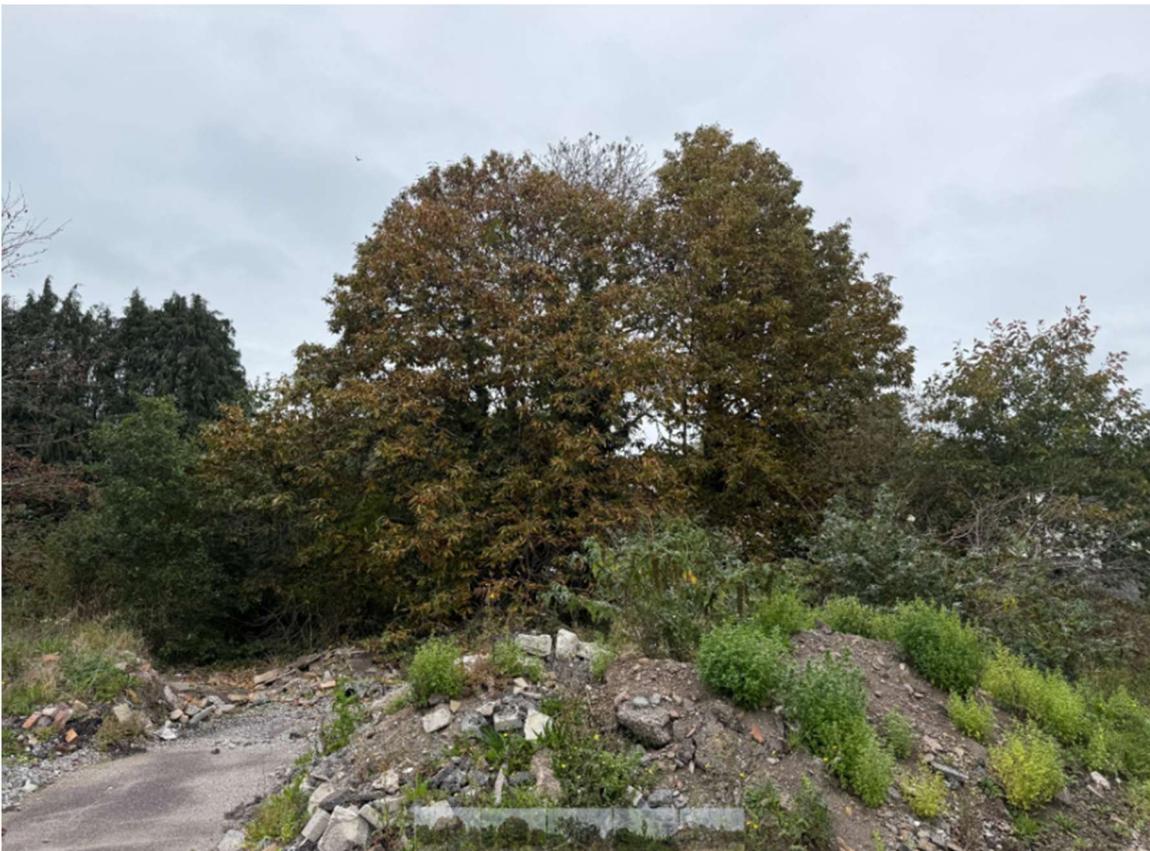
Photo 1: Tree no's 0373-75, view north.

- 3.1.5 In the northern area of the site, there are 3no. Horse Chestnut trees (0373-75) and 3no. Red Oaks (0376-78), all in good structural and physiological condition. To the west of these, there is a linear group of tall Lawson Cypress and other conifer species, ranging between 20 and 22 metres in height. These trees form dense, upright clusters with closely spaced vertical stems. While most are in good condition, three to four individuals display notable canopy dieback.

- 4.2.1 **Tree no's. 0364-67 & 0369-81:** The proposed development footprint, including buildings, pavements, roads and attenuation tank directly conflicts with these trees. Retention is unrealistic with the proposed design and these trees will need to be removed. This leads to the loss of local amenity value and biodiversity. These trees are of mixed quality but generally considered moderate. The overall potential impact is moderate and certain to occur. The loss shall be mitigated through replacement planting with appropriate species in suitable locations to restore the site's long-term landscape and ecological value.

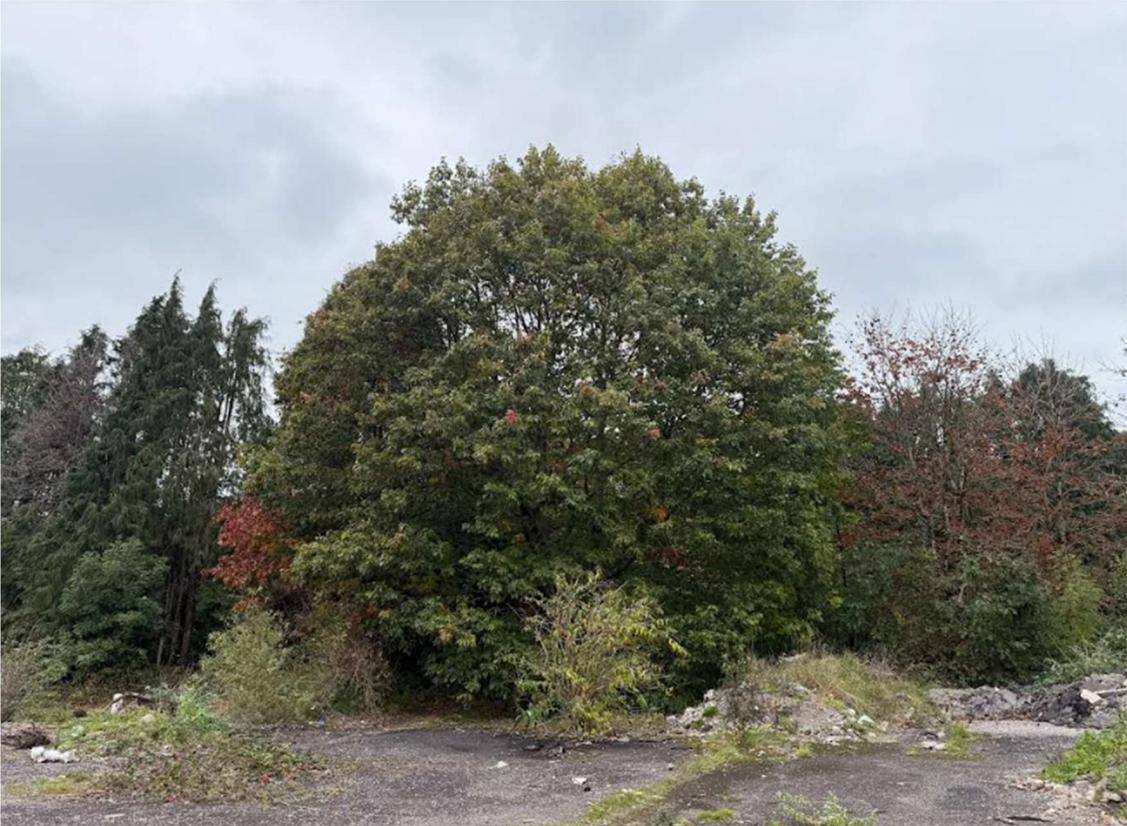
Photo 2: Tree no's.0376-78, view north.

0376	Red oak (Quercus rubra)	18	610	4/8/9/7	Mature	Good	Fair	Forked at 2m, good unions from which 4no. heavy principal stems emerge. Crown distribution predominantly south with long lateral limbs from lower and mid crown. Exhibiting good vitality but poor crown formation.	No work required	7.3	B2 (20)

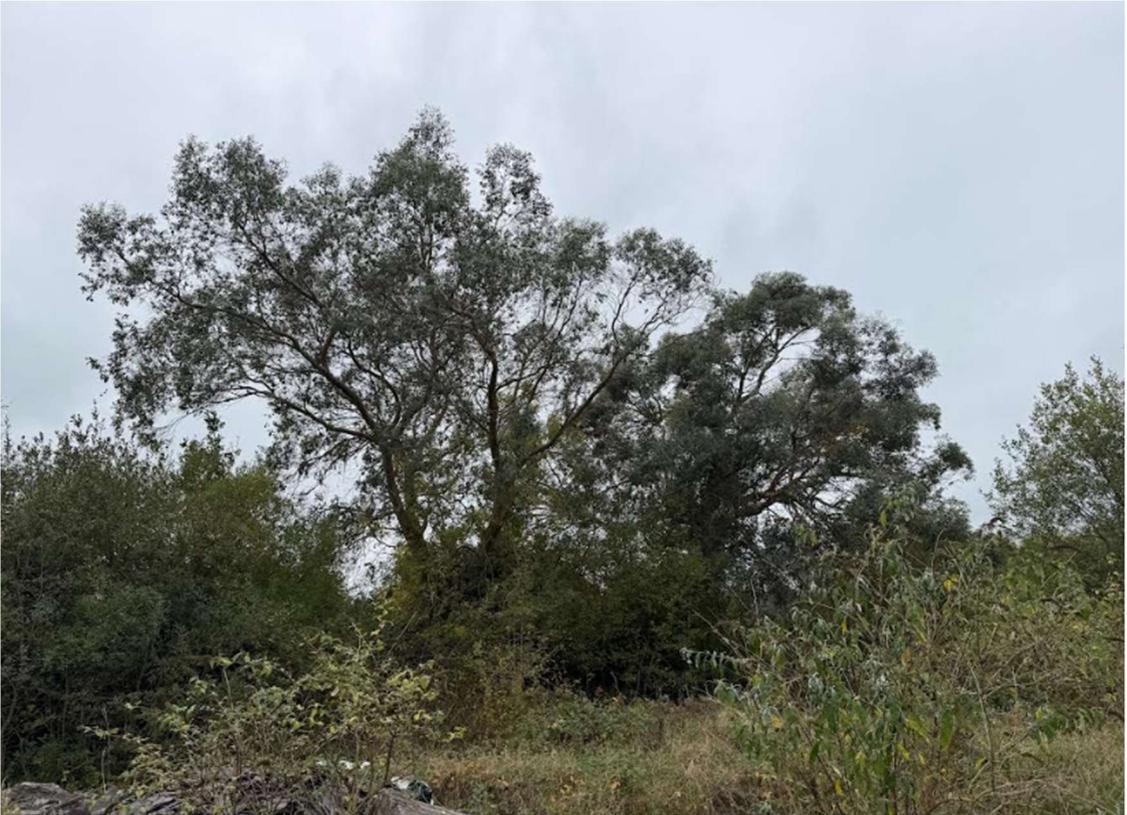
Photo 3: Tree no's. 0379 – 0380, view southwest.

- 3.1.4 Further along the driveway, two mature Cherry trees (0369-70) are present. These trees exhibit fair structural condition and good vitality. Centrally within the site, vegetation is dominated by naturally regenerated Willow and Buddleja, typical of brownfield conditions. Among this central vegetation, two early-mature Eucalyptus trees (0379-80) are located, both in fair structural condition with good vitality although 0380 displays significant storm damage within the crown.

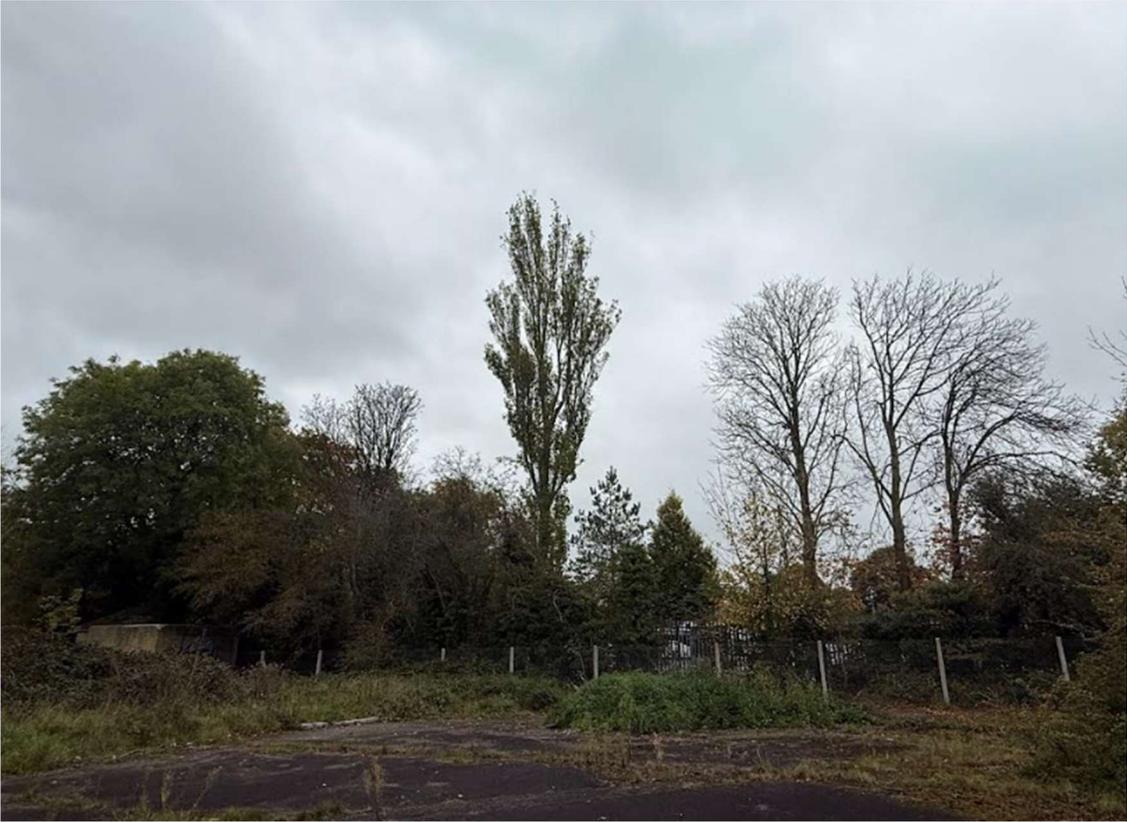
Photo 4: Tree no.0363 and Tree group 2, view east.

- 4.2.2 **Tree no. 0363:** This ash tree is in direct contact with the existing switch room which may be acting as a support/prop to the tree. Demolition of the existing Switch room may potentially make it more susceptible to windthrow. This is a realistic possibility with potentially high severity, as a weakened tree may fail in strong winds, posing a safety risk to people and property. Root stability testing is recommended to be carried out to avoid unnecessary tree removal and ensure the risk is as low as reasonably practicable.

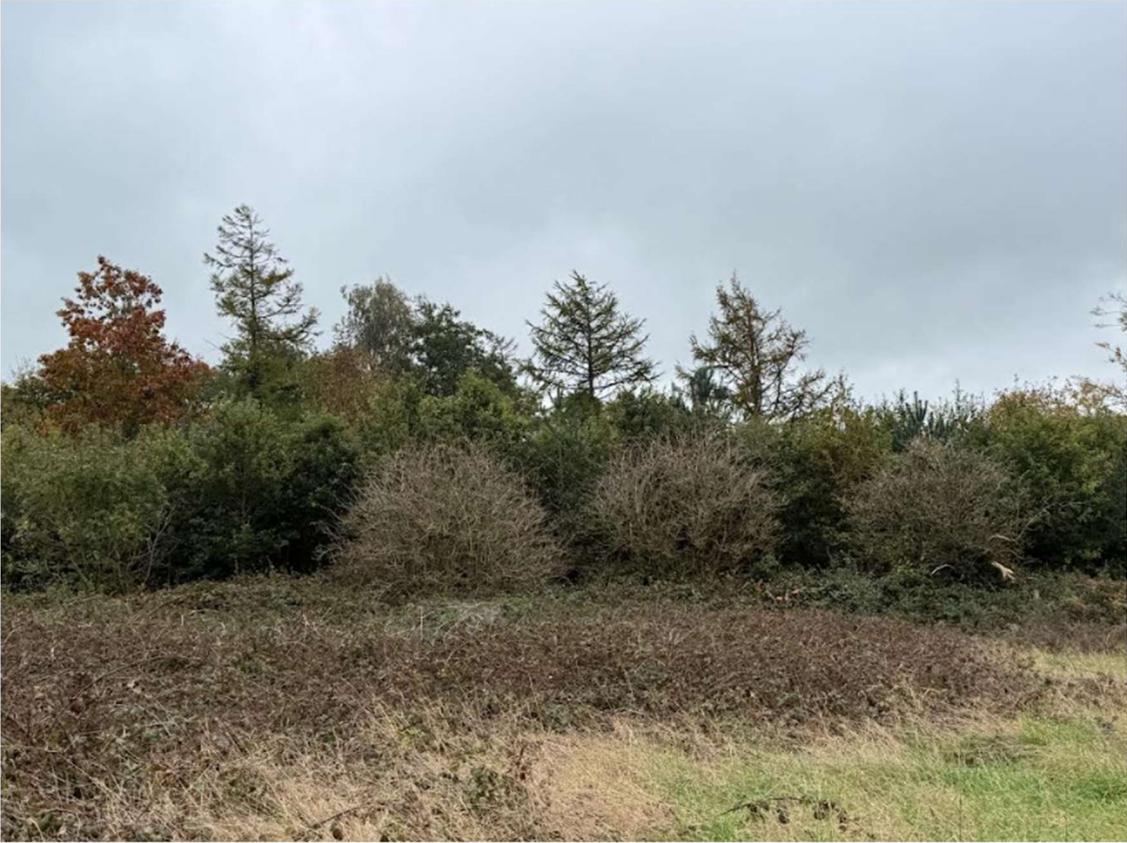
Photo 5: Tree group 3, view south.

- 3.1.7 Along the southern boundary, there is a dense stand of semi-mature trees, likely planted for screening. Species include Ash, Scots Pine, Oak, and Cherry, along with natural regeneration of Willow and Elder. These trees display good vitality and structure, with minimal overhanging limbs impacting the site. However, long-term shading and overbearance should be considered as some species may reach heights of up to 20 metres. Towards the eastern end of this boundary, 5no. semi-mature Sycamore and Ash trees slightly overhang the site by approximately 3 metres. These are lightweight lateral limbs and do not pose an immediate concern, though future pruning for clearance may be required.

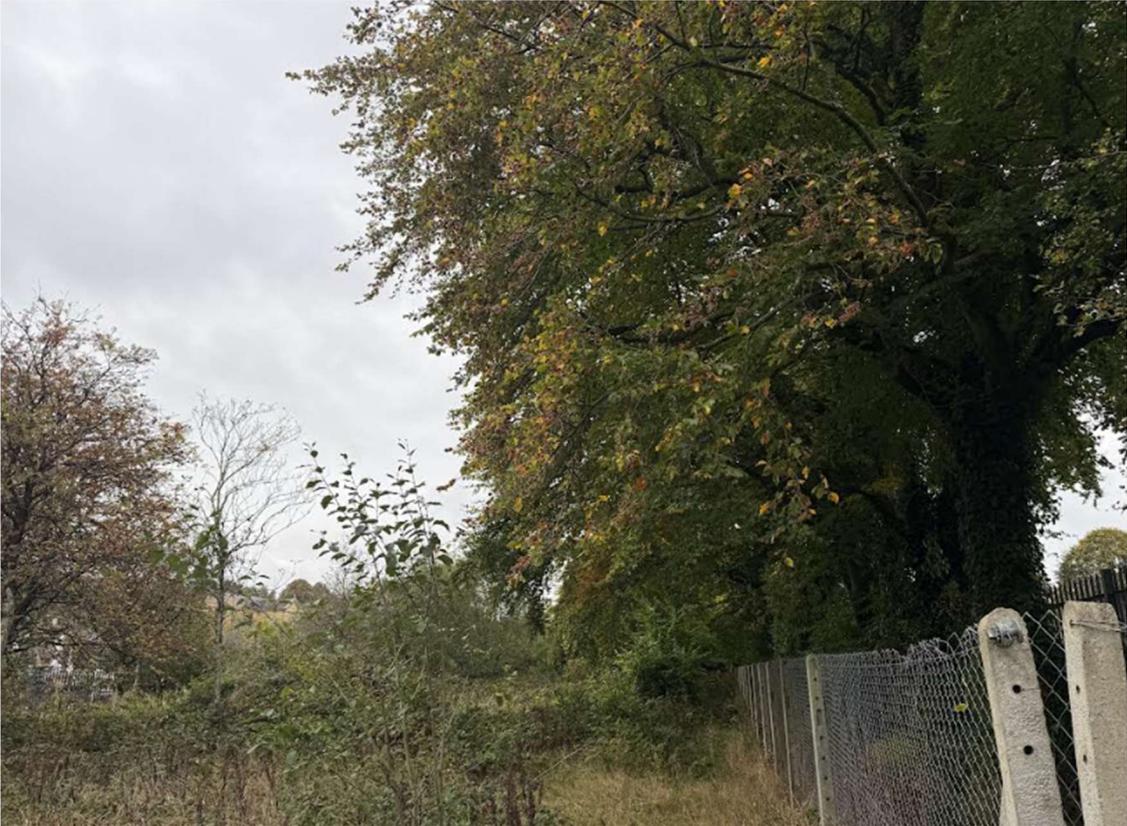
Photo 6: Tree Group 1, view east.

- 3.1.3 At the eastern entrance, a second tree line (Tree group 1) runs east to west on the southern side of the access road. This comprises approximately eleven early-mature Beech, Ash, and Hawthorn trees, with Beech being the dominant species. Typical of linear formation, their crowns extend laterally, with several limbs projecting 6–9 metres north into the site. Root encroachment from this group is also likely. Inside the entrance and extending approximately 80 metres along the driveway, there are various young to semi-mature planted and naturally regenerated trees, including Mountain Ash, Pedunculate Oak, Ash, Willow, Cherry, and Beech, interspersed with Bramble. These trees are not expected to constrain development, and some may present opportunities for transplanting.

- 4.2.6 **Tree Group 1:** Canopy conflict with the proposed structures is highly likely. The tree group currently overhangs the planned buildings, with ground clearance of approximately 1–3 metres. Pruning will be required along the northern side to provide adequate clearance for access, egress, and construction activity. The extent of pruning necessary will significantly alter the size and shape of the canopy. A substantial amount of live sapwood will be removed, which may reduce the trees' energy reserves and could result in a decline in physiological condition. This may present as shoot dieback within the crown. While pruning will create small to moderate wounds, the trees' current age and vitality suggest they should be capable of recovering without significant long-term harm. The primary impact will be visual, assessed as moderate, with a low physiological impact anticipated.

- 4.2.7 **Tree Group 1:** There is the potential for roots to be damaged as a result of soil compaction, trenching and soil stripping to allow for the proposed layout within this area of the site. The potential impact of this damage, which is likely, is significant dieback of crown branches to whole tree death within the group. The installation of appropriate ground protection measures and strict arboricultural monitoring of activities within the RPA are recommended throughout the construction phase to minimise the potential damage to roots.

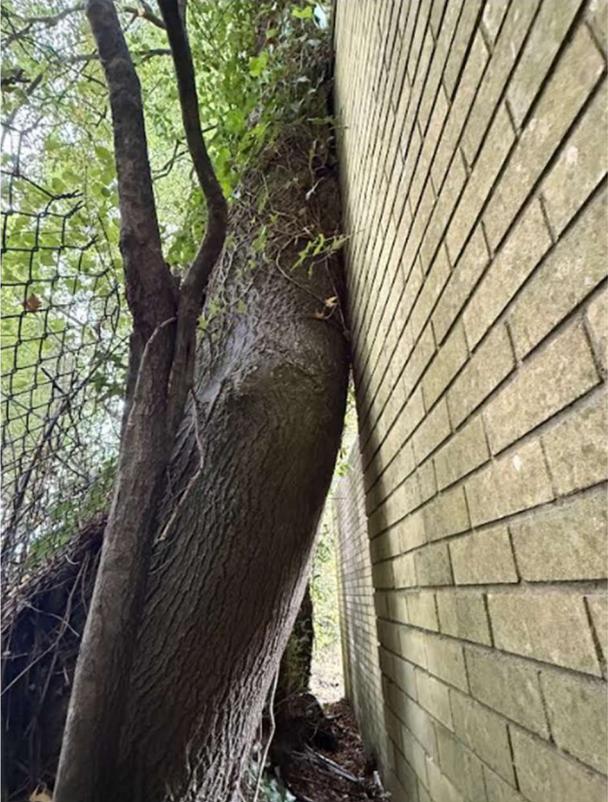
Photo 7: Tree no.0363 in direct contact with switch room.

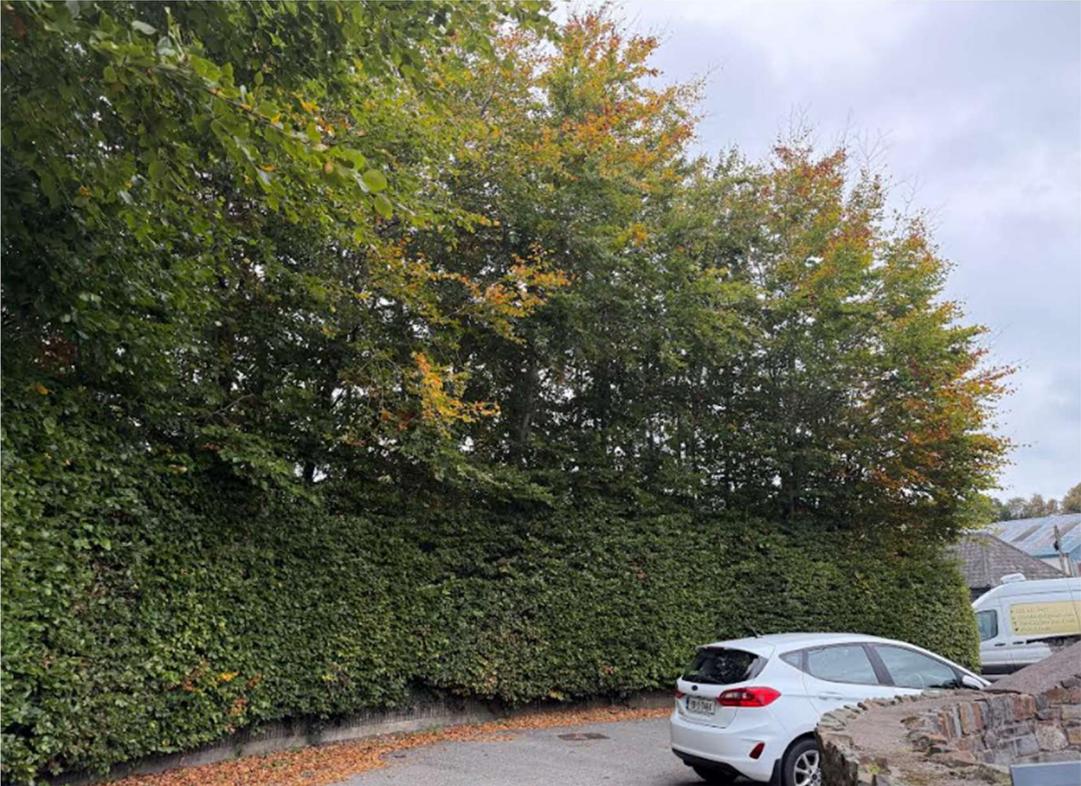
Photo 8: Hedgerow 1, view northeast.

- 4.2.4 **Hedgerow 1,2 & 4:** The proposed development directly conflicts with these hedgerows, requiring their full removal. Along the eastern boundary, Hedgerows 1 and 4 consist solely of beech with limited ecological value. The potential impact, which is certain, will therefore be predominantly visual, with only minor habitat impact. Hedgerow 2, composed entirely of *Griselinia*, will also be removed, and given its lack of visibility from the public realm and low wildlife support, this will result in negligible visual or ecological impact.
