# JCA Architects

## Conservation Report

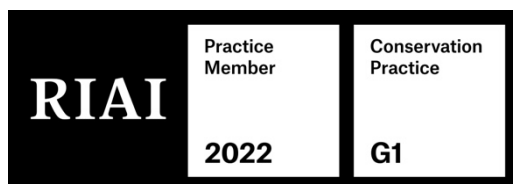
Contents	Page Number
1.0 Introduction	3
2.0 Historical Background	6
3.0 Current Description, Conservation Assessment & Recommendations for Repairs to Heritage Structures on site	8
3.1 Forge Hill Bridge	8
3.2 Lehenaghmore Bridge	17
3.3 Spur Hill Bridge	27
3.4 General Conservation Principles and Outline Specifications	39
4.0 Assessment Methodology	45
5.0 Assessment of Significance of Existing Site	48
6.0 The Proposed Development	48
7.0 Physical and Visual Impacts of the Proposed Development on the NIAH Structures on the Site	52

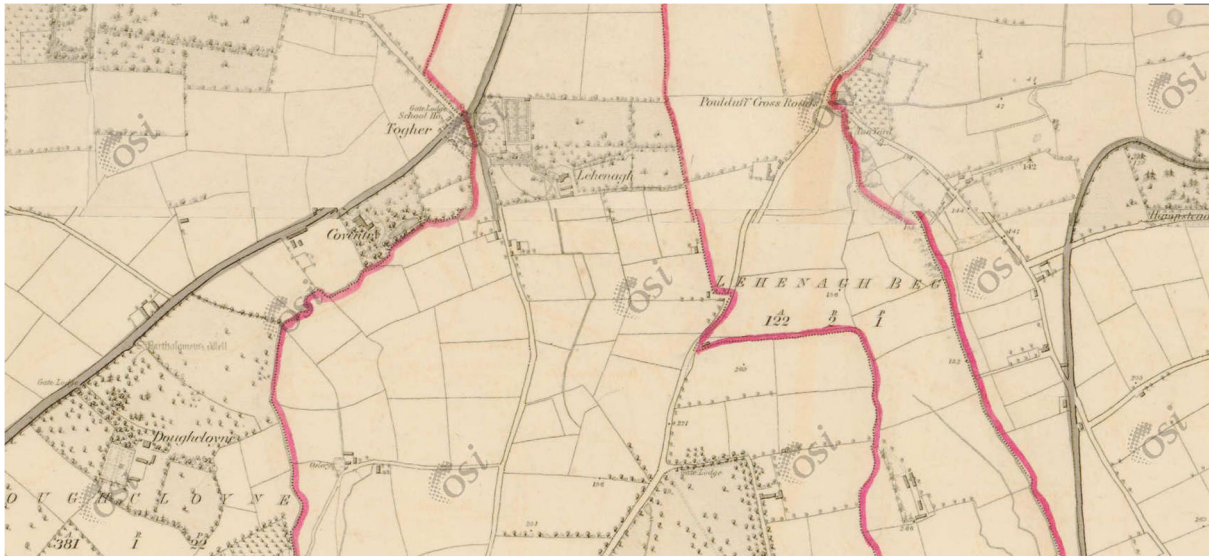
Figure 3: First edition OS map, 1841-2, showing site before rail line introduced

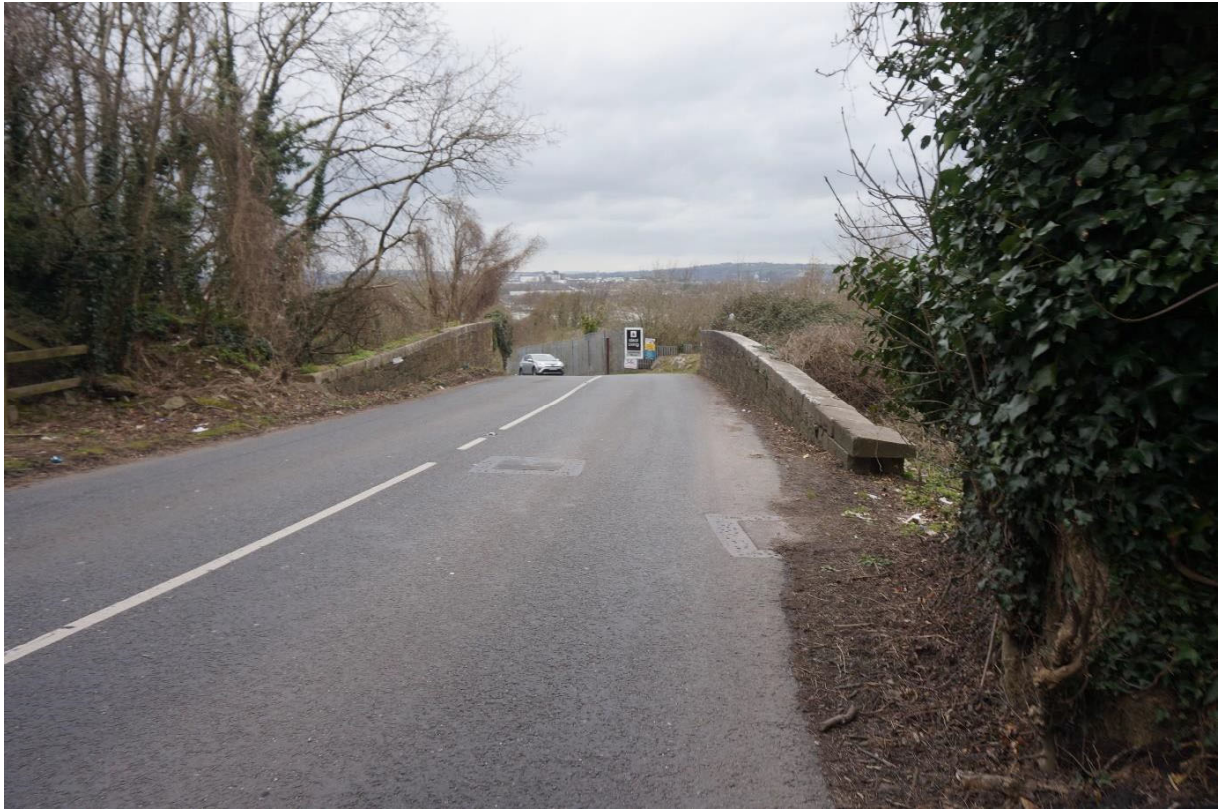
Northern approach with view of bridge parapets that increase in height across the bridge span

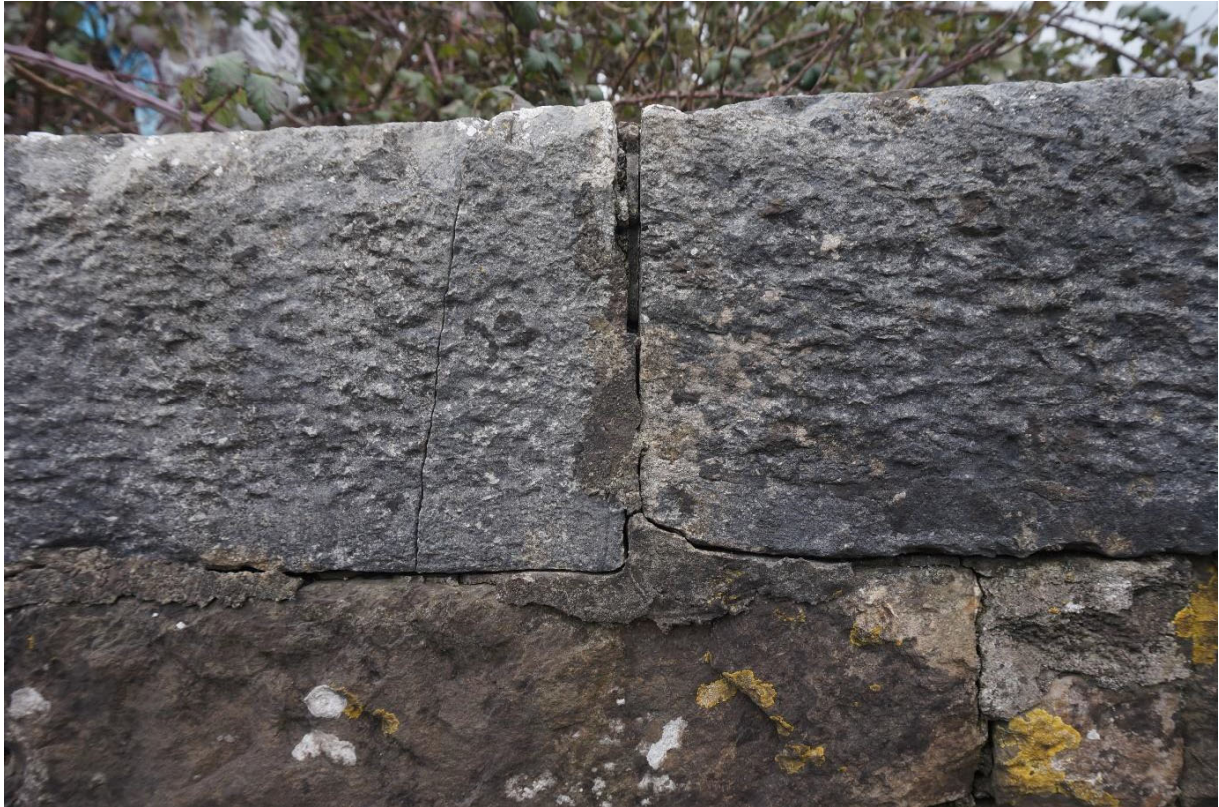
Loose and friable pointing mortars. Later replacement mortars are cement based

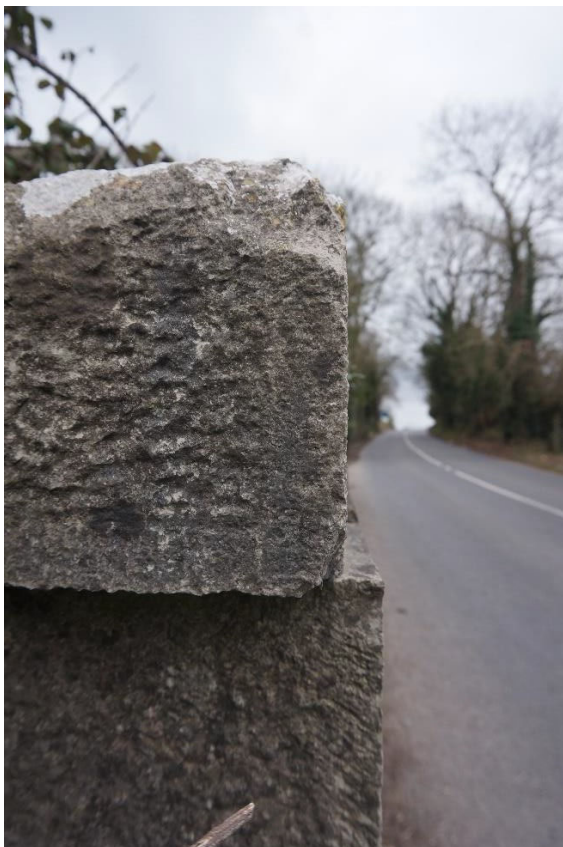
Parapet stone has shifted out of alignment on Northern end

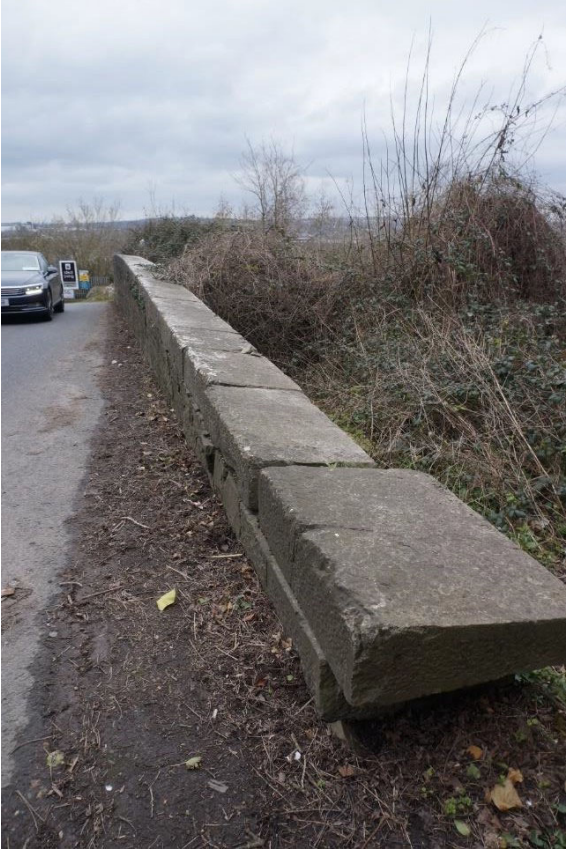
Loose and unconsolidated parapet capping stones

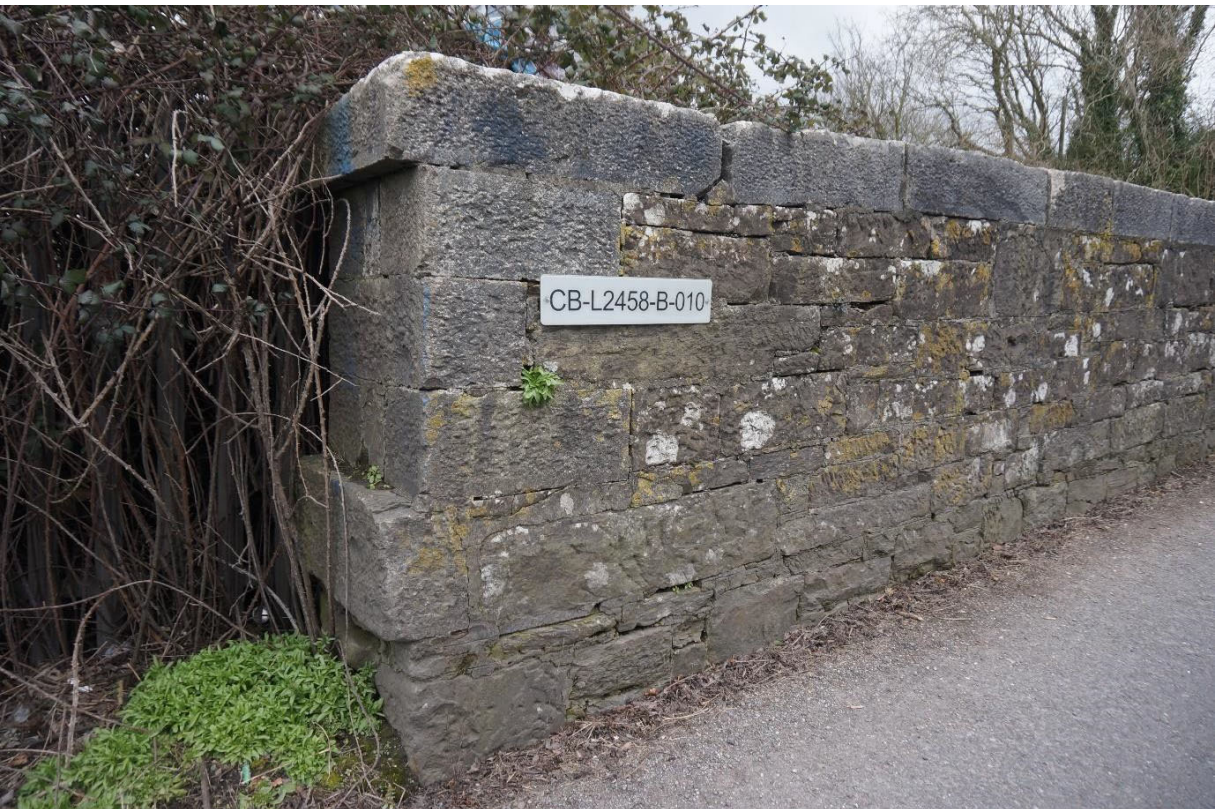
Loss of mortar pointing to ashlar stone capping and general parapet walling is evident

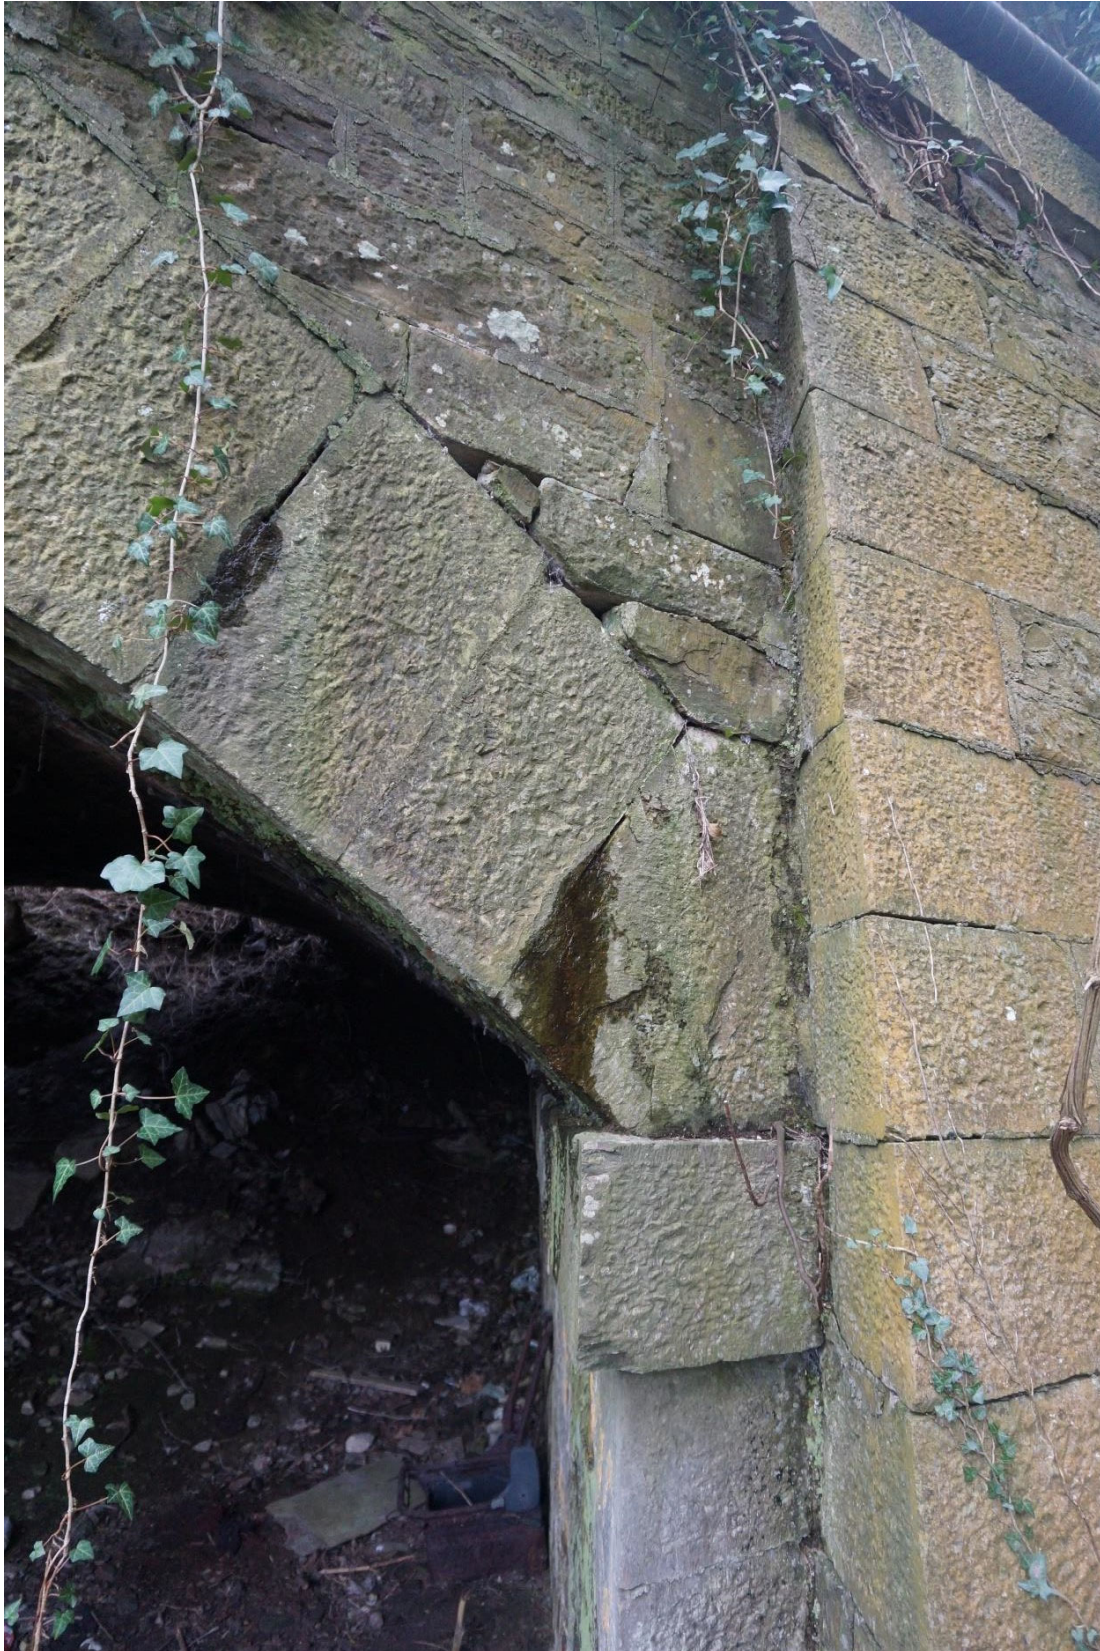
Detail of arch spring point: Considerable leaching of joints presumably caused by unsealed road surface and open stonework joints that have lost their mortar fill. Note the use of non-breathable cementitious mortars at the top of the photograph where the mortar is inappropriately brought over the stone face. Much of the ashlar stonework has lost its mortar fill.

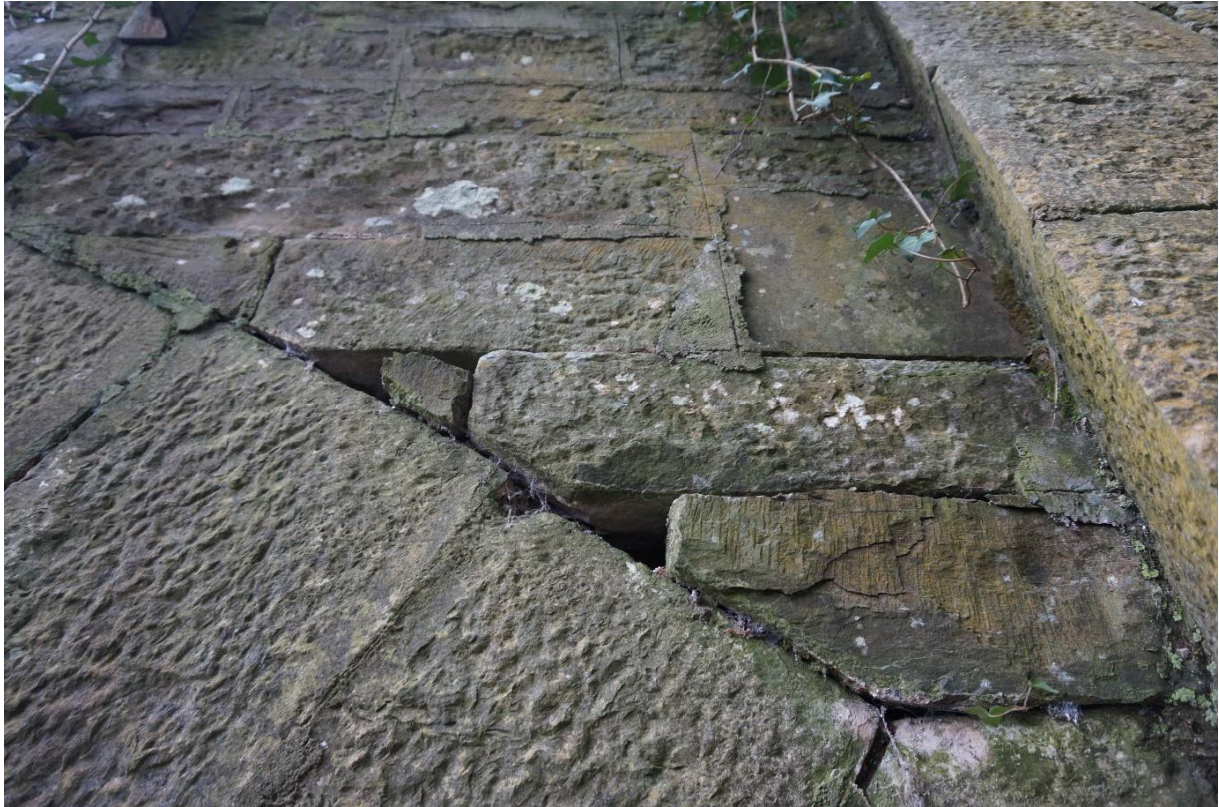
Loss of smaller stone pinnings above arch voussoirs

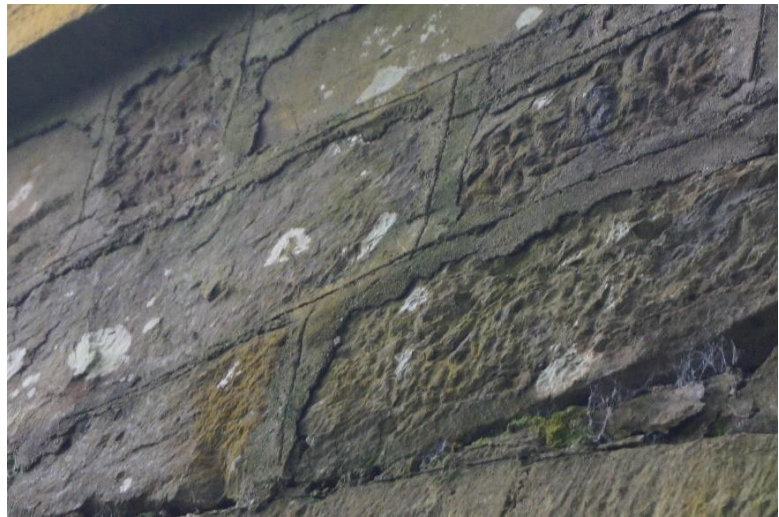
hard cement later mortar repairs with lining to define stone edge

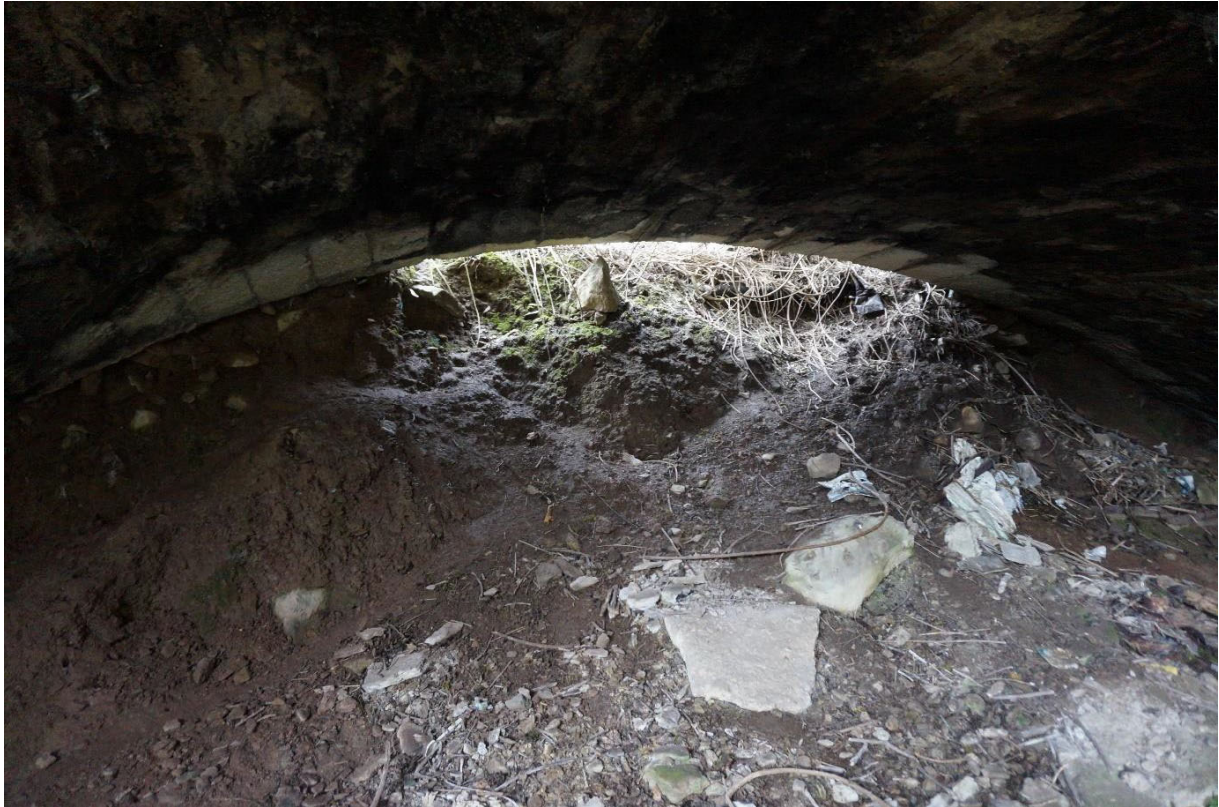
East elevation is inaccessible due to the placing of an earth mound against the barrel vault

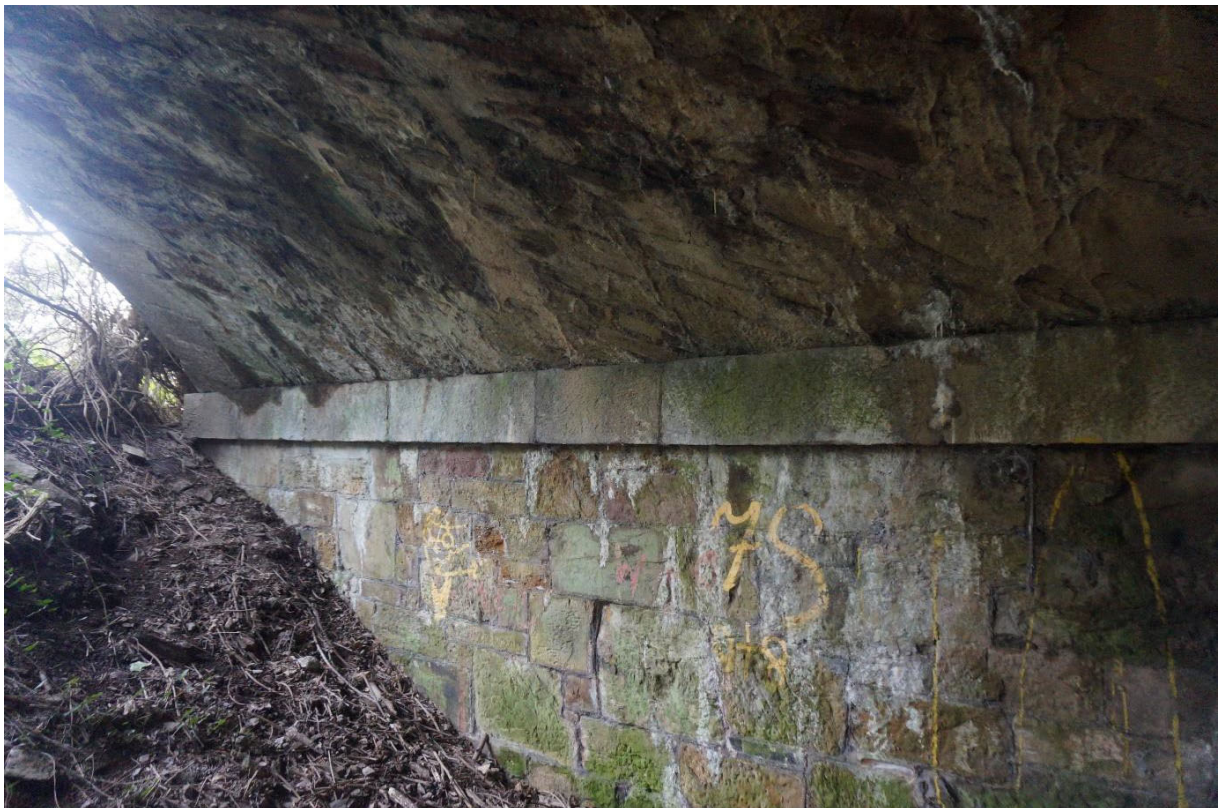
Detail of arch barrel rising from ashlar pier. Arch vault stonework is laid in a diagonal pattern and appears in good condition with mortar joinwork generally intact.

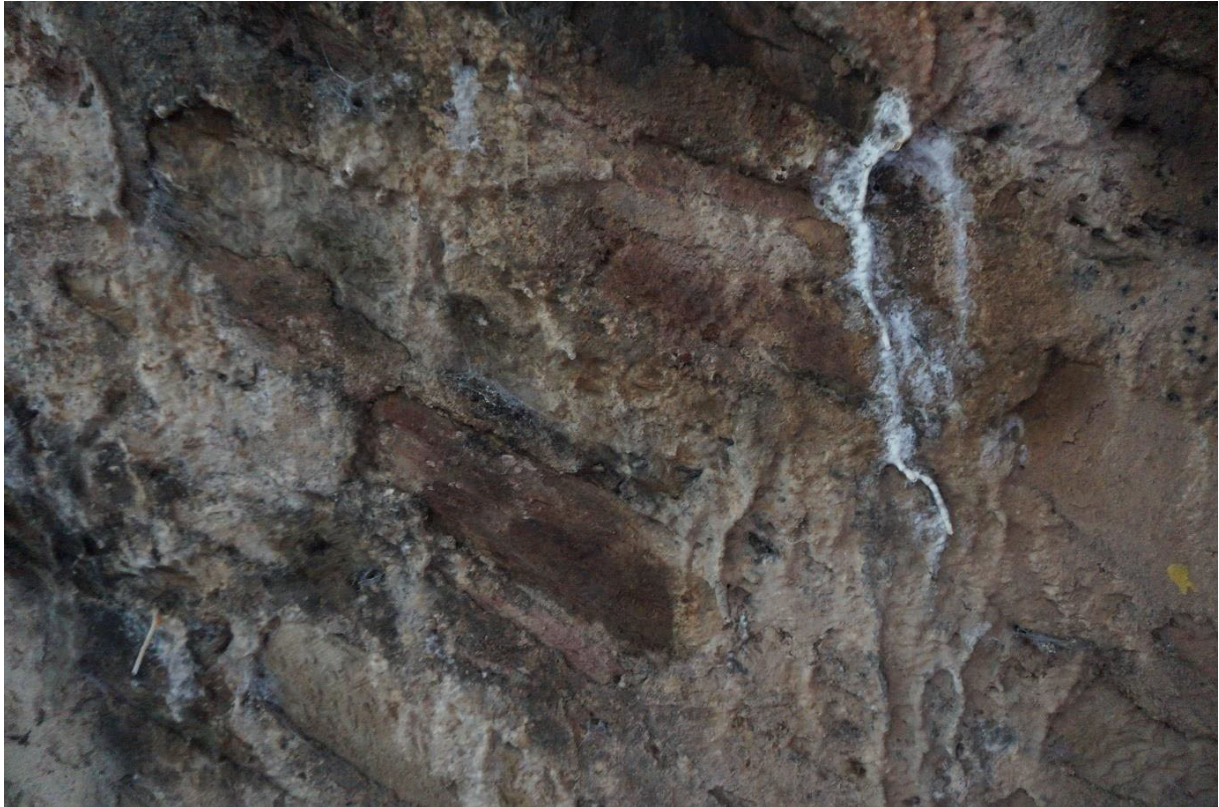
Some leaching of salts through arch barrel possibly from unsealed road surface

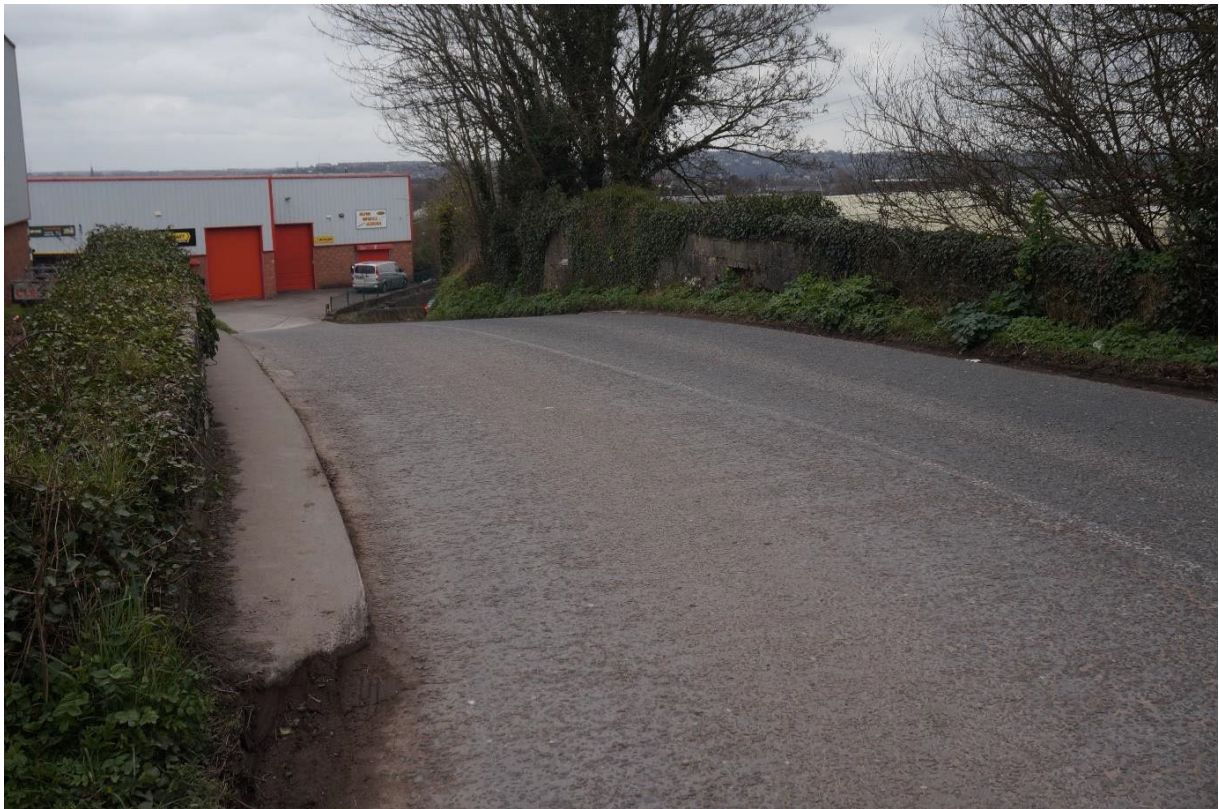
Roadway and bridge parapets looking North

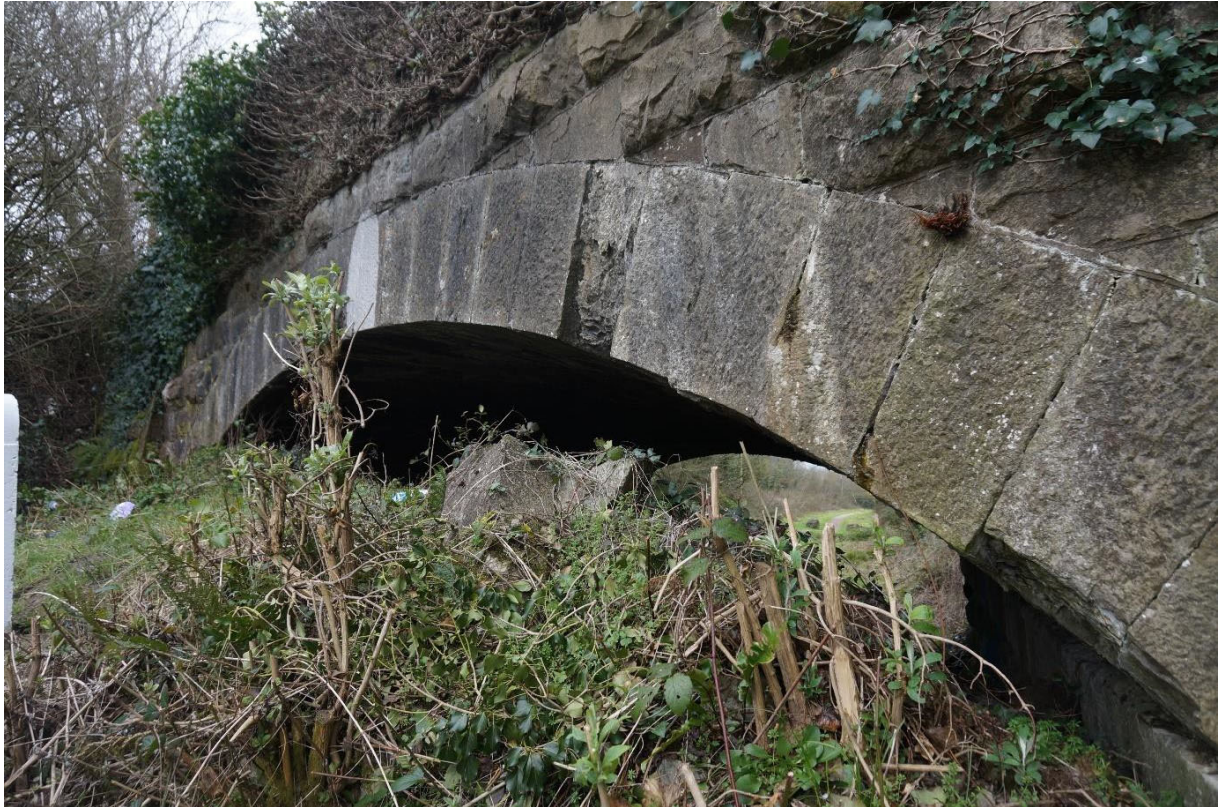
Surface damage to arch stones where earth mound built up to underside

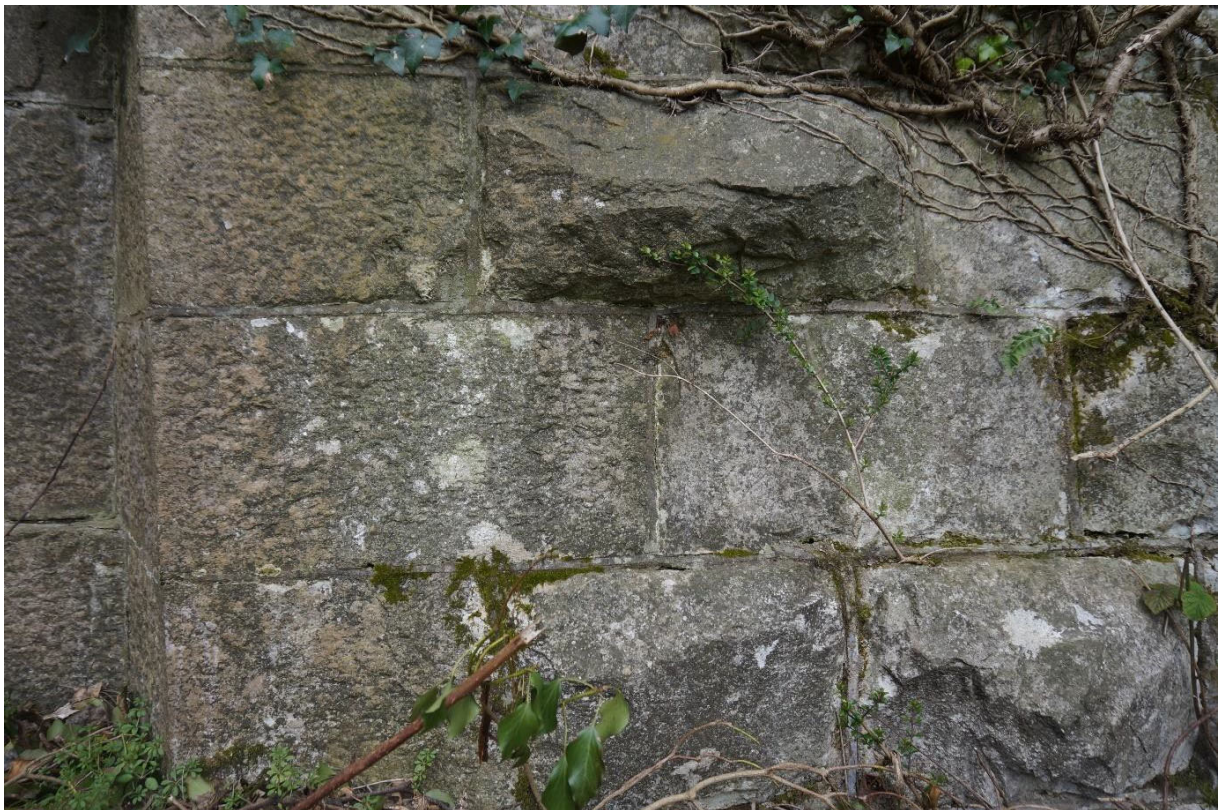
Detail of rusticated spandril stones. Note hard cement based pointing

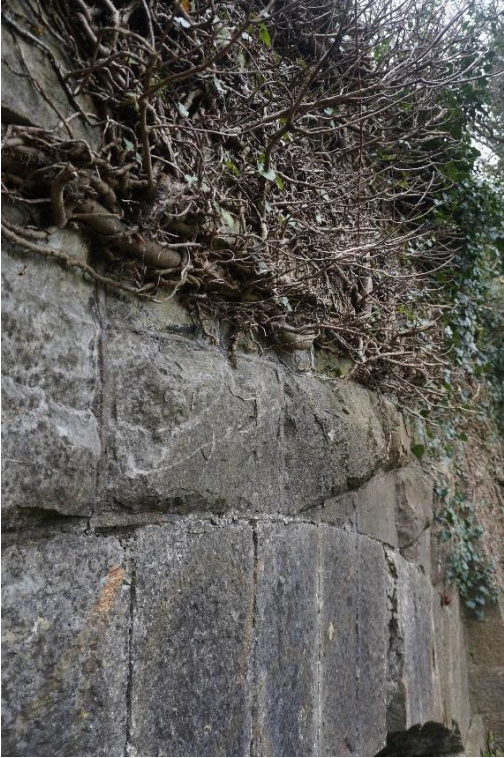
Severe invasive ivy growth beneath east parapet above arch

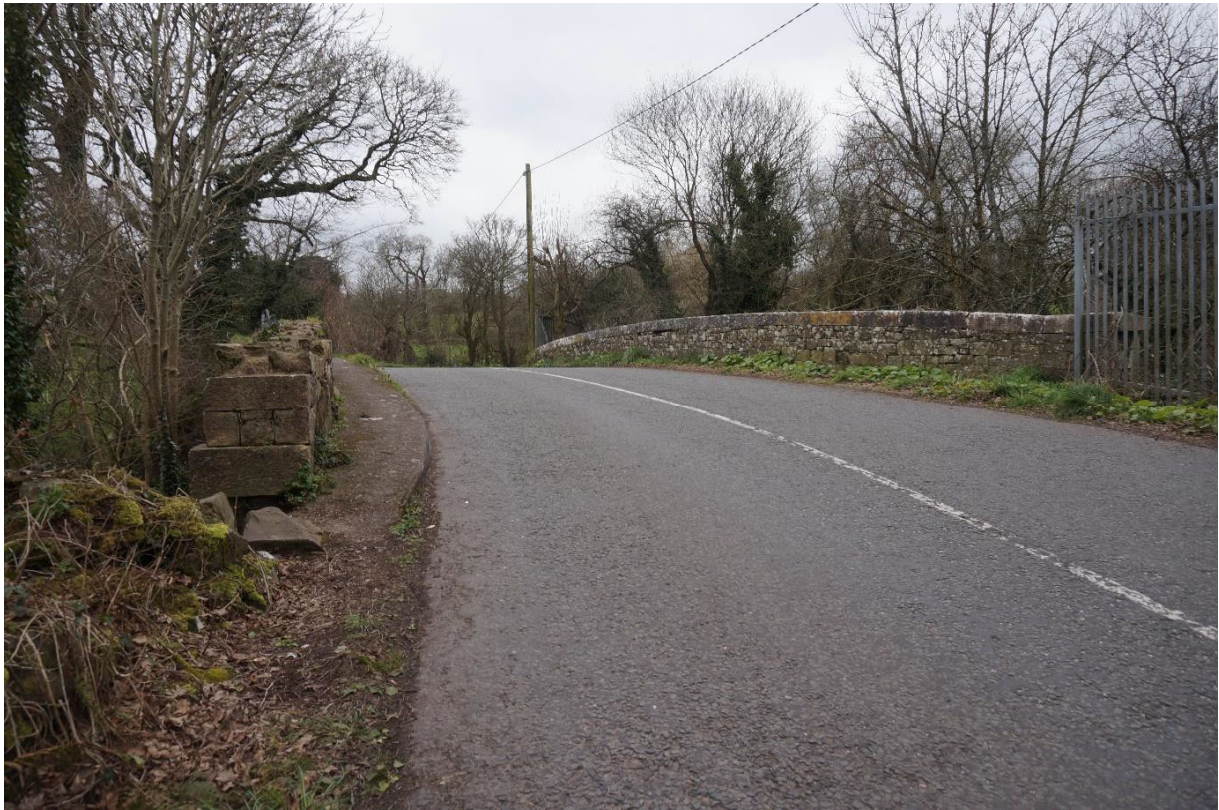
Approach road. Note intact parapet coping to East side and severe loss of stone to West

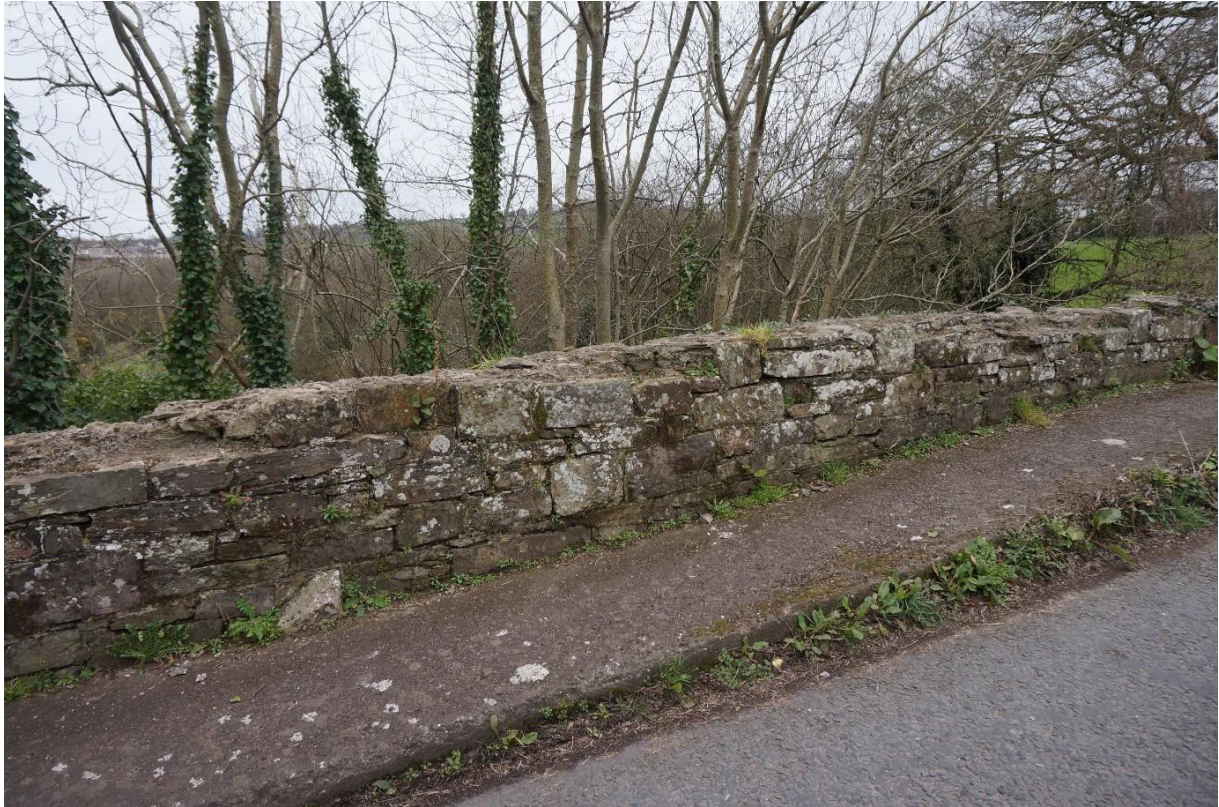
West Elevation of bridge parapet with coping and top rubble stone missing

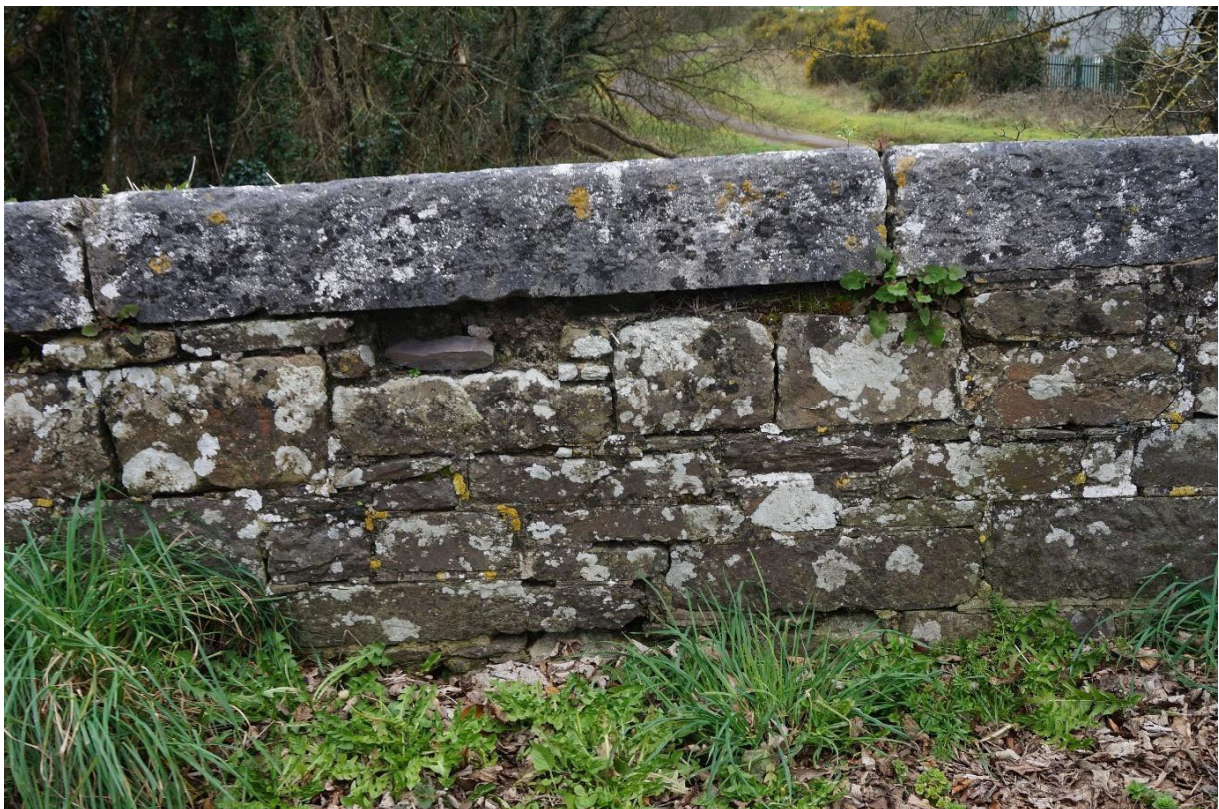
Local loss of stone beneath copings

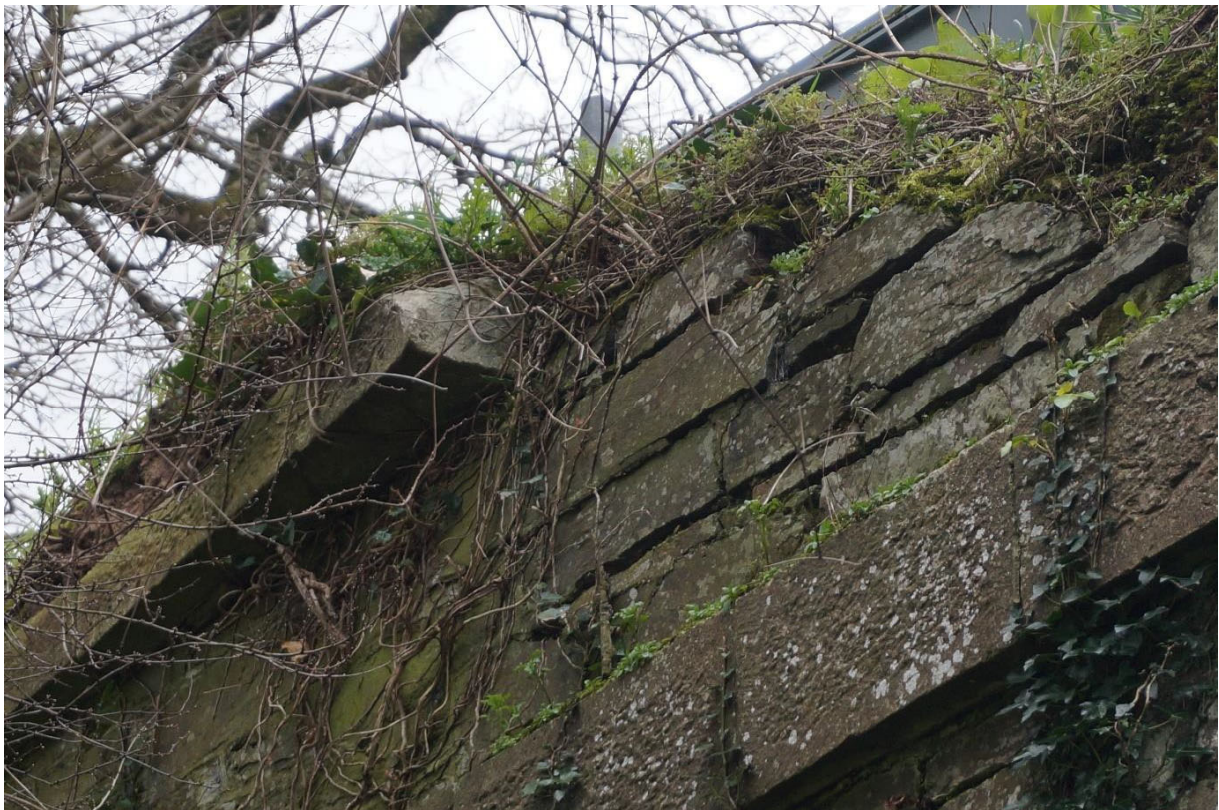
Missing and dislodged parapet copings. Note buckling of spandrel wall stones and loss of pointing

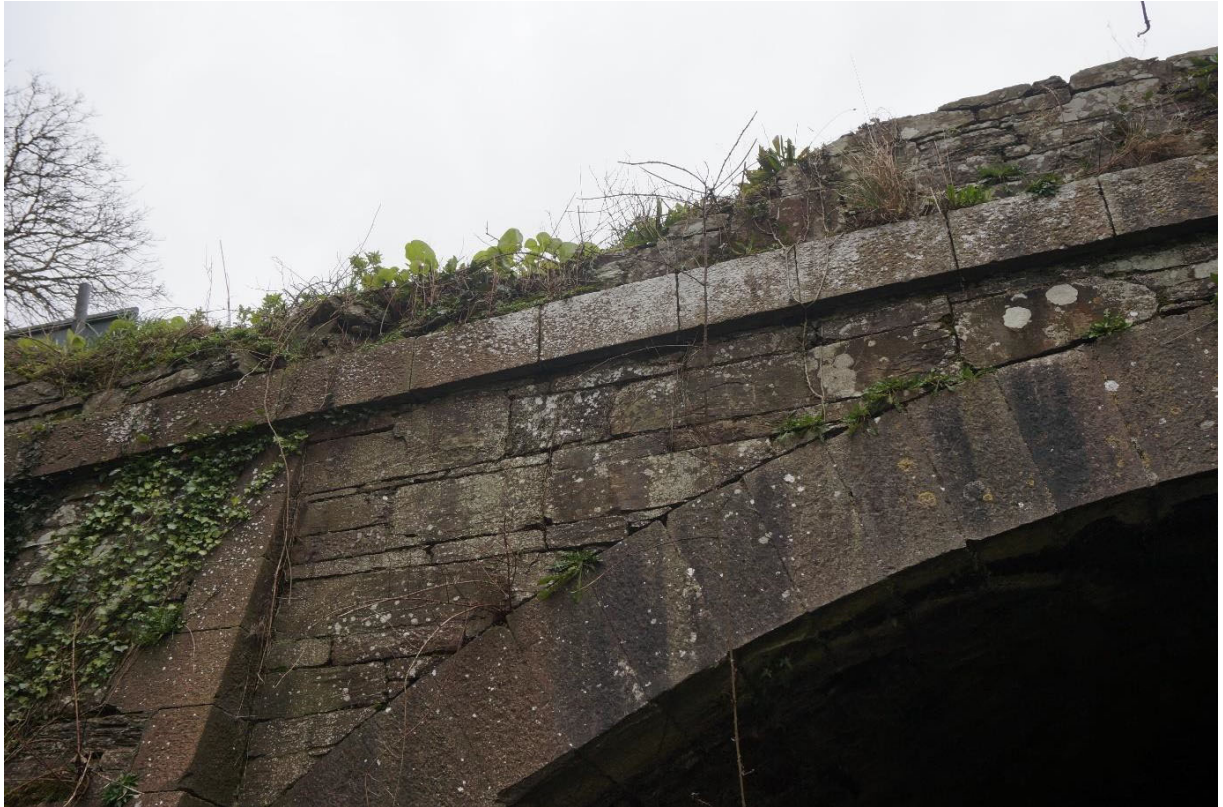
Missing, loose unconsolidated parapet stone with open jointwork

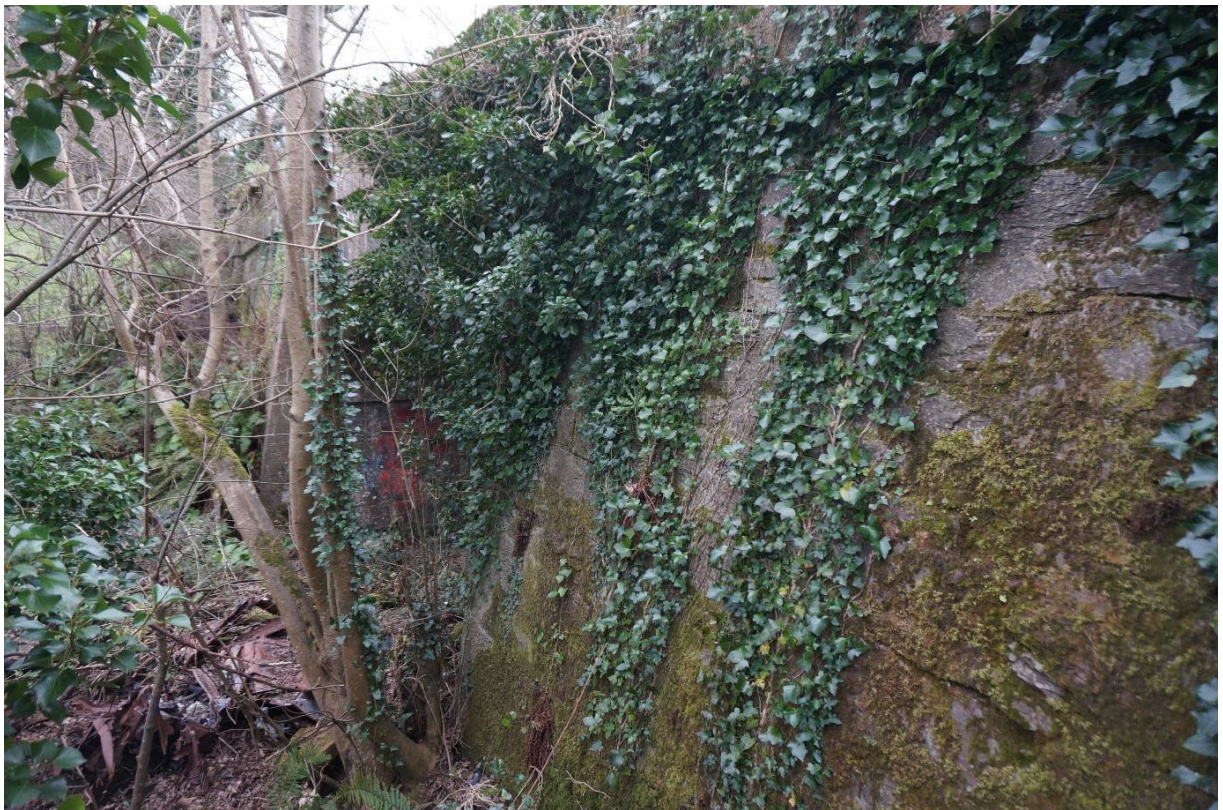
Extensive ivy overburden and tree growth on wing walls

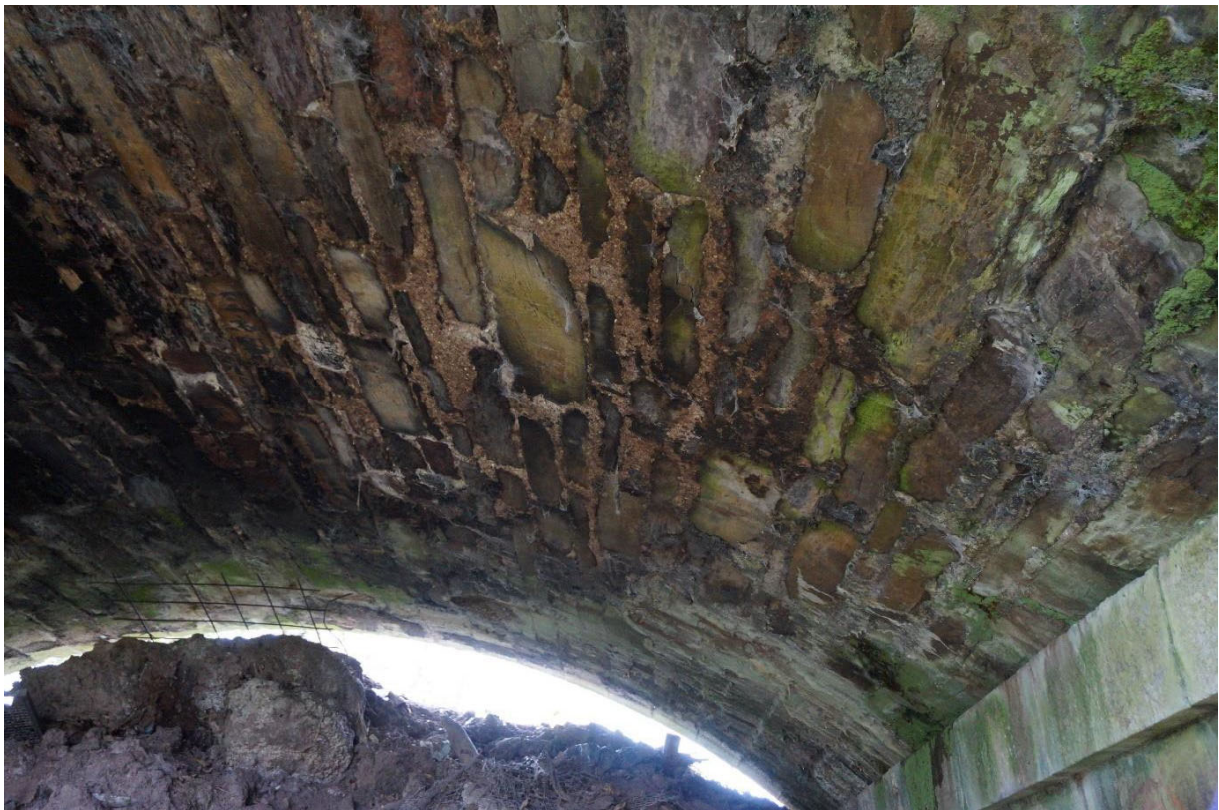
Underside of barrel vault in generally good condition

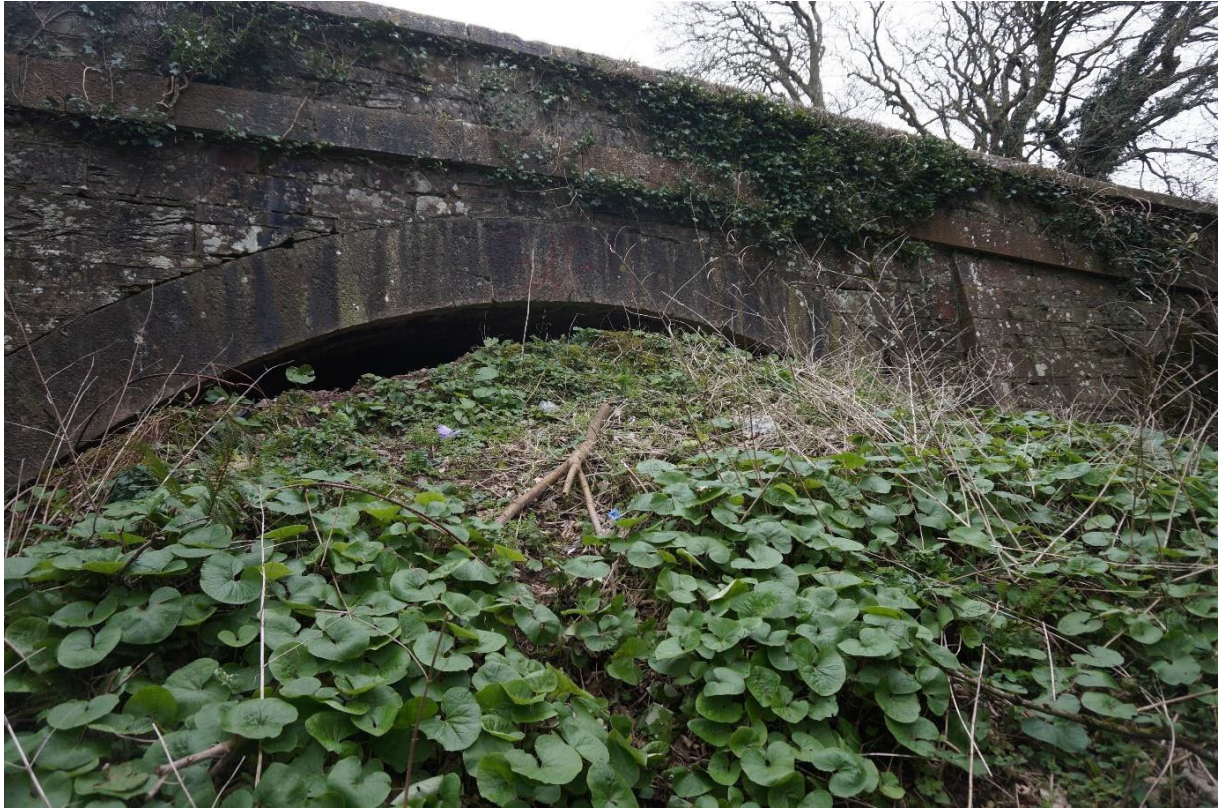
Earth mound concealing East elevation and access through arch
