Tree Report

Project: Maglin Greenway Phase 1

Report No.: MG1-FF-002

Date: May 2023

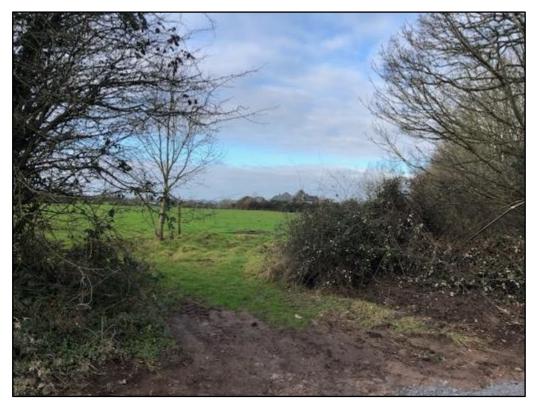
Photo 2: Sites 5 and 6 looking at single ash at site 7.

Loss of hedgerows may be seen at sites 3, 4, 5 and 6. The impact here is reduced by the presence of two field entrances either side of the existing avenue. This avenue has well established boundaries along its length and is likely to be locally important to species such as commuting bats. Site 5 is likely to be impacted on with the potential loss of the sycamore to accommodate a potential future connection to a proposed development to the north of the greenway.

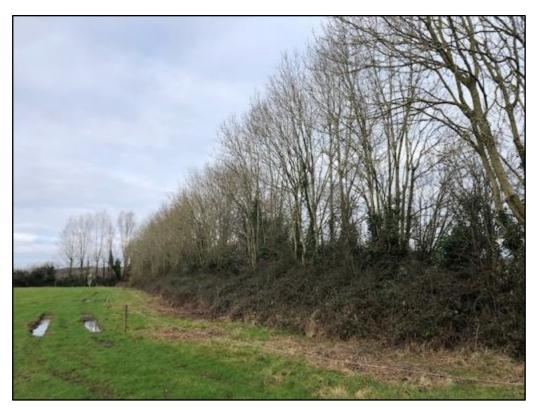
Photo 3: Sites 8 and 9.

The Blackthorn scrub and Ash treeline at sites 8 and 9 are a nice habitat feature in the area. Root damage should be avoided where possible to the mature trees. There was no evidence of 'Ash dieback' during the survey. The blackthorn is spreading into the field.

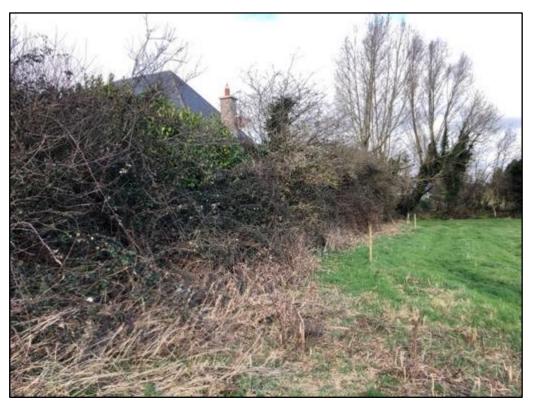
Photo 4: Sites 13 on the left, looking north at site 10, 11 and 12.

There are two mature willows at site 10 beside the poplar trees at sites 11 and 12. These are leaning into the field and may require removal.

Two boundaries that have been planted with trees are located at sites 11 and 12. The poplars at site 11 have been topped. The Poplars at site 12 are mature and are a feature at this end of the housing estate. The route will likely not have any impact on these trees. The trees are in good condition and do not appear to have any bat roost potential.

The boundary of the residences to the Southern end of Limeworth estate at sites 13, 14 and 15 are dense and may be trimmed back but should be retained where possible. Some of the boundary, along site 15, moving east has been cleared (45m) and is not as dense as you progress westwards. There are some mature hawthorns along the boundary that can be retained. There is a further length (30m) of laurel along the boundary of the last residence to the west.

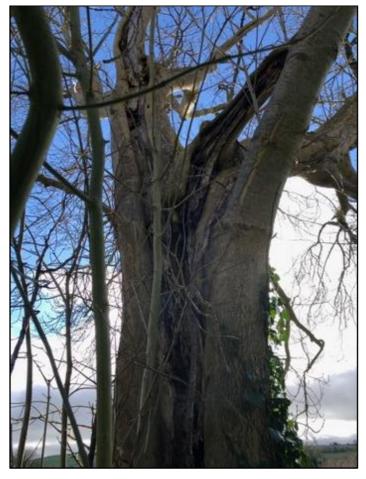
The tree at site 16 is a large ash that has some damage on its northern side. This tree may require removal on safety grounds. It may also have some bat potential.

Photo 6: Ash tree at Site 16.

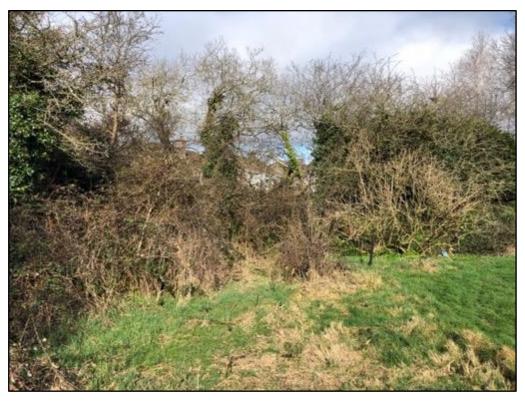
Photo 7: Site 19 and 18 (elder on the right).

Sites 17 and 19 will need to be removed. There are mature hedgerow species of elder, hawthorn, willow and blackthorn with a dense understorey of similar plants.

Site 18 is along the riparian zone on the watercourse. It is quite open as most of the dense hedgerow growth is on the southern side of the river.

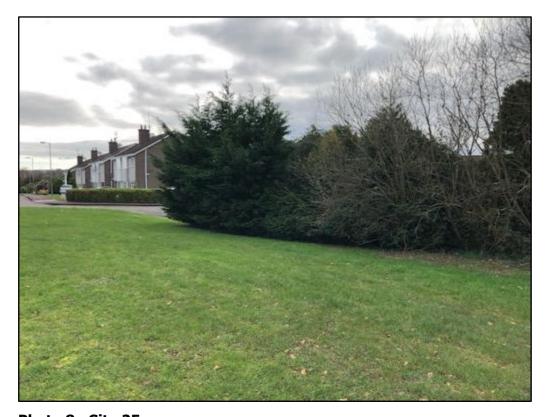
Photo 8: Site 25.

The Leylandii at sites 25 and 27 are located along the boundaries of individual residences. The removal of these would have a positive ecological impact. Removal is subject to landowner permission. They are located quite close to the route at site 27 where they are causing a significant shading effect.
