# Spring Lane and Ellis Yard Development

Stage 1 – Road Safety Audit

Cork City Council

June 2023

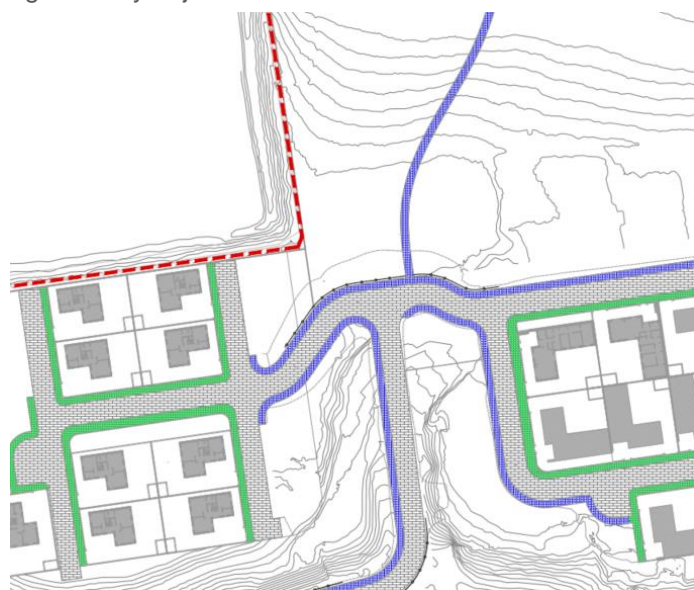
Figure 2-1 – Junction layout without road markings

The supplied drawings did not include road markings for the final layout. Without these markings it is not possible to determine the right-of-way at junctions. Where there is not a clear indication of the right of way at junctions there is an increased risk of collisions.

Ensure right-of-way is assessed at all junctions and appropriate road markings are set out in the detail design.

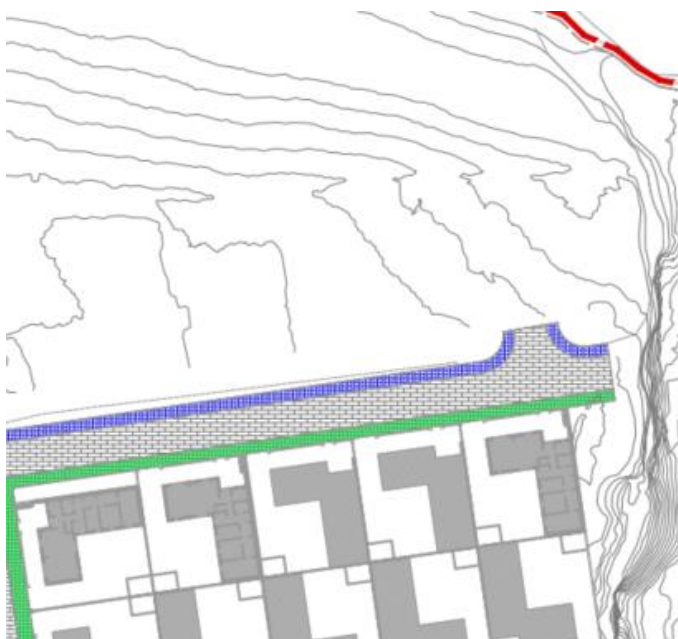
**Figure 2-2 – Turning Area.**

A number of the internal roads are cul-de-sacs. Some of these cul-de-sacs are provided with turning areas, while others are not. The turning areas that have been provided do not appear to be sufficiently sized to cater for large vehicle turning movements. Inadequate turning areas can result in material damage collisions. Without dimensions it was not possible to assess the size and adequacy of these turning areas.

The Designer should review each cul-de-sac to determine if a turning area is required and the adequacy of the provided turning areas should be confirmed with a swept-path analysis for emergency services vehicles and vehicles with trailers.

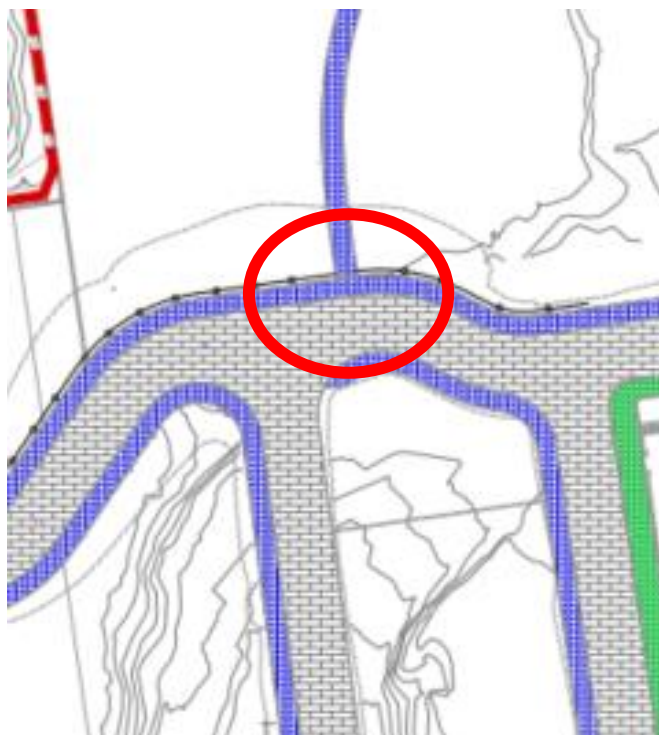
**Figure 2-3 – Safety Barrier Broken**

At the northern end of the main road the safety barrier is broken to connect the footpath linking Spring Lane to Ellis’ Yard with the footpath to the north. This will affect the containment levels of the safety barrier with the resultant risk that it could fail to perform in a collision.

The Designer should consider diverting the footpath linking Spring Lane to Ellis' Yard to the back of the safety barrier to avoid the need to break the barrier. Alternatively, the connection point of the two footpaths could be relocated away from the barrier.

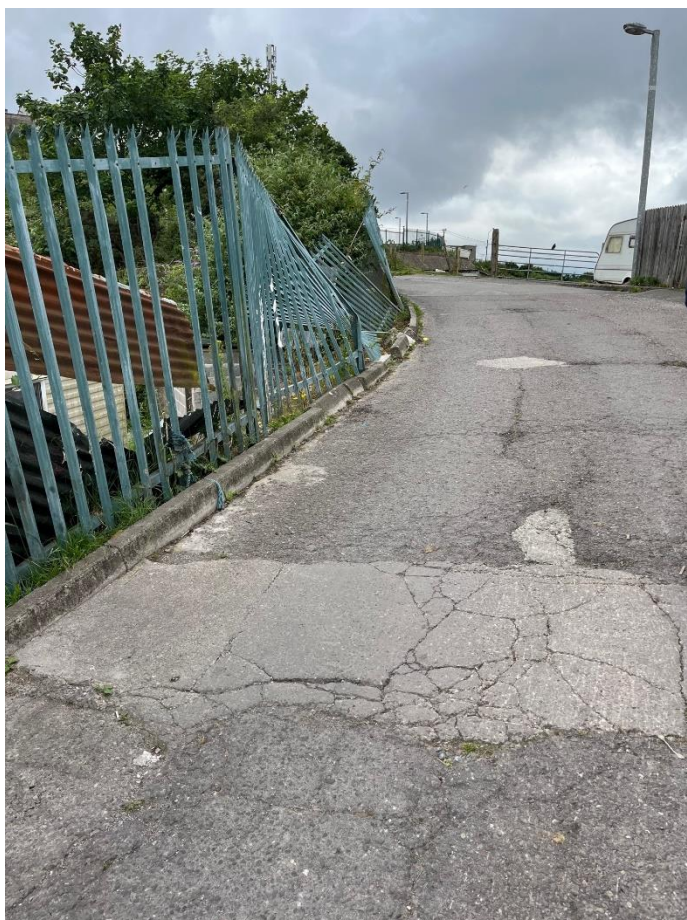
**Figure 2-4 – Location of previous loss of control incident.**

The safety barriers as indicated on drawing 5221169-ATK-XX-XX-C-930770 appear to be short and do not extend to the full length of the hazard posed by the steep embankment side slopes. This includes an area which has already been subject to loss of control type collisions (see figure 2-4). Without protection a vehicle falling over the side slopes could result in serious injuries to passengers.

As part of the detail design, the hazards should be assessed and barrier lengths, containment levels and terminal types appropriate to the site conditions should be specified.

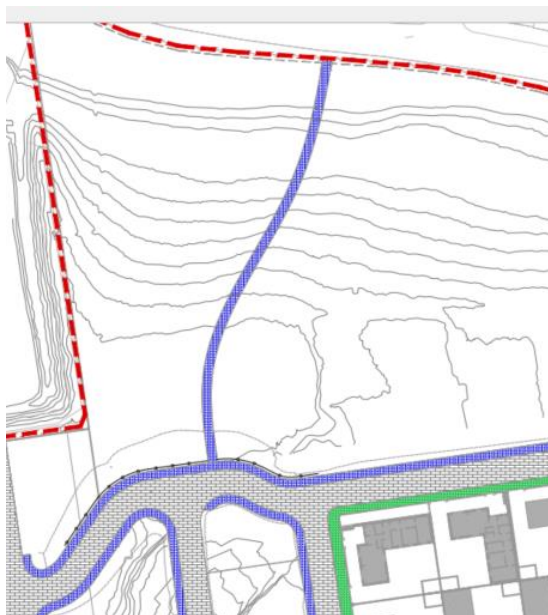
**Figure 2-5 – Northern footpath.**

The proposed northern footpath traverses sloping ground as can be seen from the contours in figure 2-5. If the footpath is too steep it will not be used and can result in pedestrians walking across rough ground, increasing the risk of slips, trips and falls.

As part of the Detail Design the Designer should consider the alignment of the footpath, selecting the most favourable vertical alignment and as close as possible to any identified desire-lines.

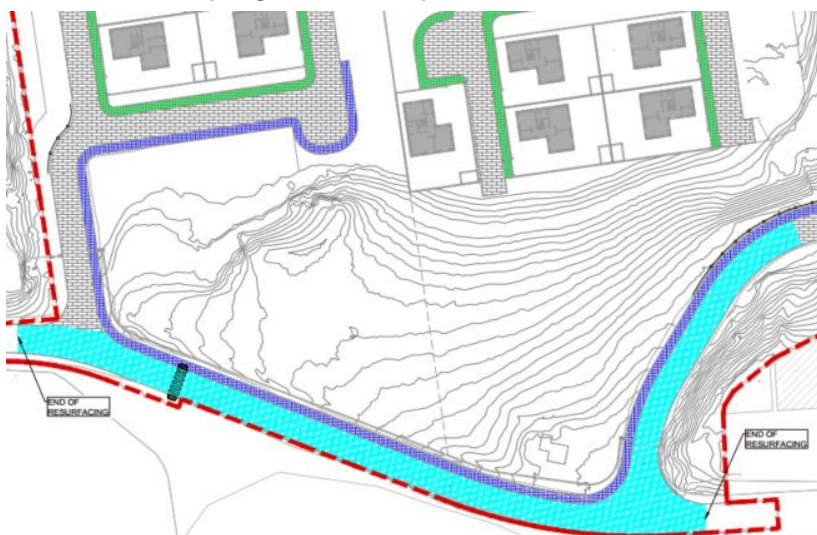
**Figure 2-6 – Entrance to site.**

There are two proposed entrances to the development from the Ballyvolane Road. While on site a number of vehicles were observed to be travelling on this road at speeds which appeared to be greater than the posted speed limits. High speeds increase the risk of collision with vehicles exiting the Ellis' Yard / Spring Lane development.

The risk of collisions at the entrances to the site should be mitigated by ensuring maximum possible sightlines are provided. Also, consideration should be given to the provision of speed control measures as party of the resurfacing of Ballyvolane Road.

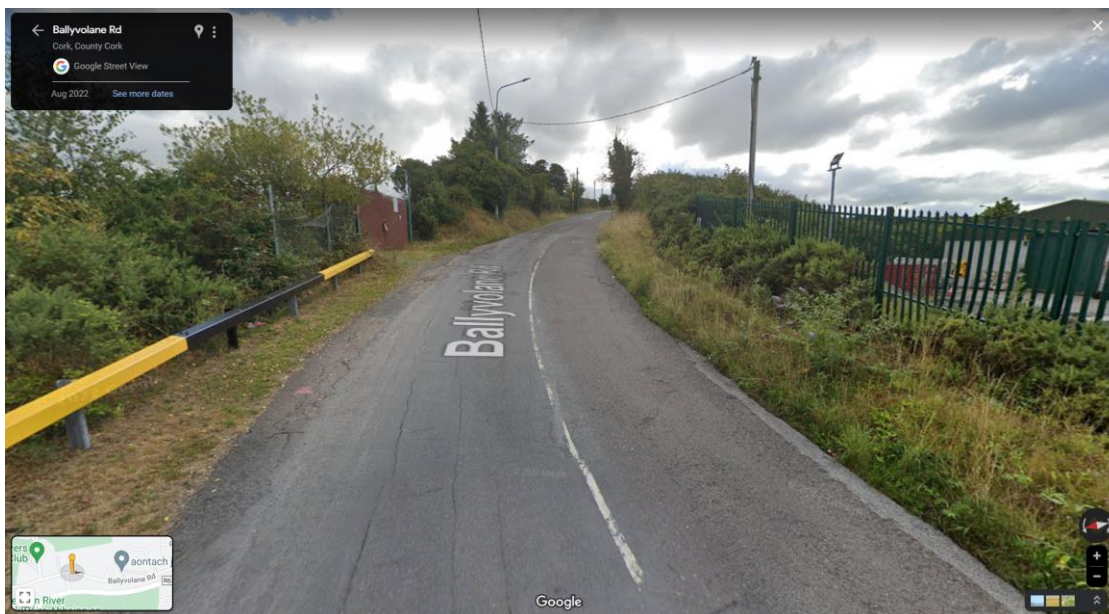
Figure 2-7 – Existing Ballyvolane Road and Ellis’s Yard Entrance.

The design drawings indicate a proposed dropped kerb and tactile paving arrangement near the Ellis’s Yard entrance, at the southeast of the site. However, there is no existing footpath on the south side of the Ballyvolane Road to receive this proposed crossing facility. Further to this, the location of this crossing facility fails to provide the most direct desire line for pedestrians exiting the Ellis’s Yard site. Both of these issues may expose a pedestrian, particularly those with mobility impairments, to a potential collision with vehicular traffic.

The existing footpath on the south side of the Ballyvolane Road should be extended to facilitate the crossing facility. The location of the crossing facility should be reviewed.

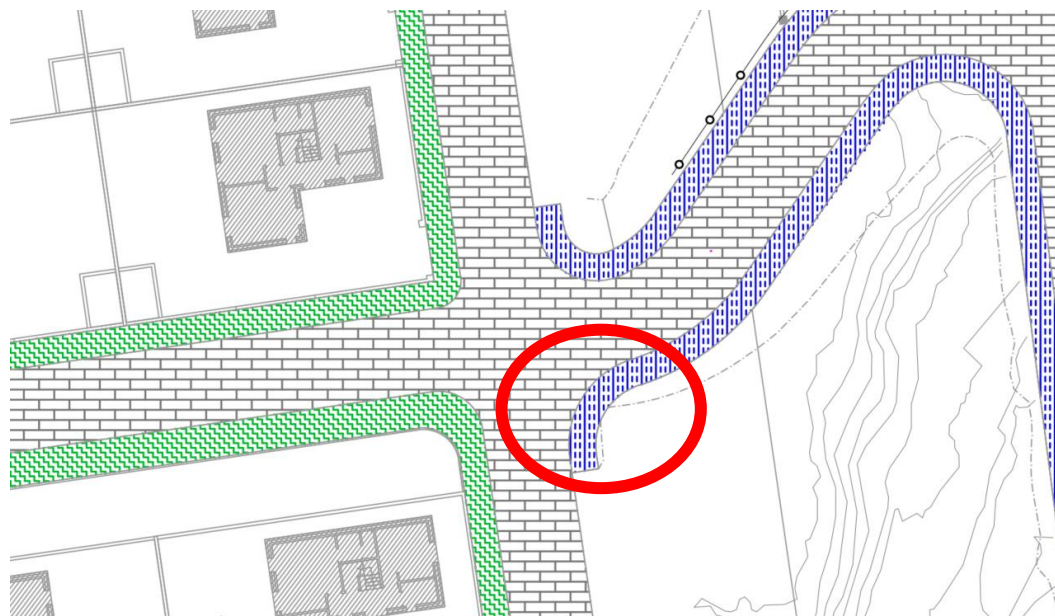
**Figure 2-9 – Wide Corner Radius**

Throughout parts of the scheme, some of the corner radii appear wide. Wide corner radii enable vehicles to take the corners at higher speed, and also reduces intervisibility between crossing pedestrians and drivers which could result in collisions with pedestrians.

Check the corner radii throughout the scheme and where appropriate the wide corner radii should be reduced.

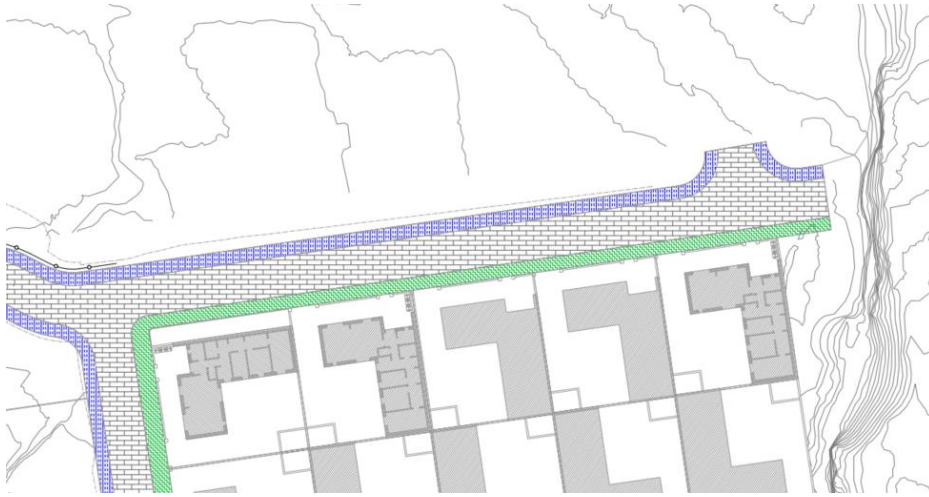
**Figure 2-10 – Straight Road**

Some of the roads within the development are conducive to excessive speeds, where the proposed road is straight over a significant length or where the gradient of the road is excessively steep. Speeding within the development may lead to collisions between vehicles or it may also lead to collisions between vehicles and pedestrians. The topography of the site makes the steep road gradients unavoidable, however it also exacerbates any potential collisions due to the level difference between the road, particularly the access road into the Spring Lane site, and the ground below.

Where possible traffic calming measures should be incorporated into the design to ensure that the risks associated with speeding withing the development are mitigated.
