# **R610 St. Patricks Junction Improvement Scheme**

Stage 1 Quality Audit

July 2026

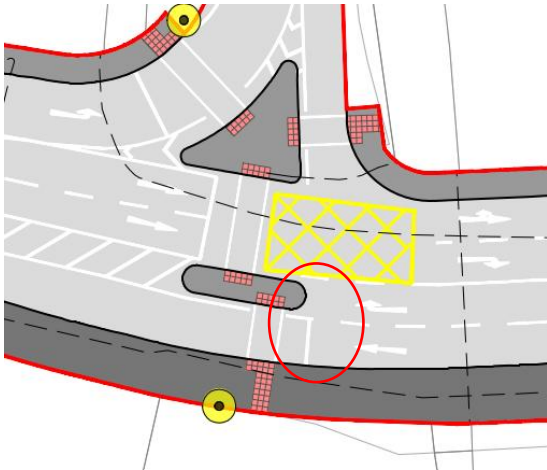
**Figure 3.2: Proposed junction layout**

A stop line has been provided for westbound traffic on Rochestown Road, however right turning traffic is to pass in front of the traffic island. The provision of a controlled pedestrian crossing on the N28 on-slip indicates that the Rochestown Road right turn lane will be required to be signal controlled. However, the presence of the traffic island, potential positioning of traffic signals and lack of a stop line may mislead right turning motorists into believing they are not controlled. Vehicles turning right uncontrolled against eastbound traffic could result in vehicles turning across the path of ahead traffic increasing the risk of collisions. In addition, vehicles may fail to stop for the pedestrian crossing leading to an increased risk of collisions with crossing pedestrians.

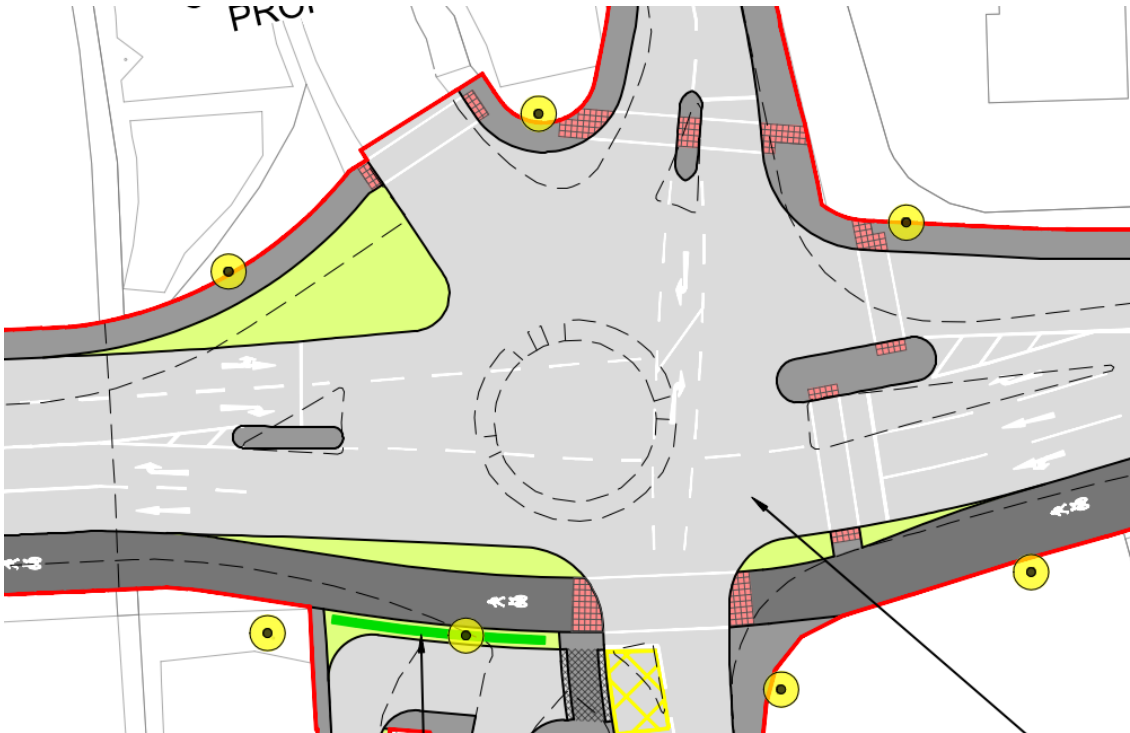
**Figure 3.4: Proposed pedestrian crossing layout.**

Controlled crossings are proposed over Westbrook, Rochestown Road and Mount Ovel. The tactile paving however is shown in multiple places without the stem which indicates to blind and sight impaired pedestrians that it is a controlled crossing. The lack of a stem may mislead users who may believe it to be an uncontrolled crossing, increasing their vulnerability to being struck by passing motorists.

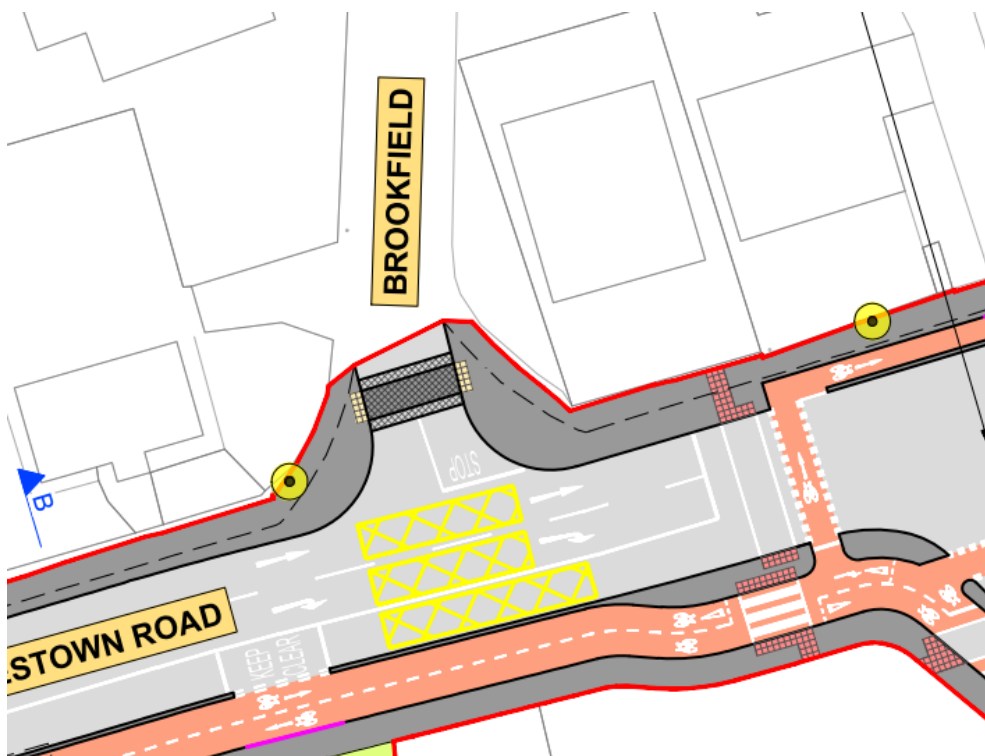
**Figure 3.5: Proposed layout at Brookfield.**

Should cyclists from Brookfield on the northern side of Rochestown Road wish to join the segregated cycle track on the southern side of Rochestown Road, they will be required to cross three lanes of traffic and be vulnerable to colliding with motorists. Alternatively, they may use the signalised pedestrian or unidirectional cycle crossing at Clarkes Hill and be at risk of colliding with pedestrians or cyclists.
