# **R610 St. Patricks Junction Improvement Scheme**

Stage 1 Quality Audit

July 2026

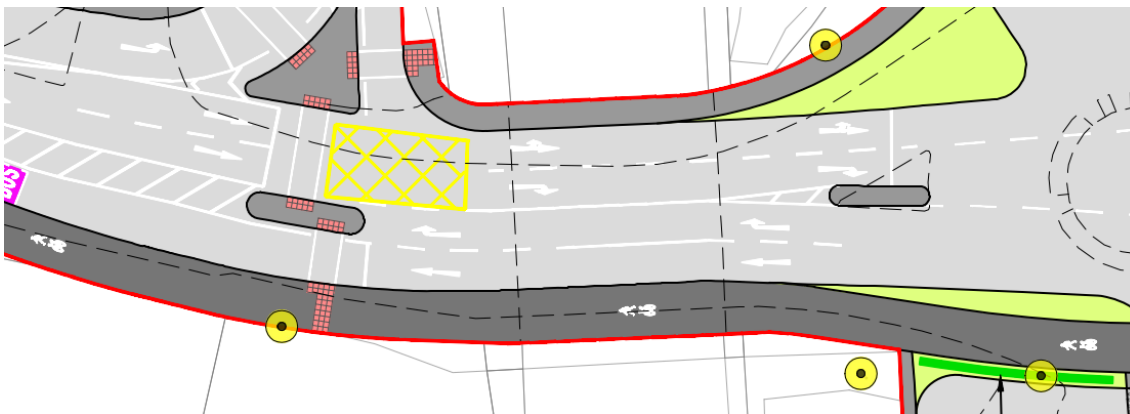
**Figure 3.1: Pedestrian and cycle symbols in same direction**

Pedestrian and cycle symbols are shown within the shared use active travel facility however they are all orientated in the same direction. The Road Safety Audit Team is concerned that having all the symbols in one direction could mislead users into believing the active travel facility operates as one-way. Should users not be clear of the intended use they may cross Rochestown Road unnecessarily, increasing the risk of conflict with motor vehicles.

#### **Recommendation**

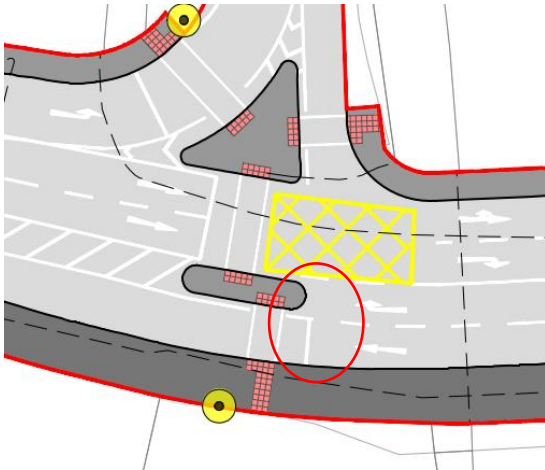
**Figure 3.2: Proposed junction layout**

A stop line has been provided for westbound traffic on Rochestown Road, however right turning traffic is to pass in front of the traffic island. The provision of a controlled pedestrian crossing on the N28 on-slip indicates that the Rochestown Road right turn lane will be required to be signal controlled. However, the presence of the traffic island, potential positioning of traffic signals and lack of a stop line may mislead right turning motorists into believing they are not controlled. Vehicles turning right uncontrolled against eastbound traffic could result in vehicles turning across the path of ahead traffic increasing the risk of collisions. In addition, vehicles may fail to stop for the pedestrian crossing leading to an increased risk of collisions with crossing pedestrians.

#### Recommendation

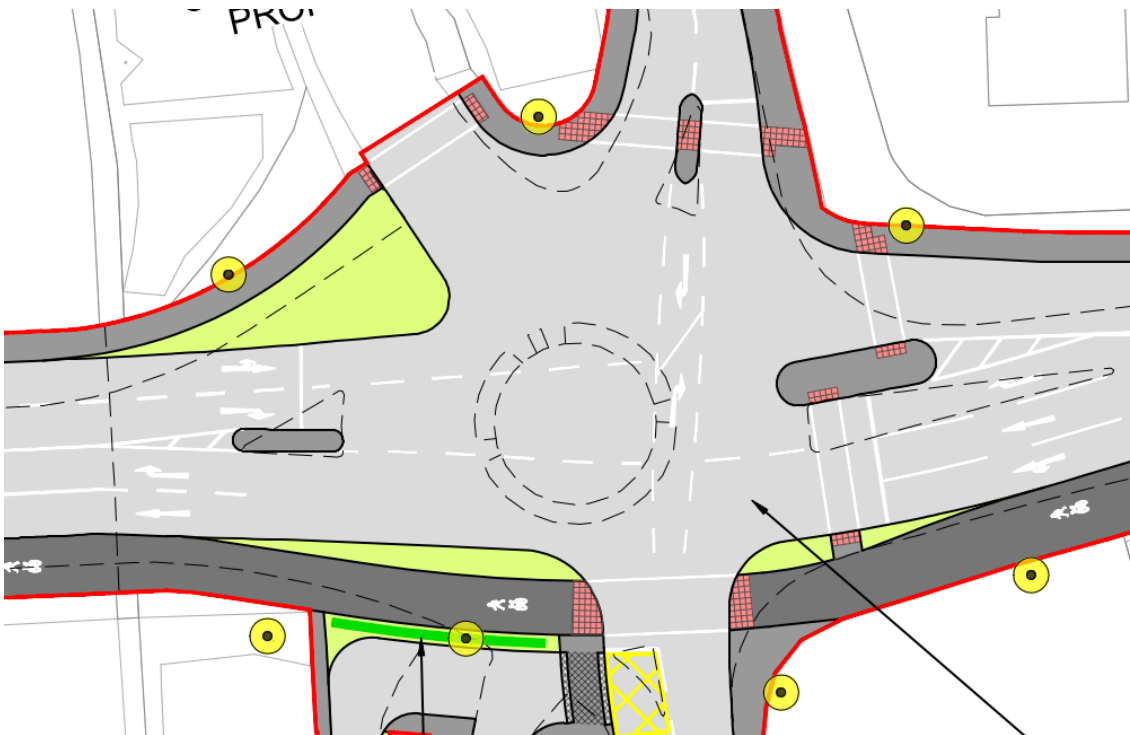
**Figure 3.3: Proposed markings within the junction.**

- Right turn lanes have been marked out for drivers turning from Woodbrook and Mount Ovel, however these are minor arms with low traffic flows. The markings also extend through the Rochestown Road westbound carriageway and therefore the junction layout may not be clear for other motorists using this junction.
- The right turn lane from Woodbrook guides right turning motorists towards the stop line for eastbound traffic on Rochestown Road.
- No right turn arrow(s) has been shown within the wide right turn lane for Rochestown Road traffic and with the other markings it may not be clear where traffic, particularly from the east, is to wait and turn.

#### **Recommendation**

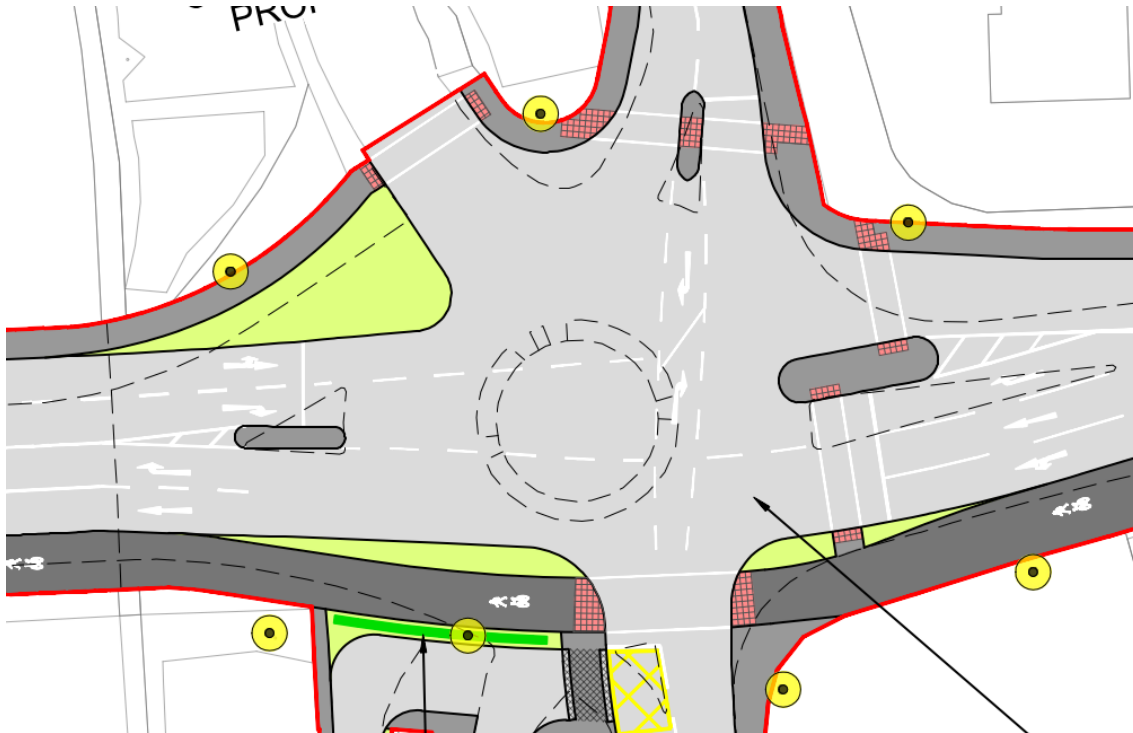
**Figure 3.4: Proposed pedestrian crossing layout.**

Controlled crossings are proposed over Westbrook, Rochestown Road and Mount Ovel. The tactile paving however is shown in multiple places without the stem which indicates to blind and sight impaired pedestrians that it is a controlled crossing. The lack of a stem may mislead users who may believe it to be an uncontrolled crossing, increasing their vulnerability to being struck by passing motorists.

#### **Recommendation**

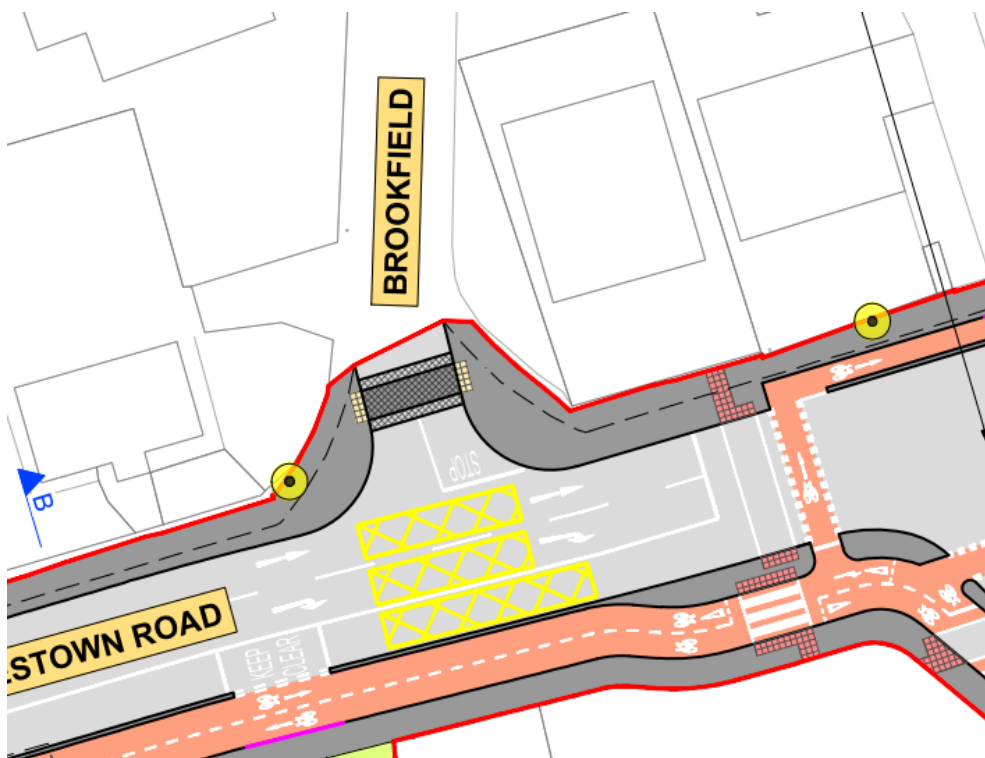
**Figure 3.5: Proposed layout at Brookfield.**

Should cyclists from Brookfield on the northern side of Rochestown Road wish to join the segregated cycle track on the southern side of Rochestown Road, they will be required to cross three lanes of traffic and be vulnerable to colliding with motorists. Alternatively, they may use the signalised pedestrian or unidirectional cycle crossing at Clarkes Hill and be at risk of colliding with pedestrians or cyclists.

#### **Recommendation**

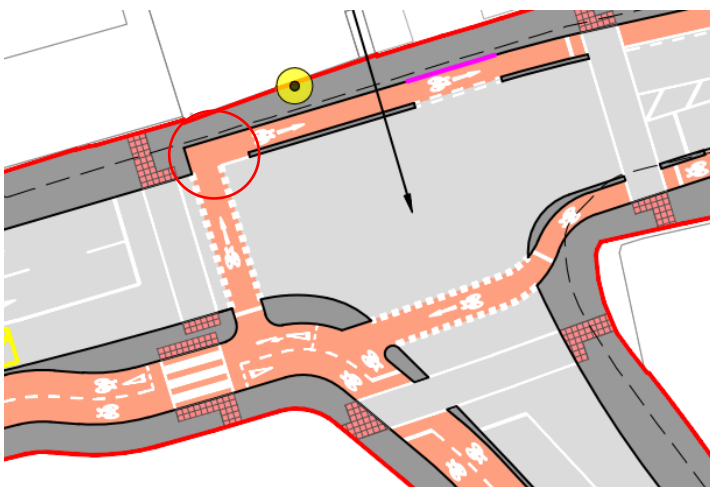
**Figure 3.6: Proposed cycle track layout at Clarkes Hill.**

Cyclists from the southern side of Rochestown Road crossing to the northern side and heading east are expected to make a 90-degree turn. This sharp turn could be a difficult manoeuvre for some bikes to undertake which could result in the kerb being clipped or overridden. Should bikes strike the kerb, it increases the risk of cyclists being unseated which may result in cyclists falling from their bikes leading to personal injury.

#### **Recommendation**

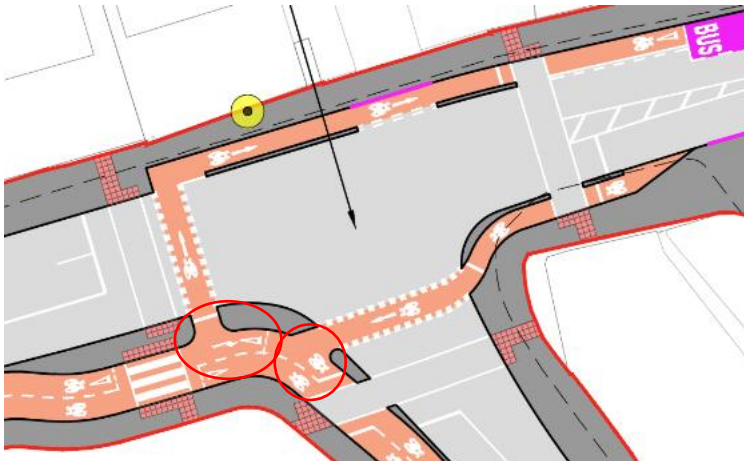
**Figure 3.7: Proposed cycle track layout at Clarkes Hill.**

The layout proposes locations where cyclists are to stop or give-way to other cyclists. The Road Safety Audit Team is concerned that cyclists waiting at these Stop and Give-way lines may block the path for other cyclists continuing on a different route potentially leading to conflict between cyclists.

#### **Recommendation**

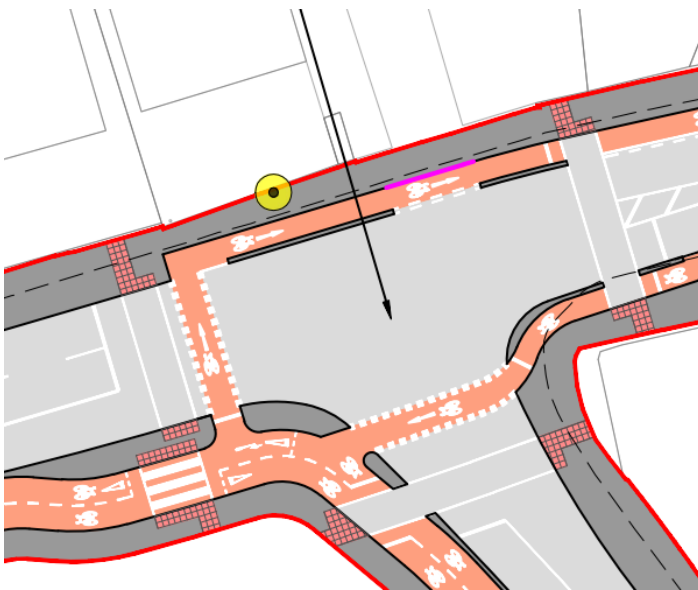
**Figure 3.8: Proposed arrangement at Clarkes Hill.**

Access to several properties is proposed within the signalised junction which do not appear to be controlled. The lack of control could result in motorists exiting the properties into the path of other traffic flows that have a green traffic signal which could result in conflict. Furthermore, through traffic may not expect vehicles to be slowing to turn within the junction leading to rear end shunt related collisions.

#### **Recommendation**

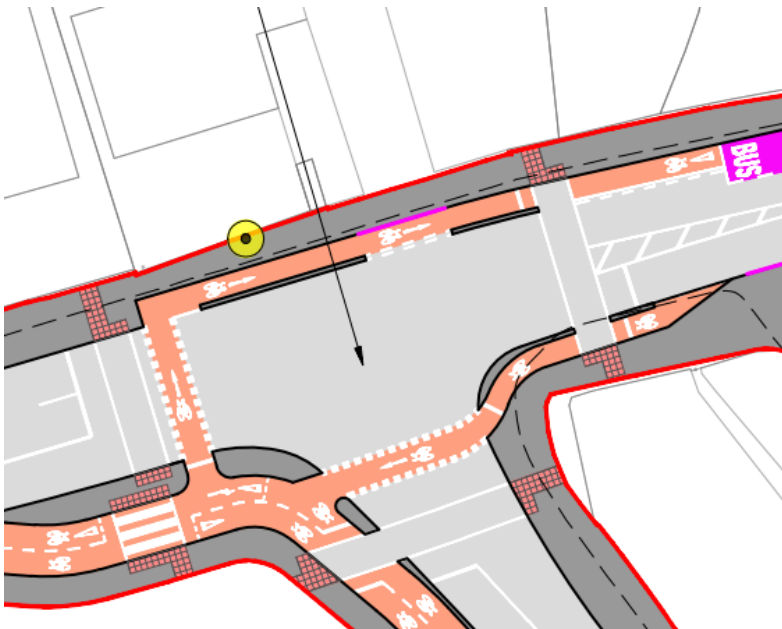
**Figure 3.9: Proposed Crossings at Clarkes Hill.**

The crossing widths, particularly on Rochestown Road eastern arm and Clarkes Hill are wide taking into account crossing of the cycle track. Should the pedestrian green times not be sufficient in length for pedestrians to complete their crossing movement, it could result in conflict with motorists or cyclists who may commence their movement before a pedestrian has completed their crossing.

#### **Recommendation**

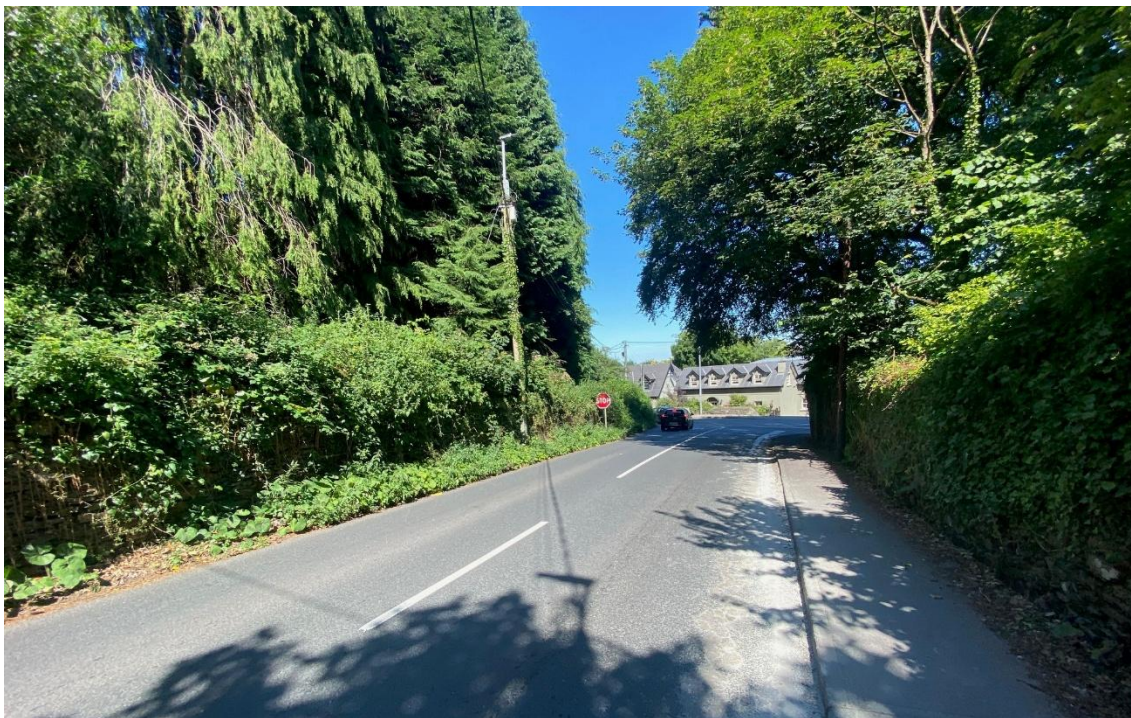
**Figure 3.10: Existing layout on Clarkes Hill.**

*Summary: Lack of clearly conspicuous traffic signals combined with high vehicle speeds may lead to drivers failing to stop appropriately on approach to the traffic signals leading to turning related collisions or collisions with pedestrians on the crossing.*

Clarkes Hill is proposed to become signalised however the Road Safety Audit Team is concerned that vehicles on Clarkes Hill may not anticipate the traffic signals and fail to stop in time. Clarkes Hill is currently heavily vegetated with branches over hanging the carriageway, and whilst the drawings show some vegetation is to be cleared, it is not clear to what extent. There is an existing kink in the alignment on the approach to Rochestown Road which hides the nearside kerblines, and whilst the kerb alignment is changing, the introduction of the segregated cycle track will likely place the nearside traffic signal equipment further from motorists' view. Furthermore, Clarkes Hill is on a downhill gradient which, if the traffic signals are not clear to approaching motorists either because they are hidden by vegetation or the alignment, could result in motorists approaching the junction at too high a speed leading to sudden braking or red-light infringements which may result in turning related collisions. In addition, should vehicles fail to appropriately stop at the signals it may lead to collisions with pedestrians or cyclists.

#### **Recommendation**

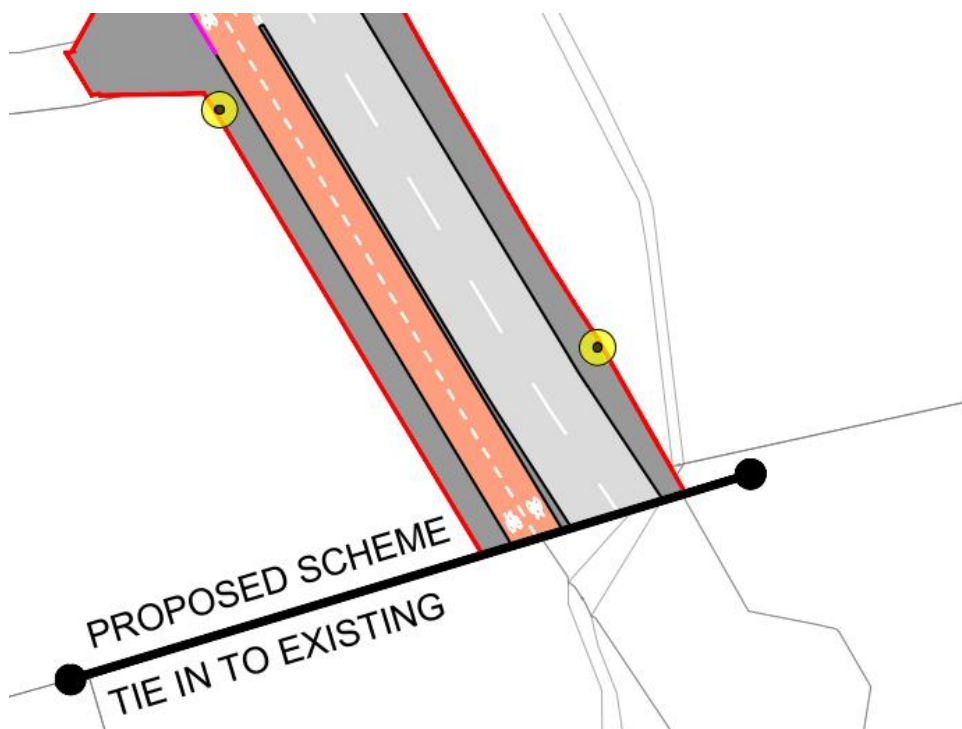
**Figure 3.11: Proposed start/end of cycle track on Clarkes Hill.**

Likewise, it is not clear how the widened footway on the eastern side of Clarkes Hill ties into the existing footway provision. Should the proposed and existing footway not tie up it could result in pedestrians tripping over the kerb edge at risk of personal injury, or they may walk in the road at risk of collisions with motorists.

#### **Recommendation**

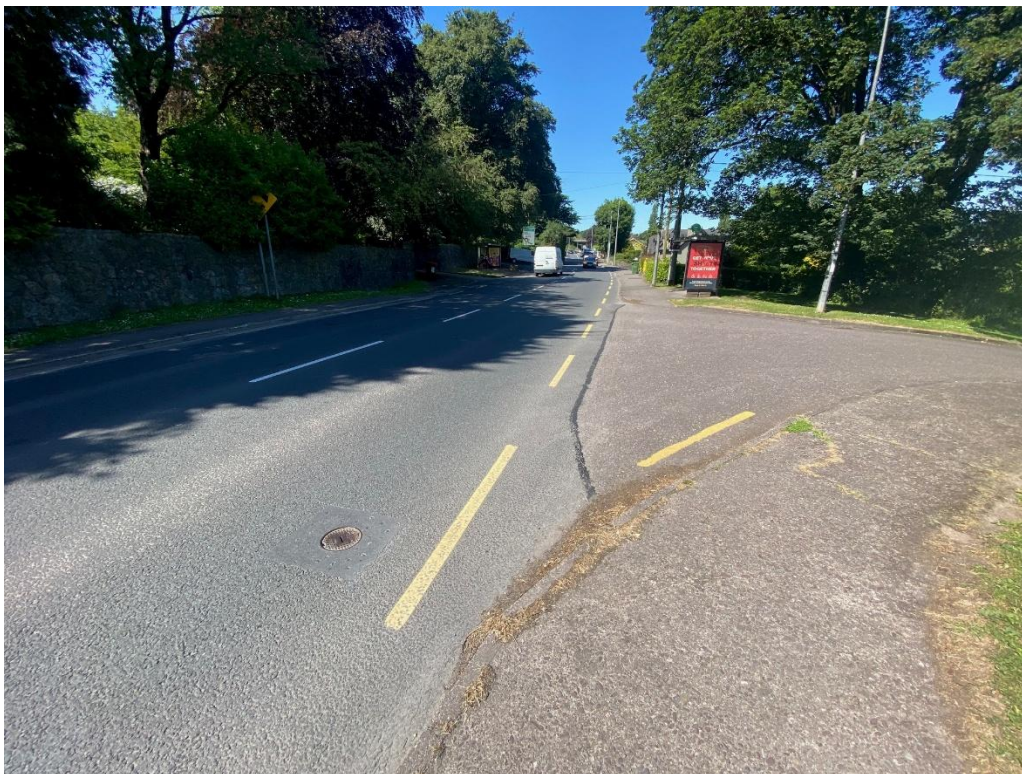
**Figure 3.12: Existing Riverside junction.**

Furthermore, there are no markings indicating to motorists exiting Riverside of the need to give-way, and whilst there aren't currently give-way markings, should motorists not recognise the need to give-way it could lead to turning related collisions.

#### **Recommendation**

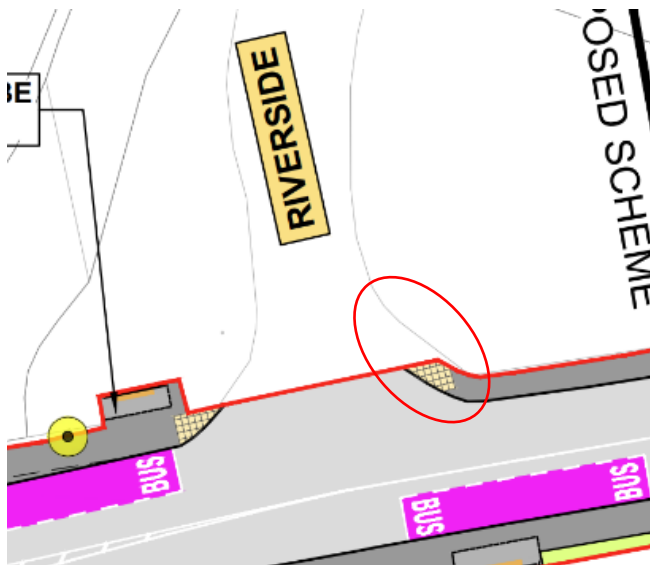
**Figure 3.13: Proposed layout at Riverside junction.**

The kerb alignment is to be amended, however it is not clear how the kerb is being modified and connecting with the existing provision on Riverside. Should the proposed footway fail to connect with the existing footway provision it could result in pedestrians being within the carriageway at risk of conflict with motorists.

#### **Recommendation**

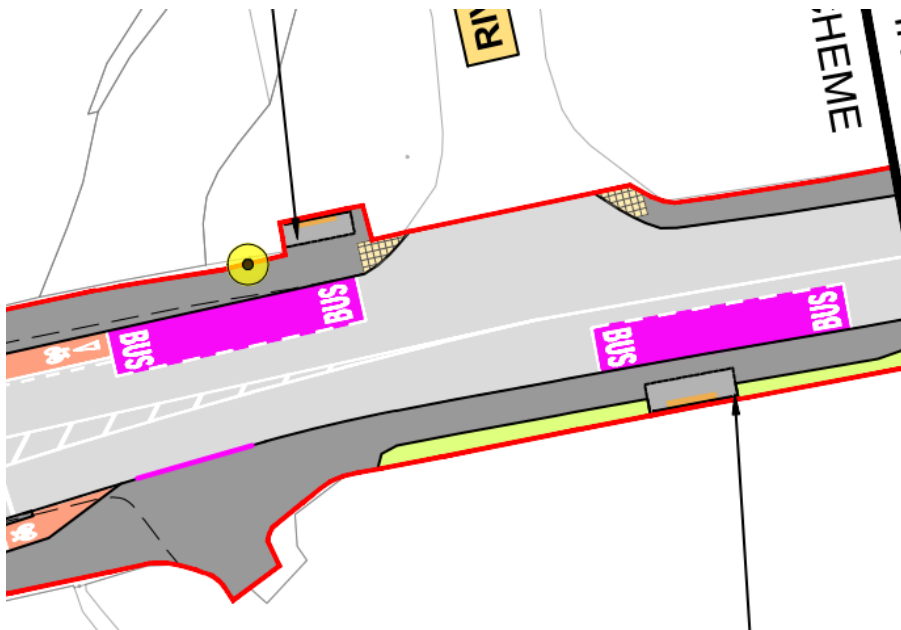
**Figure 3.14: Proposed bus stop opposite Riverside.**

The bus stop on the southern side of Rochestown Road is proposed almost opposite Riverside. There is concern that a westbound vehicle on Rochestown Road may attempt to overtake a stationary bus at the same time a vehicle pulls out of Riverside, increasing the risk of turning related collisions.

#### **Recommendation**

In terms of conflicts between the differing audits, the Road Safety Audit identified an issue regarding the provision of a bus stop opposite Riverside and potential for conflicts with turning vehicles and recommended this be relocated away from the junction. This recommendation may conflict with pedestrian accessibility and walking should the bus stop be located away from the most desirable location for bus passengers. However, this is a minor conflict where the needs of user accessibility and safety can be balanced out.
