# **R610 St. Patricks Junction Upgrade Scheme**

Stage 1 Road Safety Audit

July 2026

**Document reference:** 100287864-MMD-REP-RSA-2026-030 | B

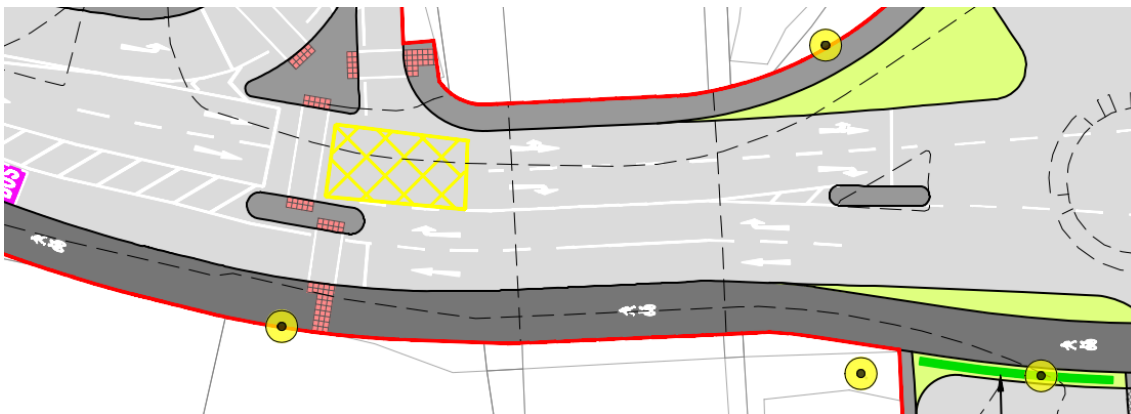
**Figure 2.1: Pedestrian and cycle symbols in same direction**

*Summary: Cycle and pedestrian symbols all in one direction could mislead users into believing it is one-way.*

Pedestrian and cycle symbols are shown within the shared use active travel facility however they are all orientated in the same direction. The Road Safety Audit Team is concerned that having all the symbols in one direction could mislead users into believing the active travel facility operates as one-way. Should users not be clear of the intended use they may cross Rochestown Road unnecessarily, increasing the risk of conflict with motor vehicles.

Provide pedestrian and cycle symbols in both directions to indicate the active travel facility operates as two-way.

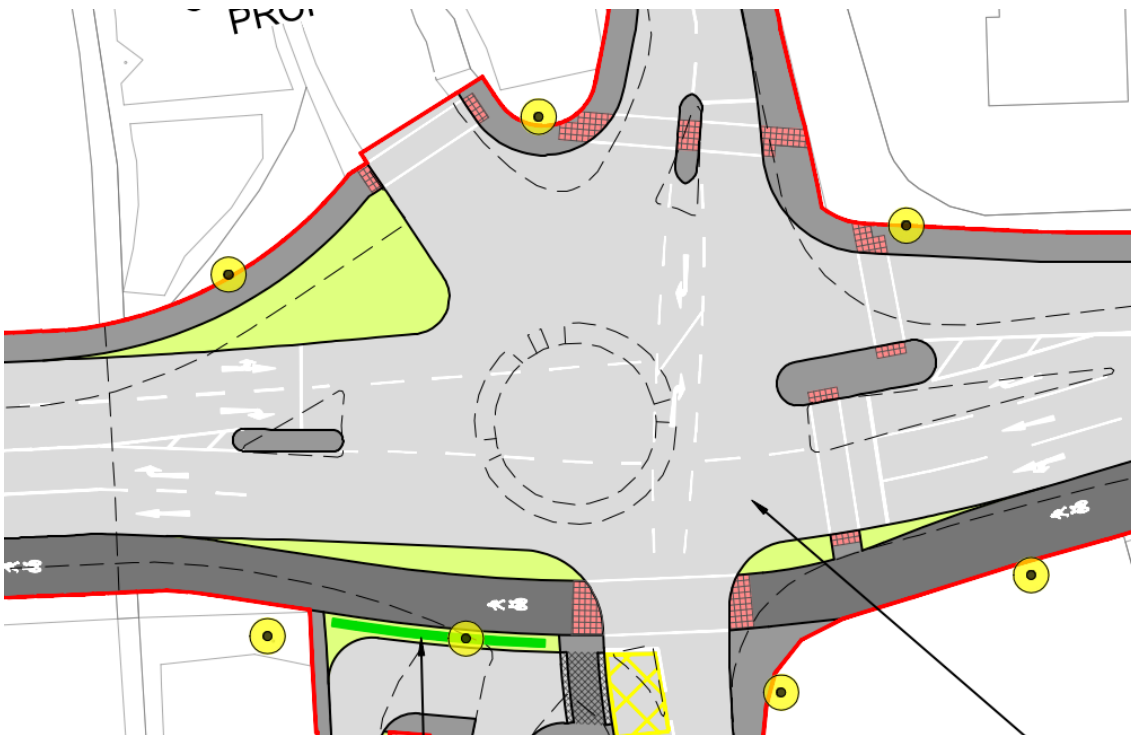
**Figure 2.3: Proposed markings within the junction.**

*Summary: A lack of clear markings for right turn manoeuvres increases the risk of turning related collisions at the junction.*

A number of issues have been identified with the markings within the Rochestown Road, N28 off-slip, Woodbrook and Mount Ovel Junction which could lead to turning related collisions.

- Right turn lanes have been marked out for drivers turning from Woodbrook and Mount Ovel, however these are minor arms with low traffic flows. The markings also extend through the Rochestown Road westbound carriageway and therefore the junction layout may not be clear for other motorists using this junction.
- The right turn lane from Woodbrook guides right turning motorists towards the stop line for eastbound traffic on Rochestown Road.
- No right turn arrow(s) has been shown within the wide right turn lane for Rochestown Road traffic and with the other markings it may not be clear where traffic, particularly from the east, is to wait and turn.

Modify the right turn lanes so that the highway layout is clearly understandable to road users.

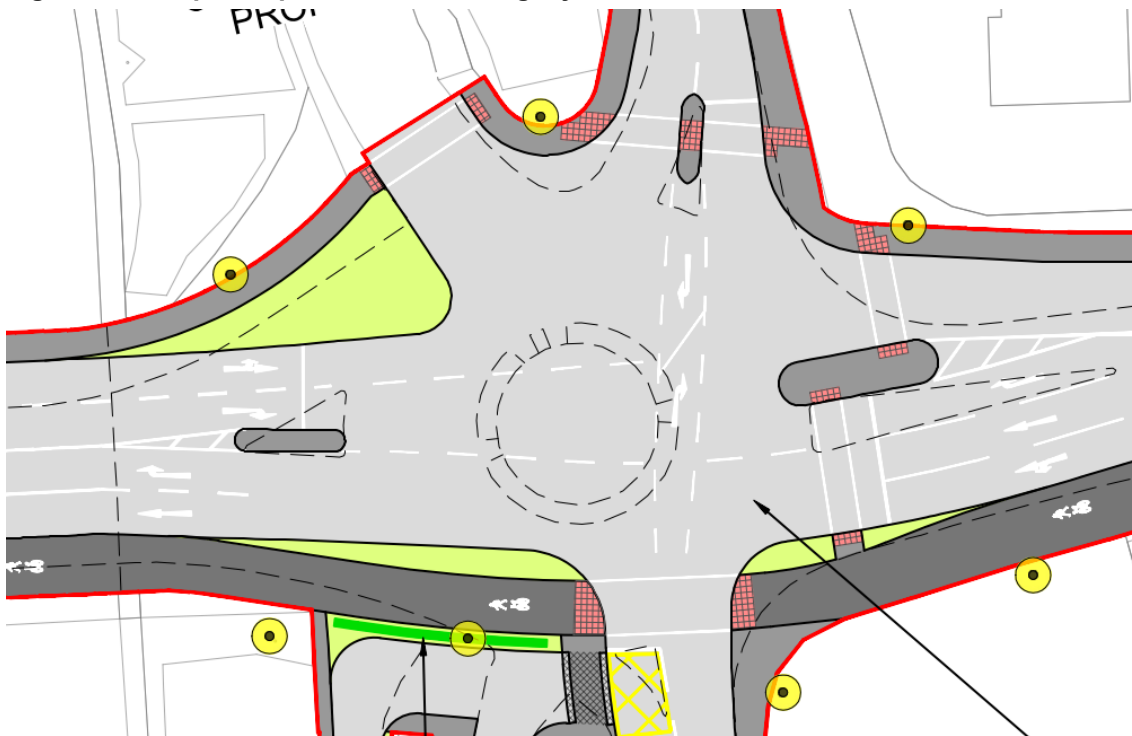
**Figure 2.4: Proposed pedestrian crossing layout.**

*Summary: Incorrect tactile paving may mis-lead sight impaired pedestrians increasing their vulnerability to being struck.*

Controlled crossings are proposed over Westbrook, Rochestown Road and Mount Ovel. The tactile paving however is shown in multiple places without the stem which indicates to blind and sight impaired pedestrians that it is a controlled crossing. The lack of a stem may mislead users who may believe it to be an uncontrolled crossing, increasing their vulnerability to being struck by passing motorists.

Provide the correct tactile paving in line with relevant guidelines to reflect they are controlled crossings.

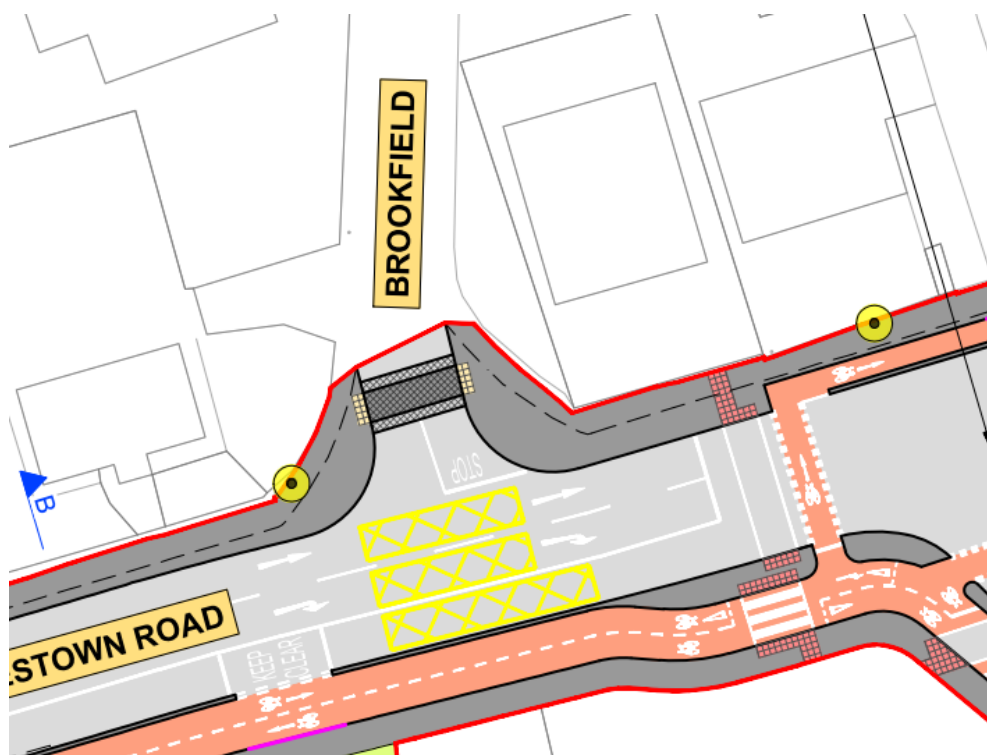
**Figure 2.5: Proposed layout at Brookfield.**

*Summary: Lack of cycle provision for cyclists on the northern side of Rochestown Road to access the cycle track may lead to use of the pedestrian or unidirectional cycle crossing potentially resulting in conflict.*

Should cyclists from Brookfield on the northern side of Rochestown Road wish to join the segregated cycle track on the southern side of Rochestown Road, they will be required to cross three lanes of traffic and be vulnerable to colliding with motorists. Alternatively, they may use the signalised pedestrian or unidirectional cycle crossing at Clarkes Hill and be at risk of colliding with pedestrians or cyclists.

Provide appropriate links between the northern and southern sides of Rochestown Road, this may involve providing a bi-directional cycle track across Rochestown Road.

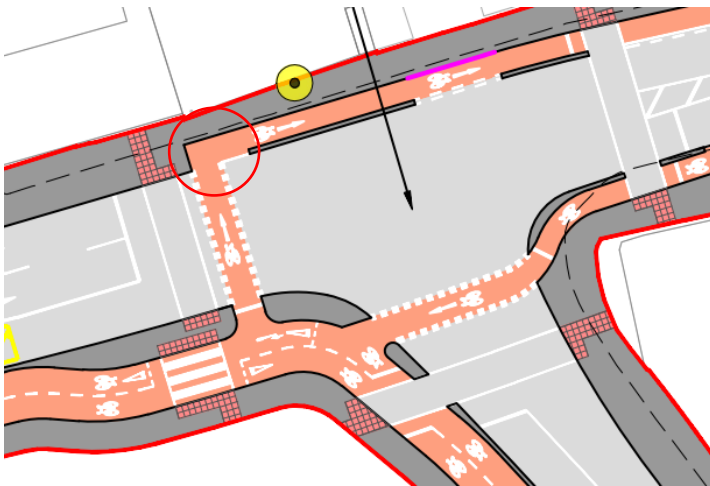
**Figure 2.6: Proposed cycle track layout at Clarkes Hill.**

*Summary: Sharp turn for cyclists may result in the kerb being clipped or over ridden leading to falls from bikes.*

Cyclists from the southern side of Rochestown Road crossing to the northern side and heading east are expected to make a 90-degree turn. This sharp turn could be a difficult manoeuvre for some bikes to undertake which could result in the kerb being clipped or over ridden. Should bikes strike the kerb, it increases the risk of cyclists being unseated which may result in cyclists falling from their bikes leading to personal injury.

Relax the angle of the cycle track so that it is more gentle and easier for cyclists to turn.

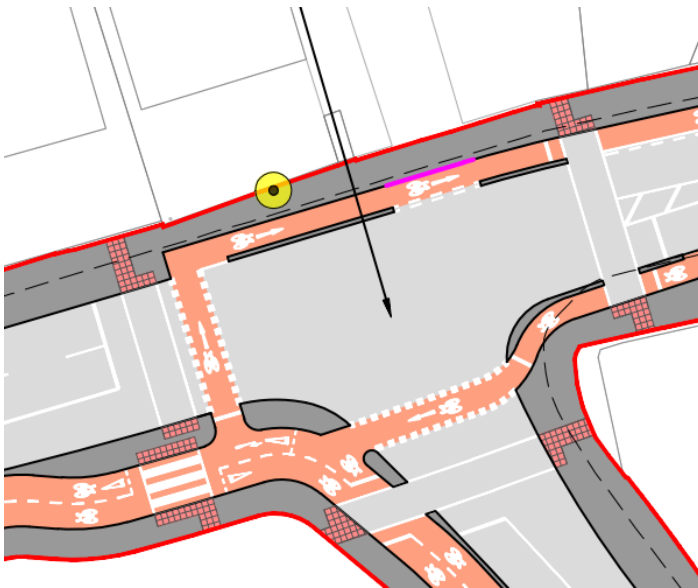
**Figure 2.8: Proposed arrangement at Clarkes Hill.**

*Summary: Lack of control for those properties entering / exiting within the signalised junction could result in rear end shunt and turning related collisions.*

Access to several properties is proposed within the signalised junction which do not appear to be controlled. The lack of control could result in motorists exiting the properties into the path of other traffic flows that have a green traffic signal which could result in conflict. Furthermore, through traffic may not expect vehicles to be slowing to turn within the junction leading to rear end shunt related collisions.

Provide signal control for those exiting from Clarkes Hill northern arm. The junction may need formalising and potentially narrowing

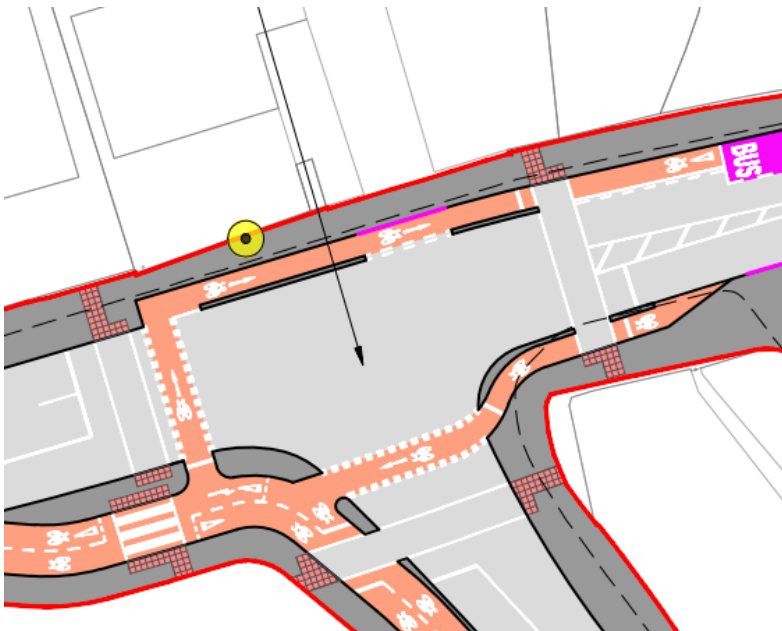
**Figure 2.9: Proposed Crossings at Clarkes Hill.**

*Summary: Lack of appropriate green times for length of crossing may result in pedestrian collisions with motorists and cyclists.*

The crossing widths, particularly on Rochestown Road eastern arm and Clarkes Hill are wide taking into account crossing of the cycle track. Should the pedestrian green times not be sufficient in length for pedestrians to complete their crossing movement, it could result in conflict with motorists or cyclists who may commence their movement before a pedestrian has completed their crossing.

Provide sufficient pedestrian green times to allow a pedestrian to fully cross the carriageway and cycle track prior to other signal stages receiving a green light.

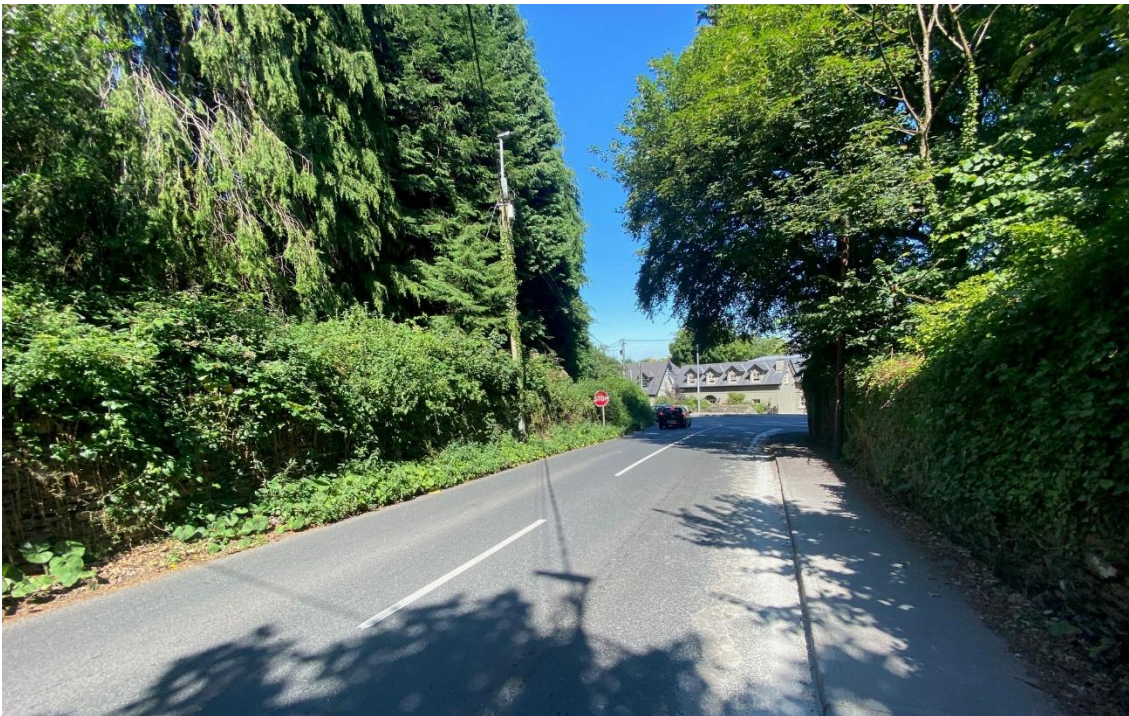
**Figure 2.10: Existing layout on Clarkes Hill.**

*Summary: Lack of clearly conspicuous traffic signals combined with high vehicle speeds may lead to drivers failing to stop appropriately on approach to the traffic signals leading to turning related collisions or collisions with pedestrians on the crossing.*

Clarkes Hill is proposed to become signalised however the Road Safety Audit Team is concerned that vehicles on Clarkes Hill may not anticipate the traffic signals and fail to stop in time. Clarkes Hill is currently heavily vegetated with branches over hanging the carriageway, and whilst the drawings show some vegetation is to be cleared, it is not clear to what extent. There is an existing kink in the alignment on the approach to Rochestown Road which hides the nearside kerblines, and whilst the kerb alignment is changing, the introduction of the segregated cycle track will likely place the nearside traffic signal equipment further from motorists' view. Furthermore, Clarkes Hill is on a downhill gradient which, if the traffic signals are not clear to approaching motorists either because they are hidden by vegetation or the alignment, could result in motorists approaching the junction at too high a speed leading to sudden braking or red-light infringements which may result in turning related collisions. In addition, should vehicles fail to appropriately stop at the signals it may lead to collisions with pedestrians or cyclists.

Site the traffic signals so that they are clearly conspicuous on the Clarkes Hill northbound approach to Rochestown Road and undertake appropriate vegetation clearance/removal. It may also be appropriate to provide high friction surfacing on the approach to the signal Stop line.

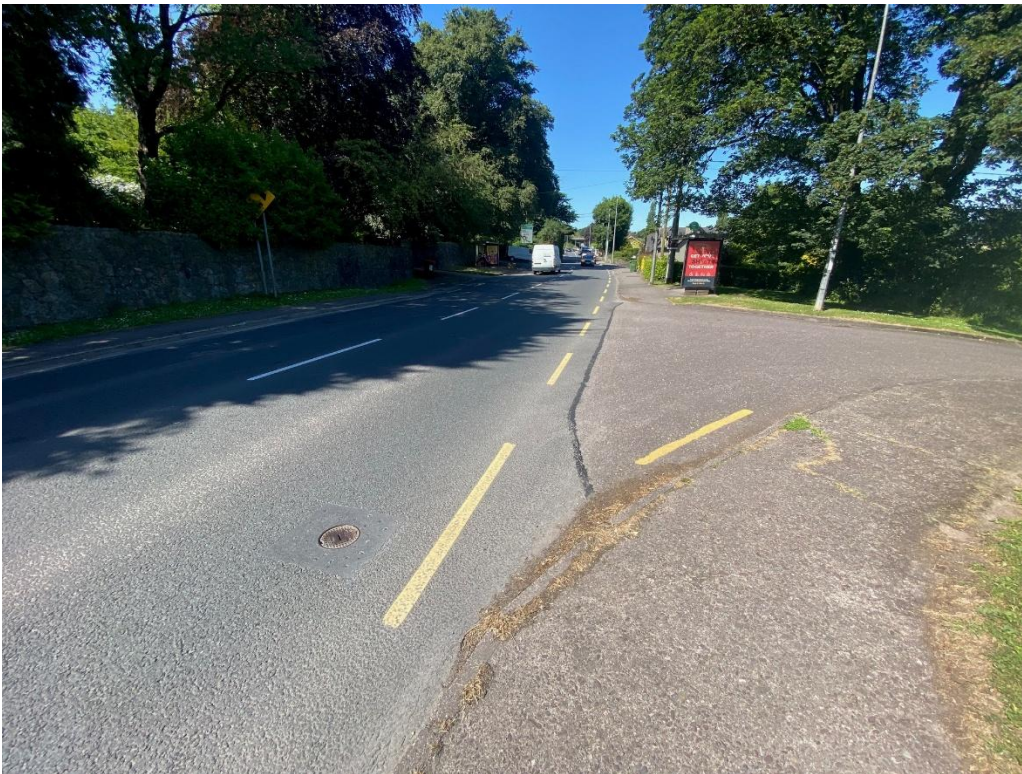
**Figure 2.12: Existing Riverside junction.**

*Summary: High vehicle speeds, and wide crossing distance may make crossing pedestrians vulnerable to being struck. A lack of give-way markings may result in turning related collisions.*

Riverside is a wide junction with pedestrians proposed to cross at its widest point in line with the footway. Unlike the other junctions it is not proposed to become a raised table crossing and there is concern that vehicle turning speeds could be high. Given the wide crossing distance and potential for higher vehicle speeds, crossing pedestrians could be vulnerable to being struck by turning motorists.

Furthermore, there are no markings indicating to motorists exiting Riverside of the need to give-way, and whilst there aren't currently give-way markings, should motorists not recognise the need to give-way it could lead to turning related collisions.

Provide a raised table crossing over Riverside and where possible reduce the junction radii to reduce vehicle speeds. Provide give-way markings to indicate the need for traffic on Riverside to give-way to traffic on Rochestown Road.

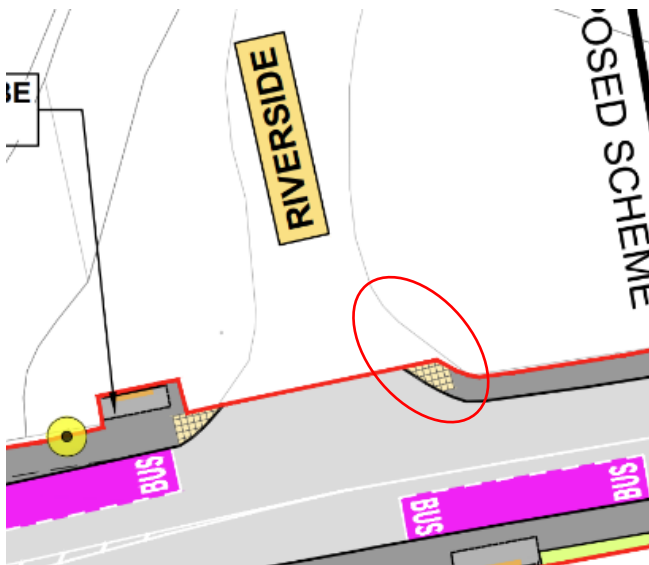
**Figure 2.13: Proposed layout at Riverside junction.**

*Summary: Inappropriate tie in on Riverside could result in pedestrians walking within the carriageway at risk of conflict with motor vehicles.*

The kerb alignment is to be amended, however it is not clear how the kerb is being modified and connecting with the existing provision on Riverside. Should the proposed footway fail to connect with the existing footway provision it could result in pedestrians being within the carriageway at risk of conflict with motorists.

Continue the footway from Rochestown Road into Riverside.
