# **Ecology Survey Report**

Nash's Boreen Pedestrian & Cycle Scheme

**Client:** DBFL

**Document Title:** Ecology Survey Report

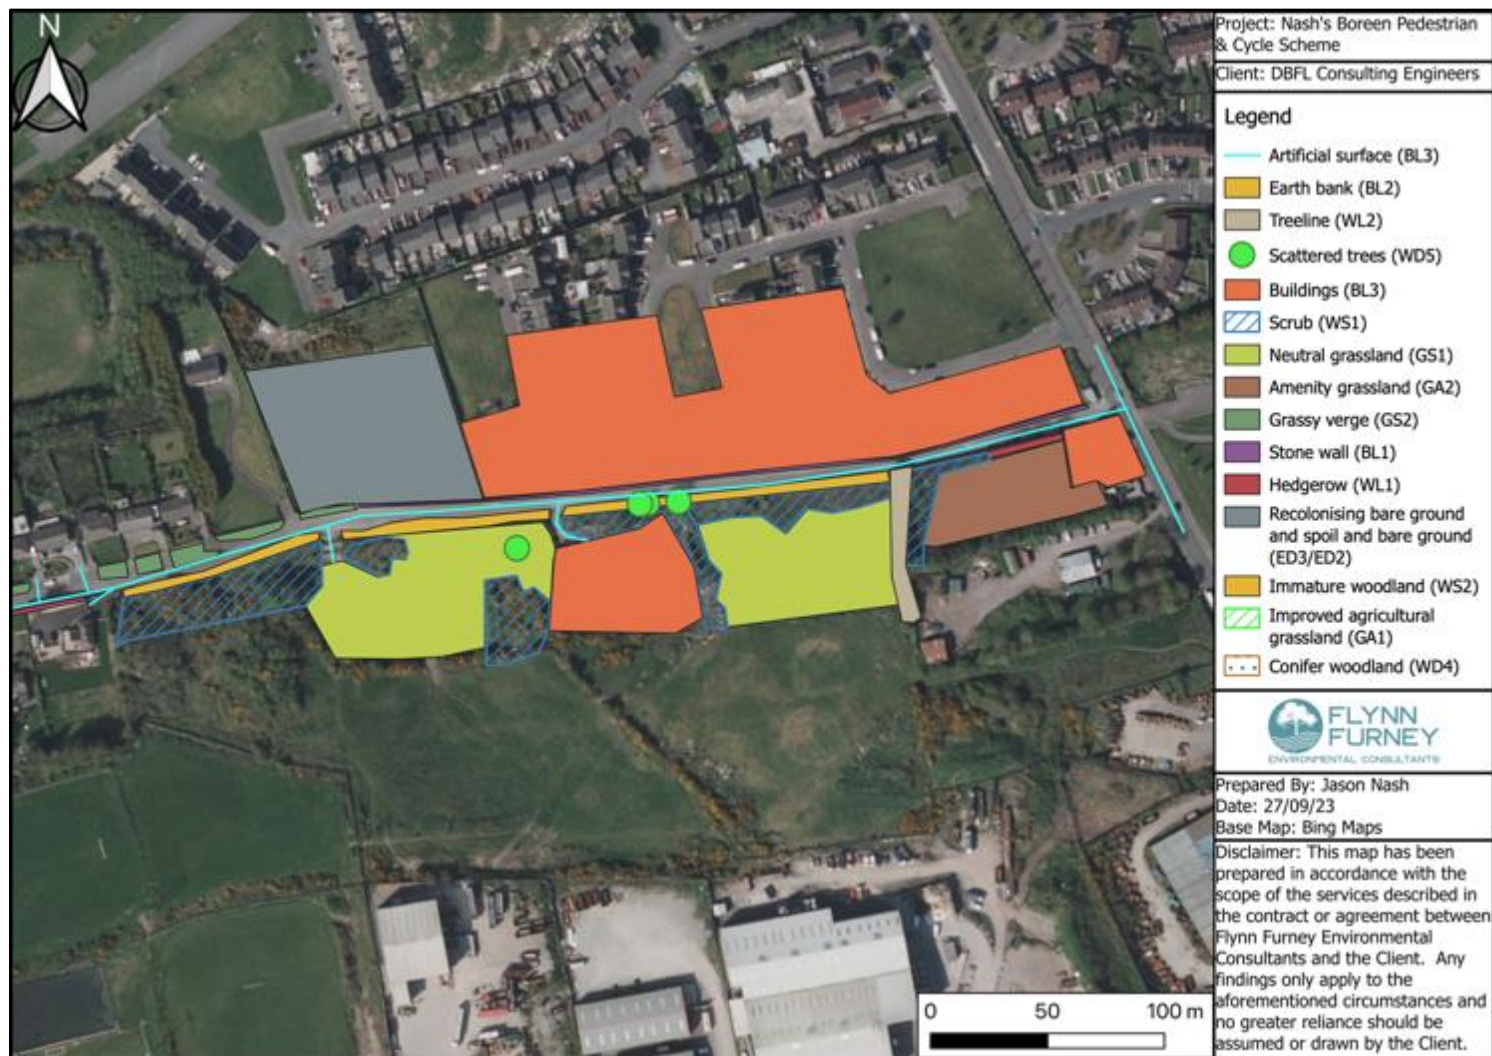
The eastern end of the route starts at Upper Fairhill and proceeds along into Nash's Boreen, which is an artificial surface (**BL3**). This is bordered by grassy verge (**GS2**), stone wall (**BL1**), buildings (**BL3**) and a hedgerow (**WL1**) composed mainly of Waxyleaf privet (*Ligustrum quihoui*) on the southern side of the road and a pavement with residential buildings (**BL3**) and stone wall (**BL1**) on the northern side.

Proceeding westwards, surrounding lands on the southern side of Nash's Boreen are dominated by amenity grassland (**GA2**), with neutral grassland (**GS1**) further on, separated by an earth bank (**BL2**) from the road. This earth bank is composed of grass (*Lolium* spp.), hawthorn (*Crataegus monogyna*), bramble (*Rubus fruticosus*) and nettle (*Urtica dioica*). Areas of scrub (**WS1**), dominated by bramble and nettle, are punctuated within the neutral grassland and amenity grassland. Trees such as hawthorn, sycamore (*Acer pseudoplatanus*) and elder (*Sambucus nigra*) are punctuated along the earth bank on the southern side of the boreen, with a treeline (**WL2**) forming a field boundary, whilst a stone wall and residential buildings persist along the northern border.

Figure 2: Habitat Map (Section 1)

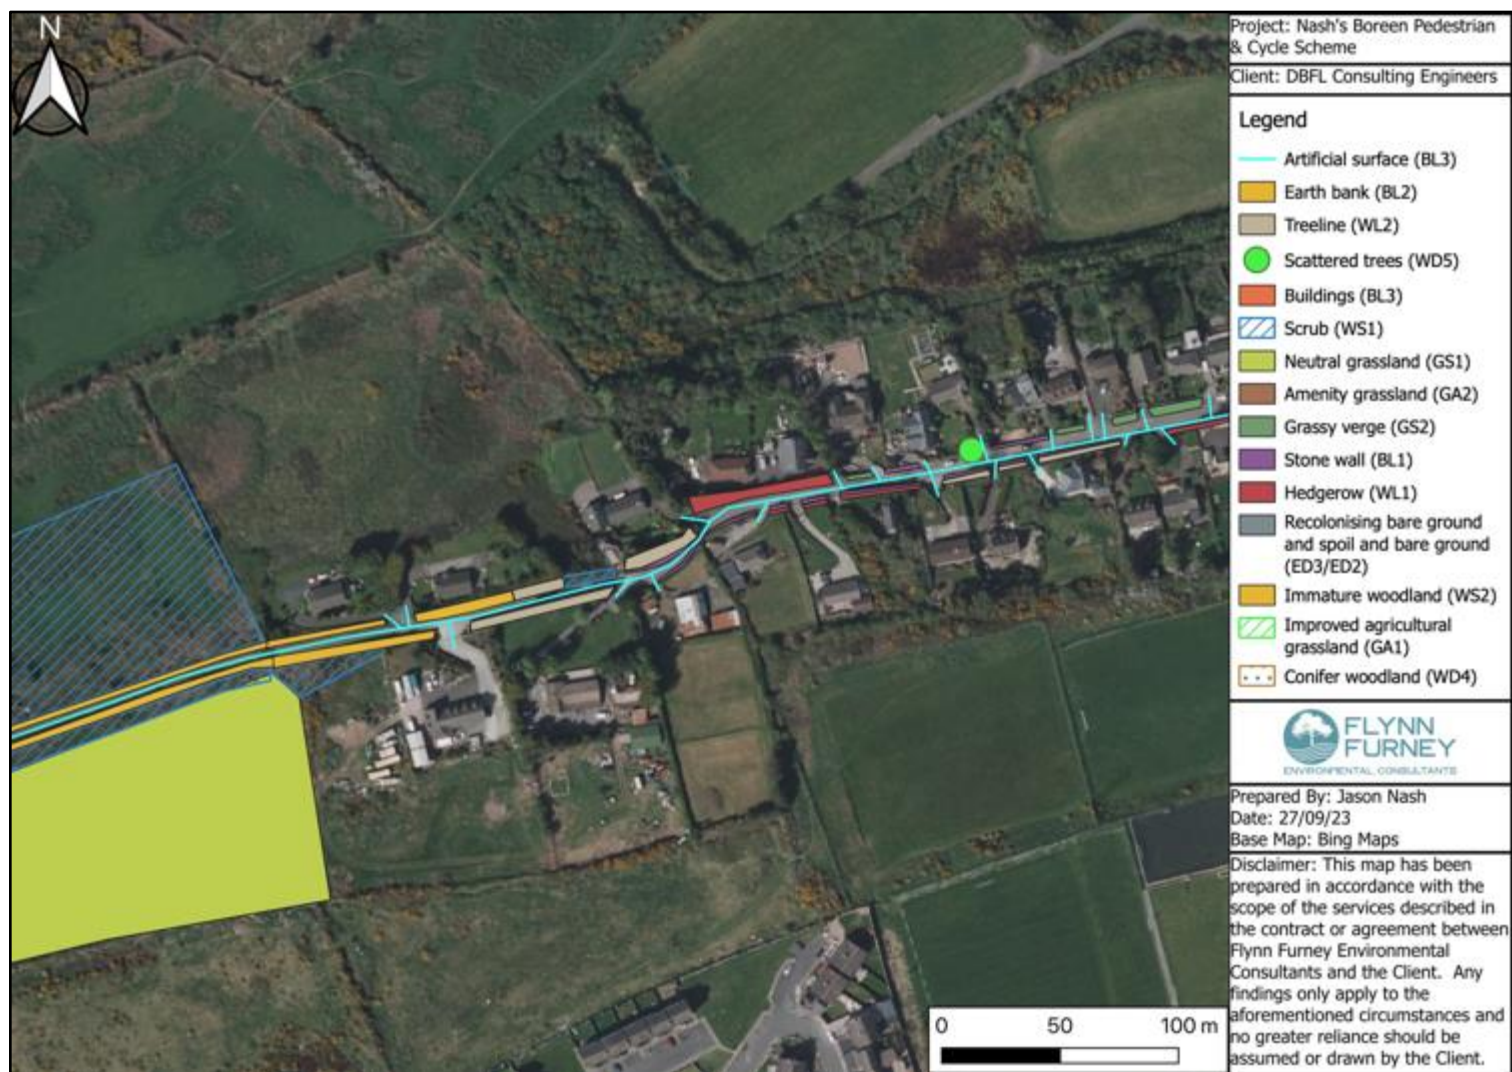
At grid reference 51.91586, -8.49607, recolonising bare ground (**ED3**) and spoil and bare ground (**ED2**) is present on the northern side of the road to the west of the residential estate. An earth bank and scrub comprised of willow (*Salix* sp.) and gorse (*Ulex europaeus*) is present on the southern side opposite this area. Grassy verge is present once again west of these areas on both sides of the road, with a line of residential houses present to the north.

Stone walls and some flower beds and borders (**BC4**) are present on the both sides of the road, with hedgerows and earth banks also present and persisting eastwards until grid reference 51.91453, -8.50331 and the area becomes more semi-rural. At this point, neutral grassland is present to the south, whilst scrub and improved agricultural grassland is present to the north. Scrub is mostly composed of nettles and briars, with willowherb (*Epilobium* spp.) also dominant. Stone walls and earth banks form field boundaries here.

Figure 3: Habitat Map (Section 2)

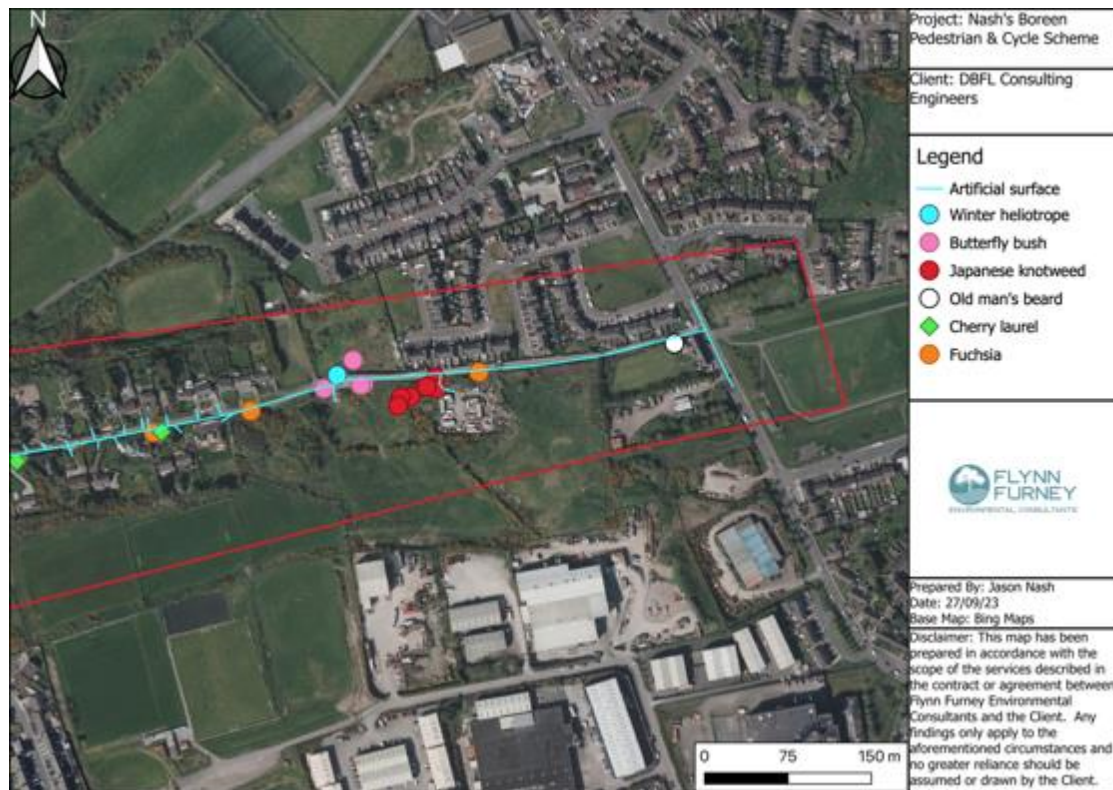
Invasive alien plant species (IAPS), listed under the 3rd Schedule of the European Communities (Birds and Natural Habitats) Regulations 2011 were recorded along and adjacent to the route. This included Japanese Knotweed (*Fallopia japonica*).

Other IAPS were recorded adjacent to and along the route. These were:

- Old man's beard (*Clematis vitalba*)
- Winter heliotrope (*Petasites fragrans*)
- Fuchsia (*Fuchsia magellanica*)
- Butterfly bush (*Buddleja davidii*)
- Cherry laurel (*Prunus laurocerasus*)

Figure 7: IAPS Map (Section 1)

- Japanese Knotweed is present along the route. As it is part of the Third Schedule listed on Sections 49 and 50 of the European Communities (Birds and Natural Habitats) Regulations 2011 (S.I. 477 of 2011), it is advised that an Invasive Species Management Plan is drawn up prior to them commencement of any works onsite.

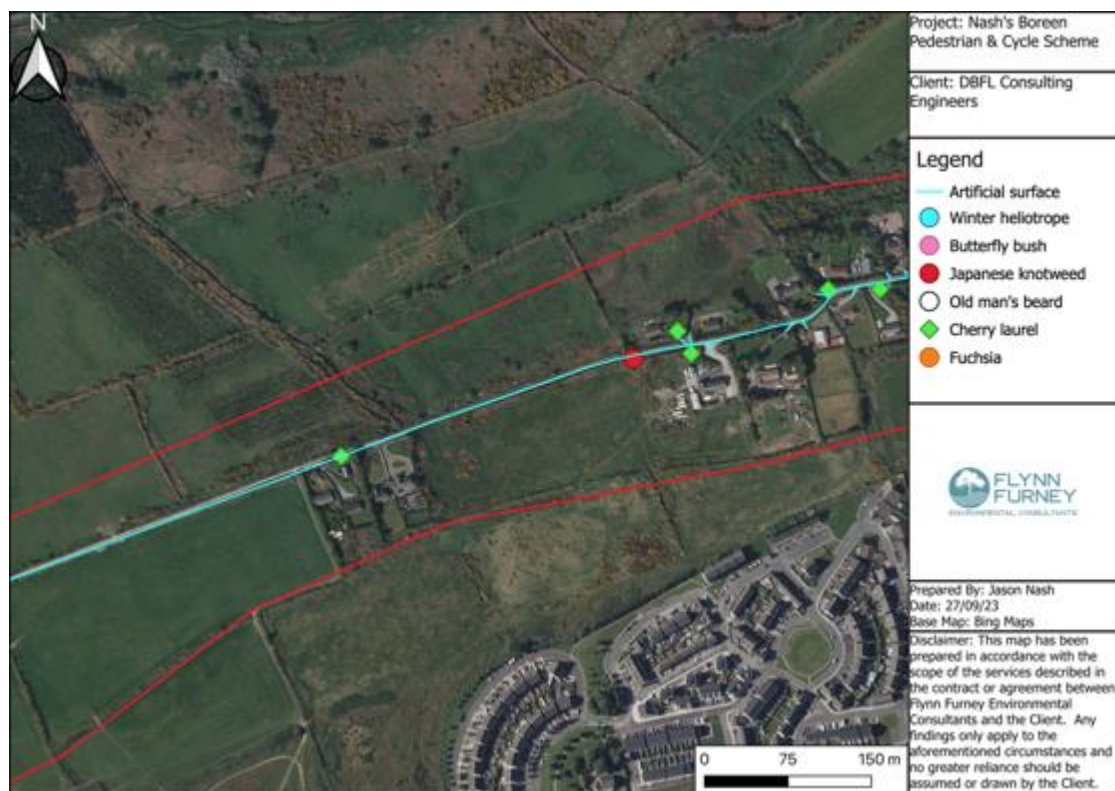
Figure 8:

IAPS Map (Section 2)
