## 2.0 PROPOSALS

### 2.1 TREE REMOVAL

### 2.2 TREE ADDITIONS

## *Tree Survey Documents*

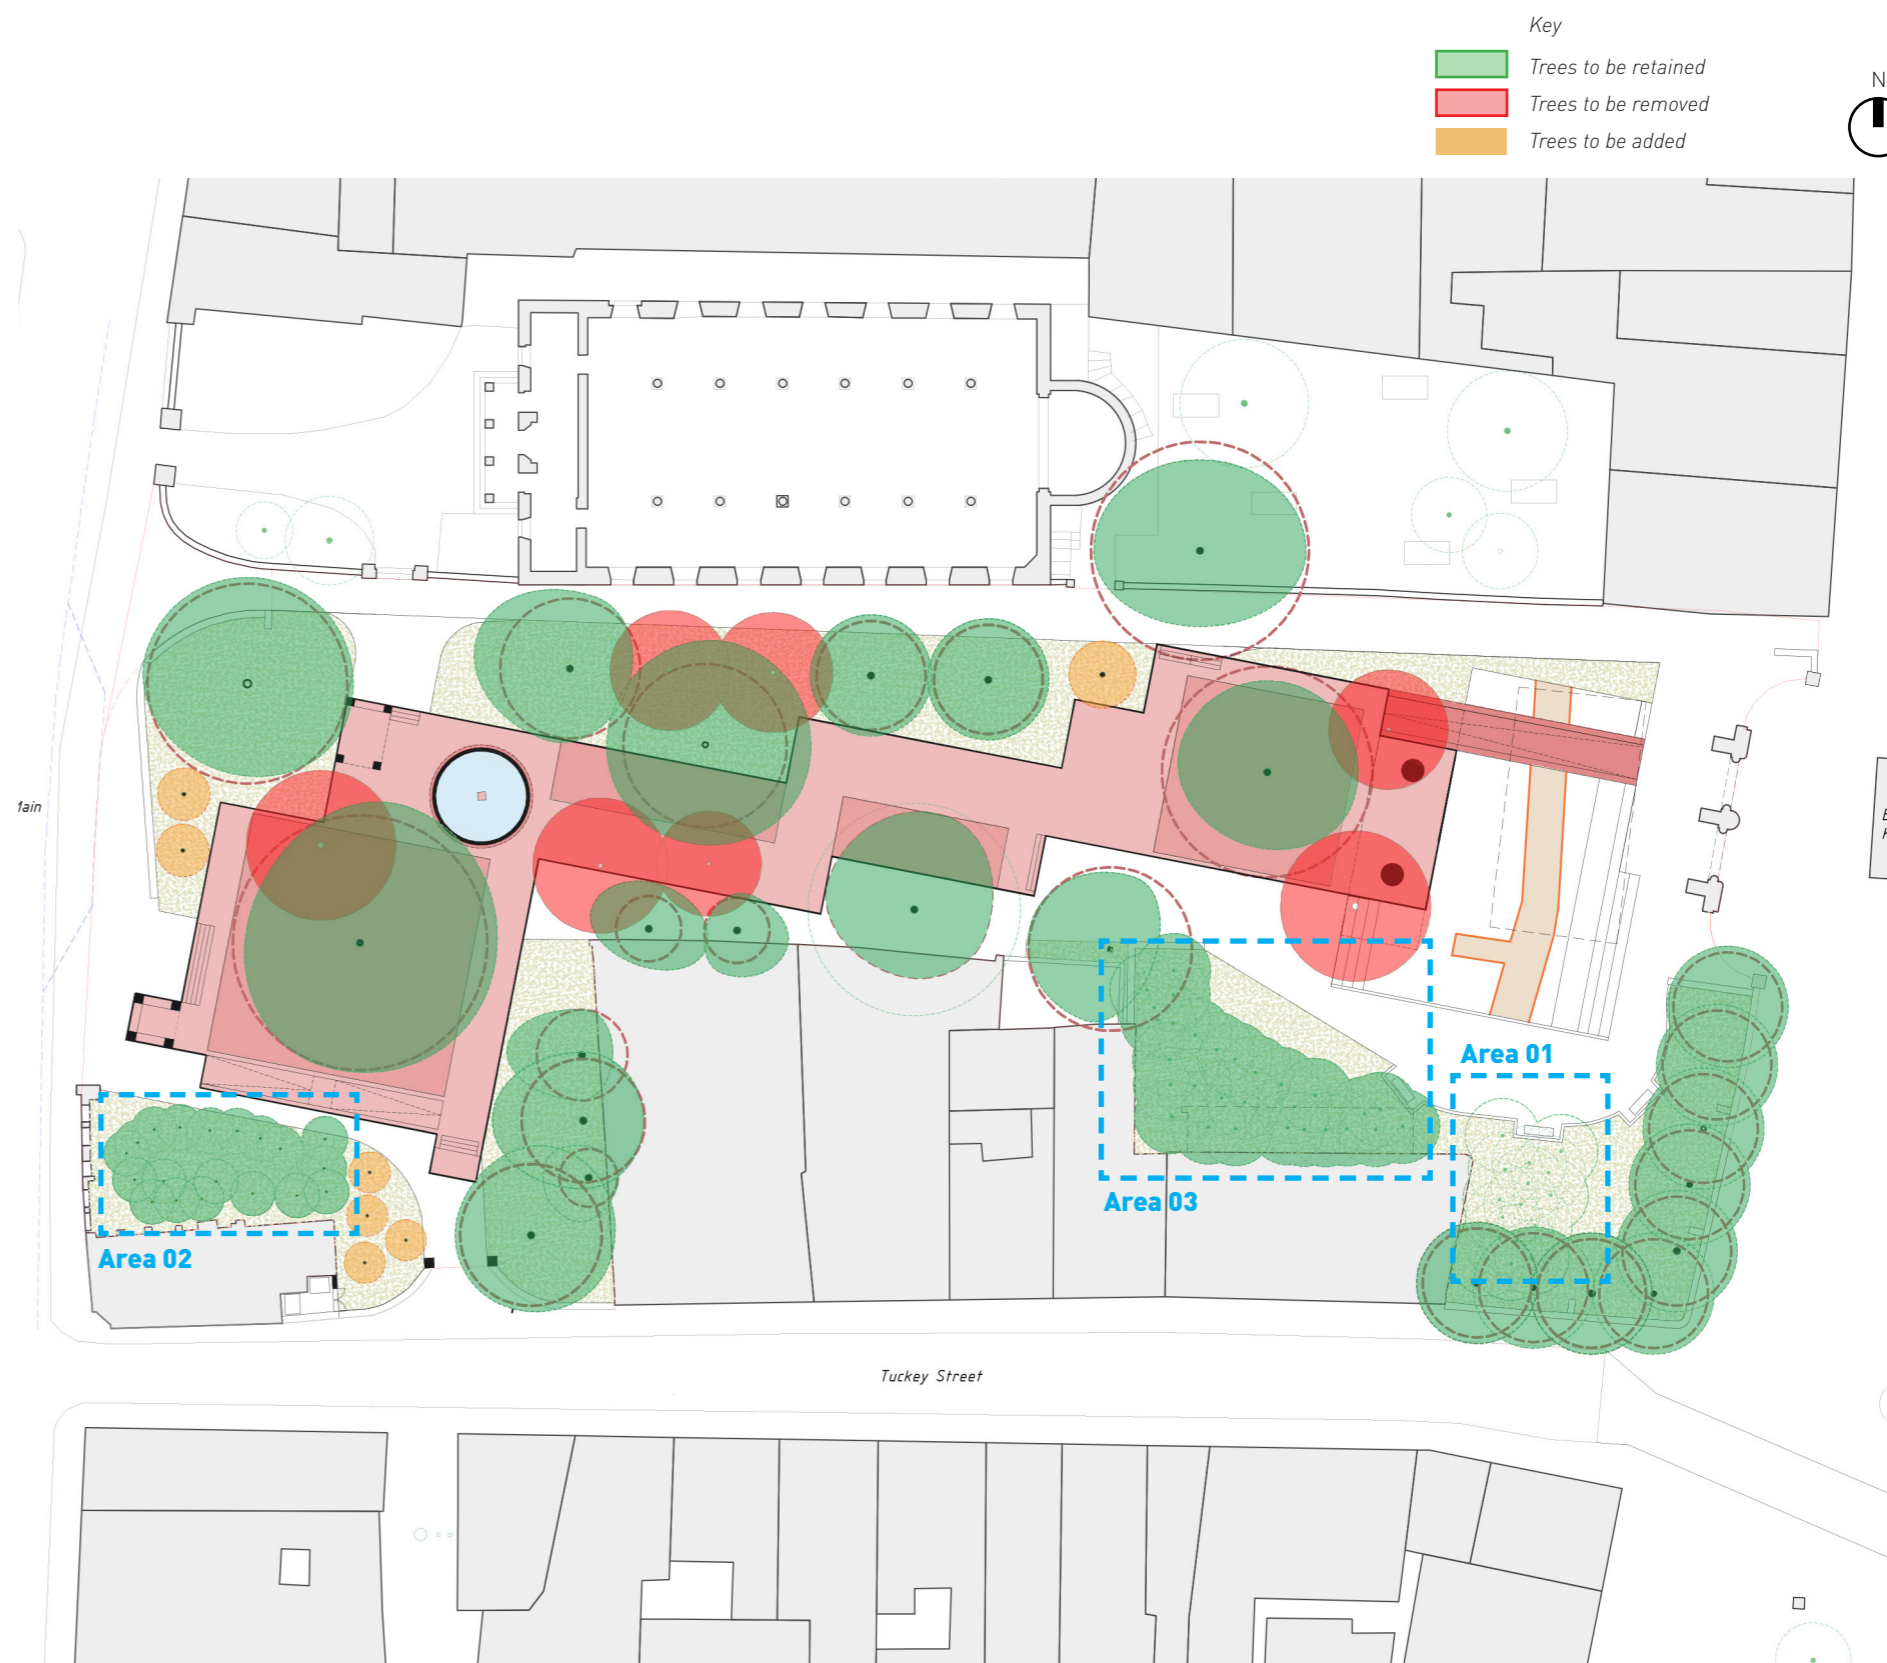
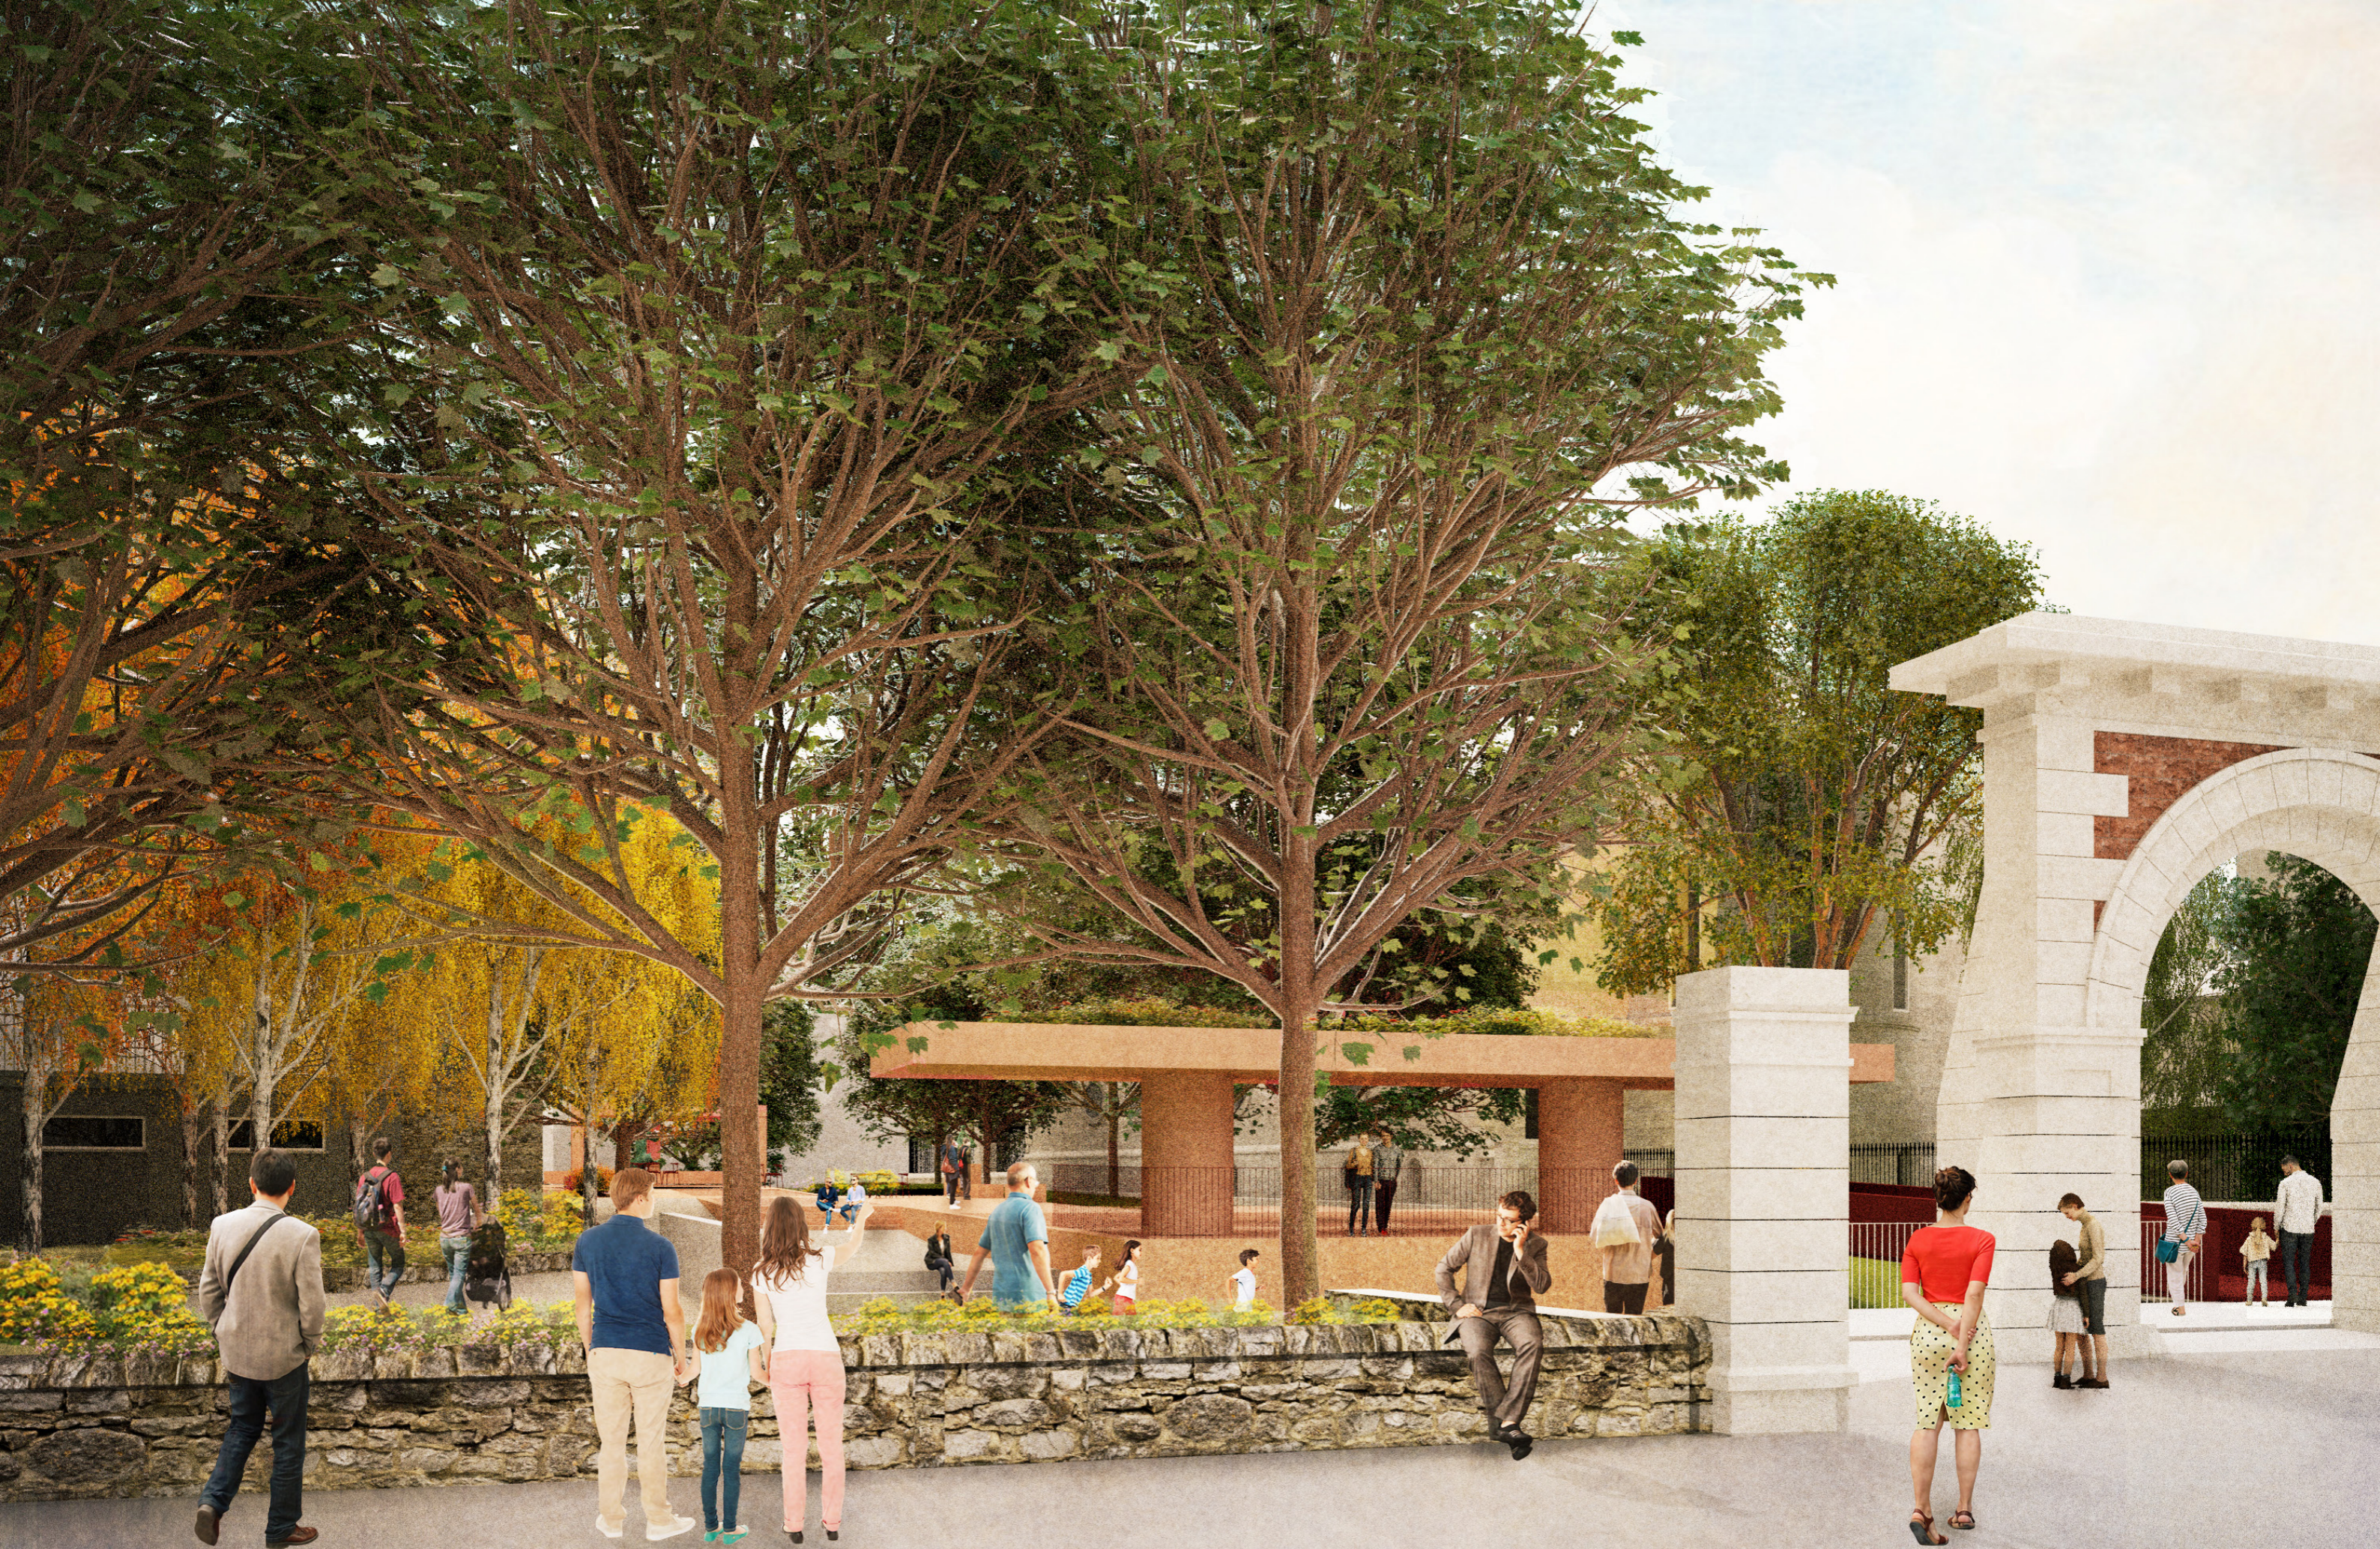
- Area 01: We're proposing to retain the entirety of the birch grove facing Grand Parade (to the eastern gable of the Mason's Hall)
- Area 02: We're proposing to retain the entirety of the birch grove located to the rear of The Oval pub on South Main Street
- Area 03: We're proposing to retain the entirety of the The Chernobyl Dedication Grove trees to the rear of the Masonic Hall on Tuckey Street.
