## TREE SURVEY

**Proposed Cycle Route,  
Glanmire,  
Co Cork.**

**January 2022**

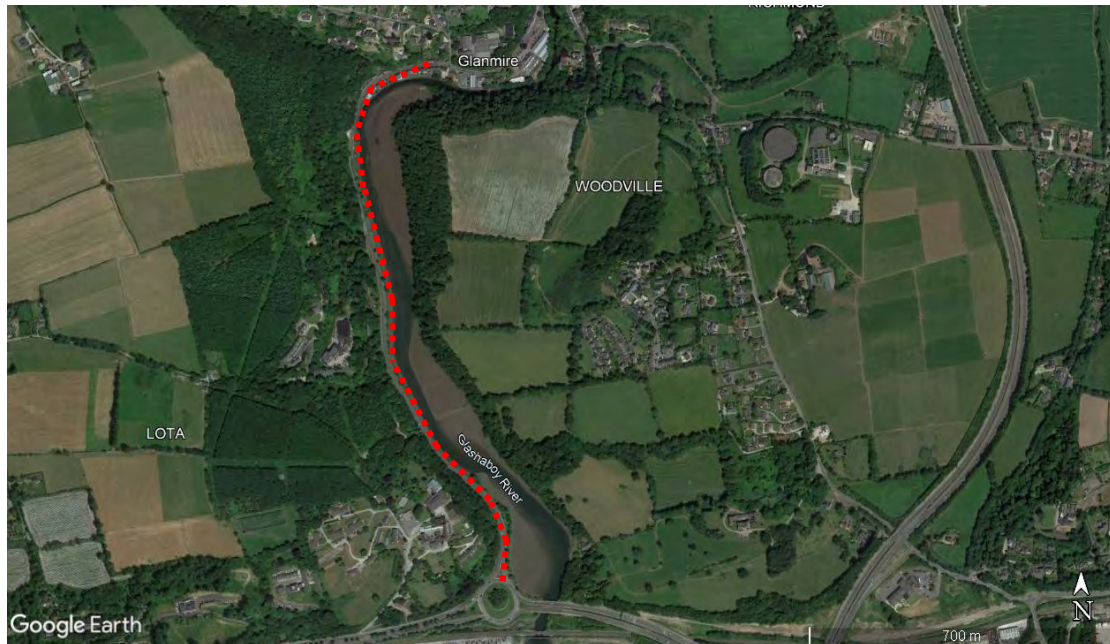
Figure 1: Low resolution satellite image of approximate tree survey area in red (courtesy of Google Earth).
