**St. Bartholomew's Holy Well (C0086-006----),
Doughcloyne, Cork**

Archaeological Impact Assessment

December 2022

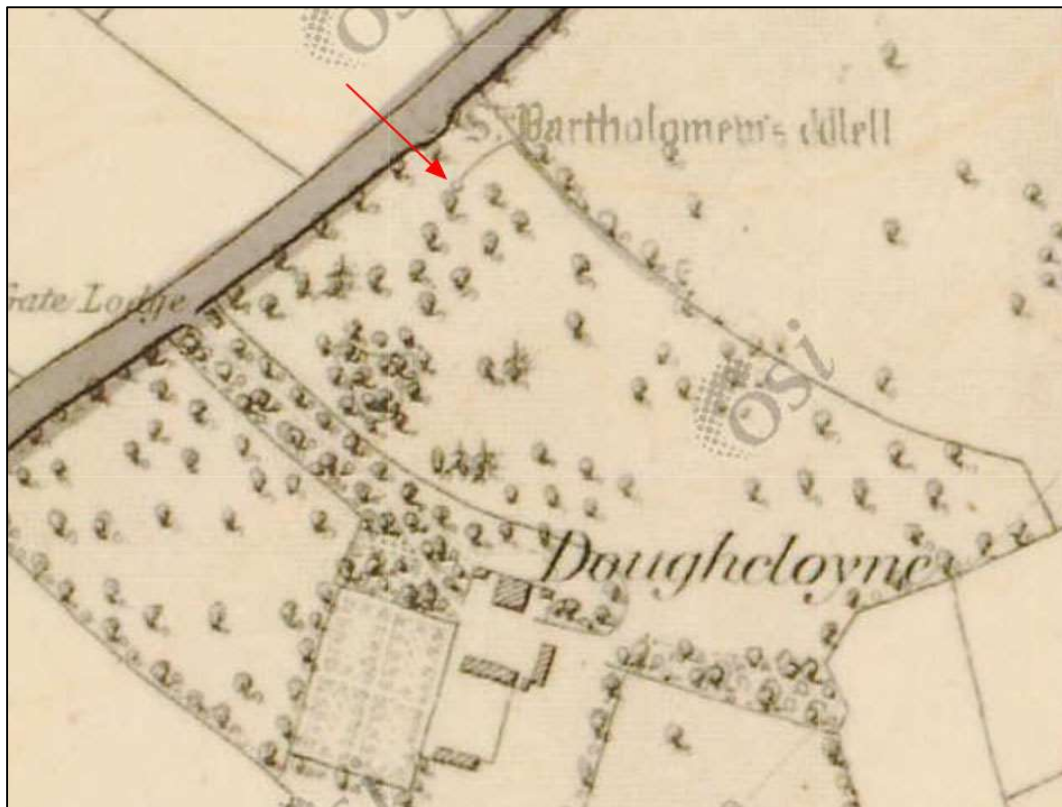
Figure 3: Extract from the 1st edition 6-inch OS map (surveyed 1841) with arrow indicating possible location of holy well (OSI Licence: SU 0003322)

that it was located close to the side of the road rather than on the road itself. The detail on the 6-inch OS map, which was surveyed in 1841, appears to indicate that the well was located in the field to the east of the road at a distance of c.20m from the roadside (**Figure 3** below). This indicates that its former location may not have been under the bridge but rather within the adjacent field to the east.

The cartographic sources examined for the subject site comprised the first 6-inch edition OS map (surveyed 1841), the 25-inch OS map (surveyed 1899) and the Cassini edition 6-inch map (published 1938). The first edition 6-inch map shows the location a few years before the railway track was constructed and 'St. Bartholomew's Well' is clearly labelled and appears to be indicated as a small circular feature (a symbol typically used by the Ordnance Survey to indicate wells) located c.20m to the east of the Spur Hill road which is also present on this map (**Figure 3**). A number of planted trees are shown within its environs, and these may correspond to the avenue of sycamore trees referred to by Smith in 1774 although no clear formal avenue feature is depicted. These trees may have formed part of landscaping associated with Doughcloyne House which is shown in the area further to the south.

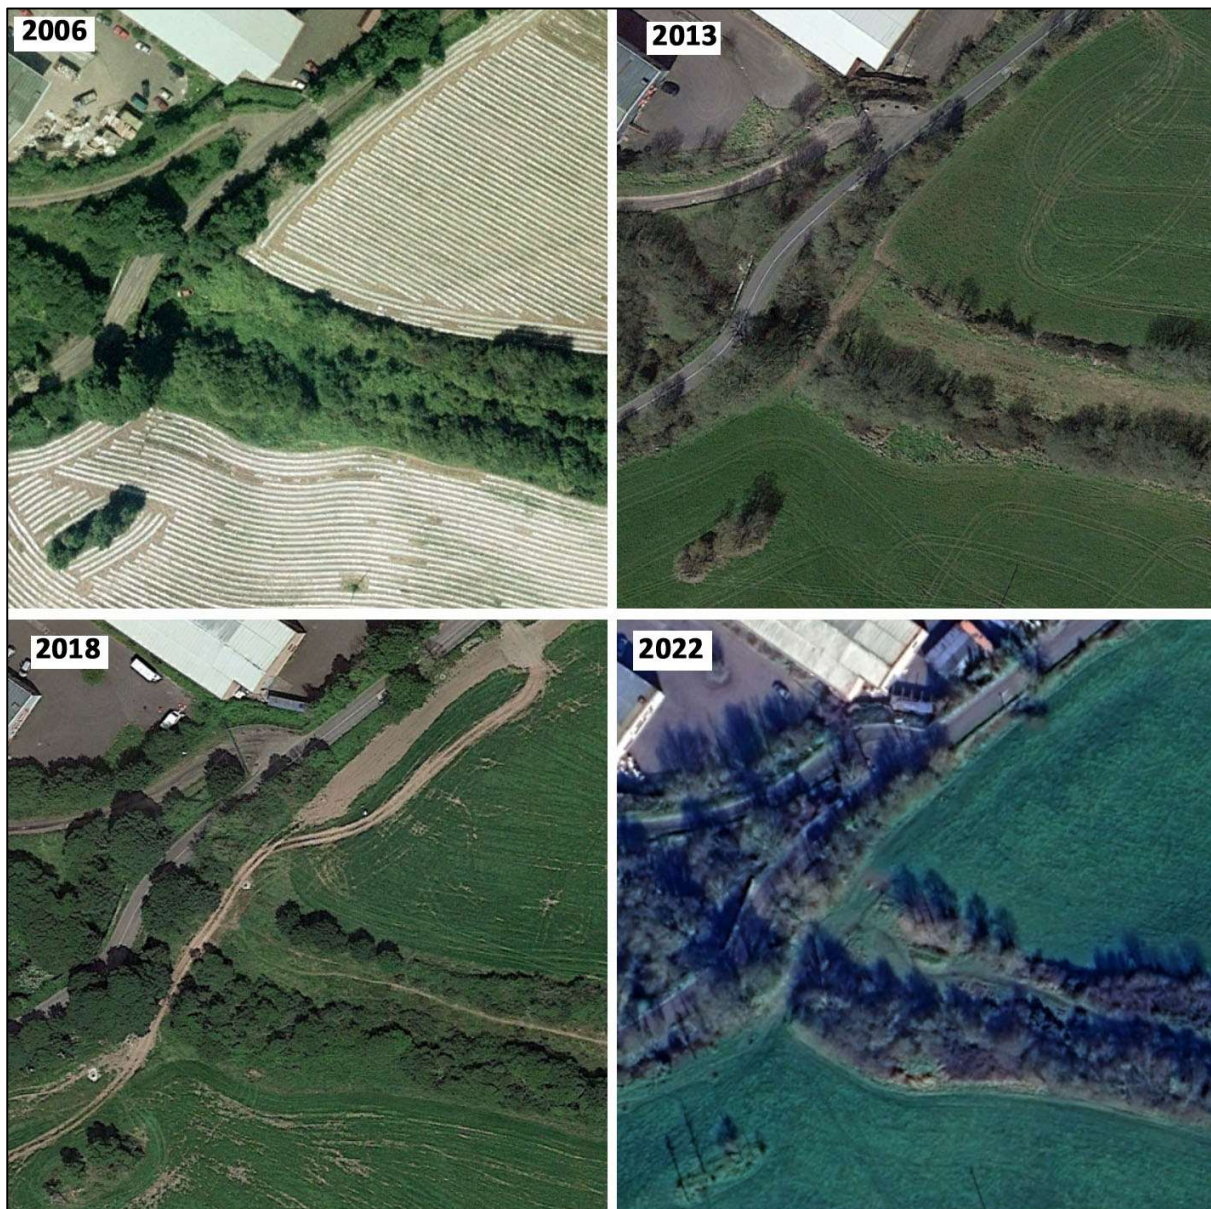
Figure 7: Google Earth images of the general location

A review of online aerial and satellite imagery of the location was carried out to ascertain if any traces of the holy well, or associated features, were evident and also to appraise any recent interventions in the area. The extent of the disused railway line is clearly evident as an overgrown area between two vacant fields on all reviewed images and no traces of the holy well or any potential associated features are visible. A small cluster of trees in the field to the south of the railway line are visible as an avoided area during the agricultural works on the 2006 image. This location was inspected during the field survey and comprises a natural bedrock outcrop. Also of note on the 2006 image is the fact that the existing field gap in the section of the railway line to the east of Spur Hill road was not present at that time. It is visible on subsequent images indicating that it was created in order to allow access between the two fields at some point after 2006. The ground works visible on the 2018 image extend through this field gap and appear to have taken advantage of this existing access feature rather than creating it. The detail on the 2022 image indicates that grass regrowth has occurred in the area disturbed by the 2018 ground works.

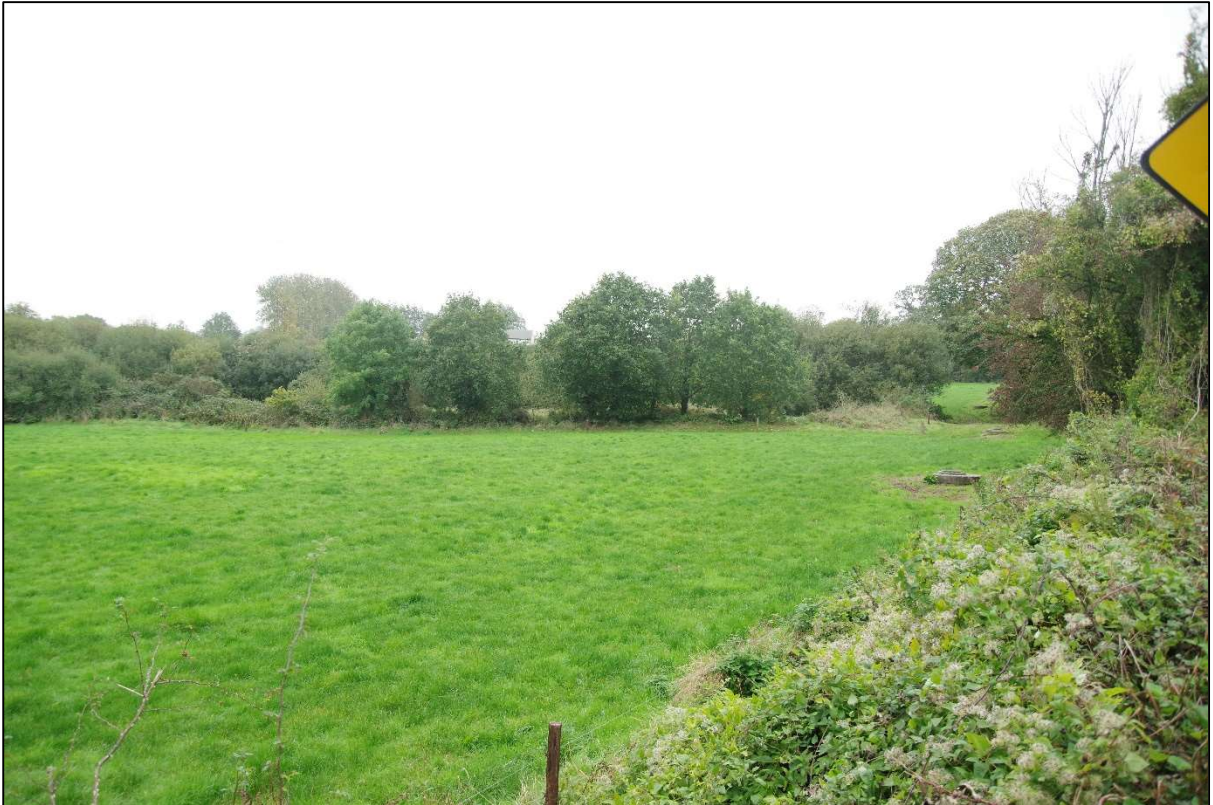
No surface traces of the holy well, including any remains of a stone built surround or a later capping of the spring, were noted within the accessible areas of the railway line, or within the adjacent fields, during the site inspection. It is noted that while the presence of thick vegetation along the railway line restricted the inspection, the likelihood exists that the Archaeological Survey of Ireland's conclusion that the construction of the railway destroyed the holy well is correct.

Plate 1: View towards former railway line from south (location is within tree line in centre of frame)

It is recommended that licensed archaeological supervision of the clearance of vegetation, and any required ground excavation works, within the overgrown section of the former railway line in the environs of the recorded location of the holy well be carried out during the construction phase to confirm that no surviving traces of the site exist.

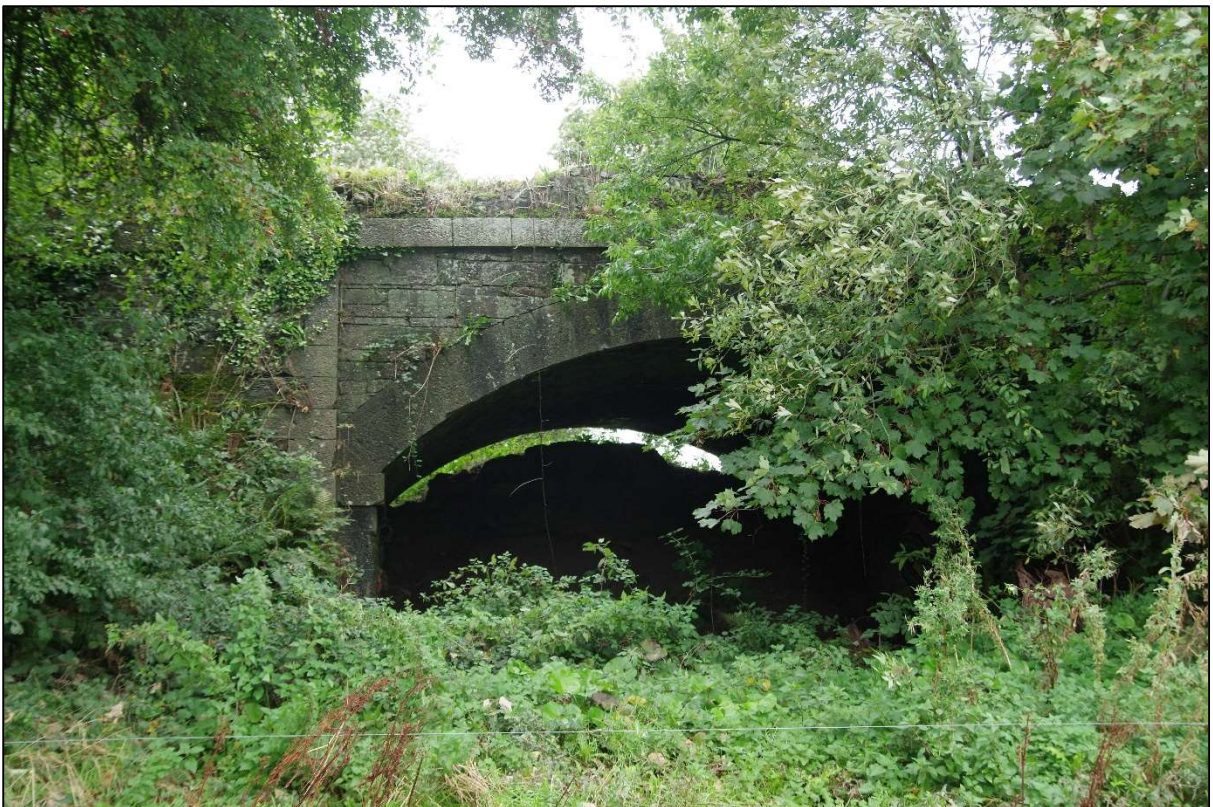
The route of the railway line is clearly evident as an overgrown strip of heavily overgrown ground between two vacant green fields and extends in a curvilinear line towards the east. The railway bridge over Spur Hill road remains in good condition although the area under the span is heavily overgrown and has been intentionally blocked with a large dump of spoil on the western side. There are also frequent inclusions of dumped material under the bridge and on its east side. The presence of thick overgrowth restricted views of the ground surface in this area.

Plate 2: View of Spur Hill railway bridge from east with overgrowth and soil dump visible

It is recommended that the area to be supervised should encompass the area under the railway bridge as well as the section of the railway extending 30m east of the bridge.

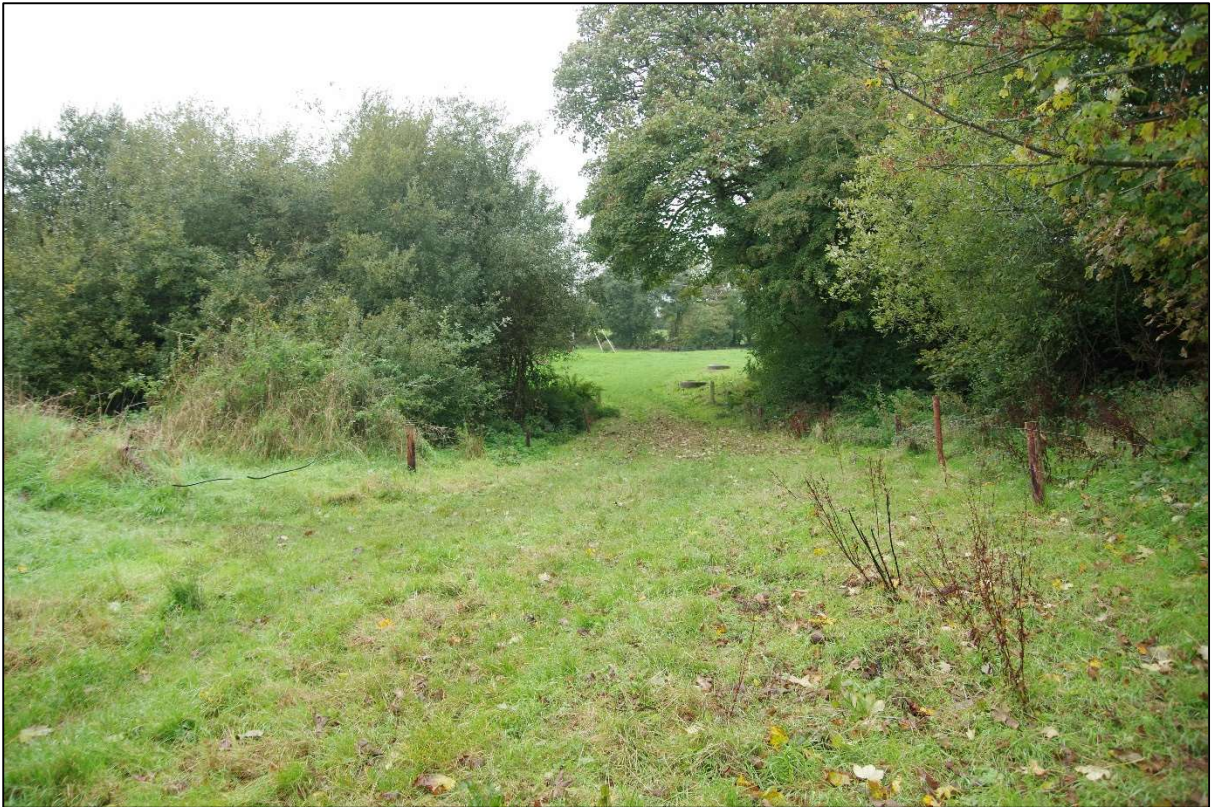
The field gap across the section of the former railway line to the east of the bridge is grass-covered and measures 8m-10m in width. A line of manholes of recent appearance extend to the north and south of the gap and are likely associated with the ground works visible on the 2018 Google Earth image.

Plate 3: *View from north of modern field gap extending across the section of the former railway to the east of the bridge*

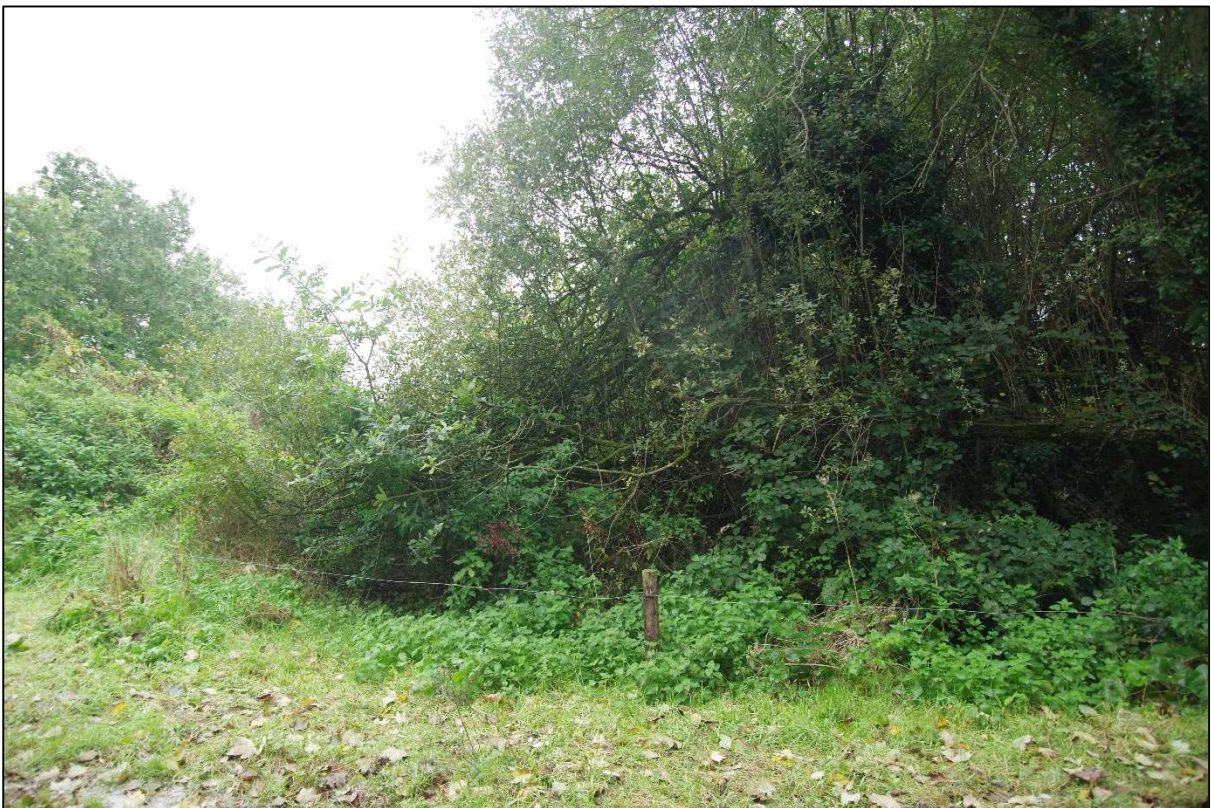
The section of the railway extending to the east is heavily overgrown with trees and brambles which almost completely restrict access to the internal area of the line. Where accessible, it comprises an area slightly raised above ground level in the adjoining fields to the north and south. The width of the overgrown area delimiting its extent increases from c.30m in the west end of the field to c.55m in the west end, which broadly mirrors its original layout as indicated on the 25-inch OS map (**Figure 5**). A steep-sided cut channel (c. 1m wide by 1m deep) extends eastwards along the north end of the line and this likely forms the remains of a drainage channel that flanked this section of the line, perhaps in part created to channel ground water rising from a natural spring that fed the former holy well.

Plate 4: *View from west of overgrown section of former railway line (taken from field gap)*

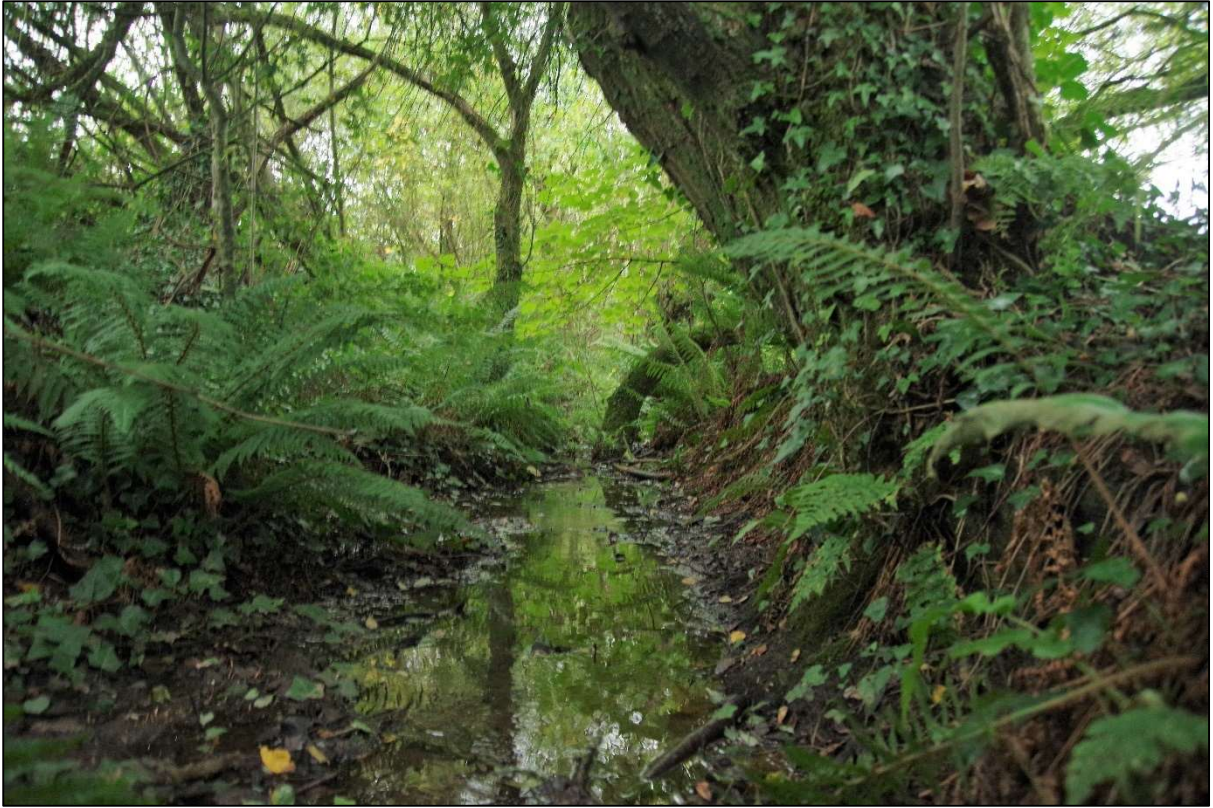
Plate 5: View of drainage ditch within overgrown area
