**Arboricultural Impact Assessment and Tree Protection
Plan (BS5837:2012)**

Blarney Residential Scheme

Blarney, Co. Cork

10-03-2026

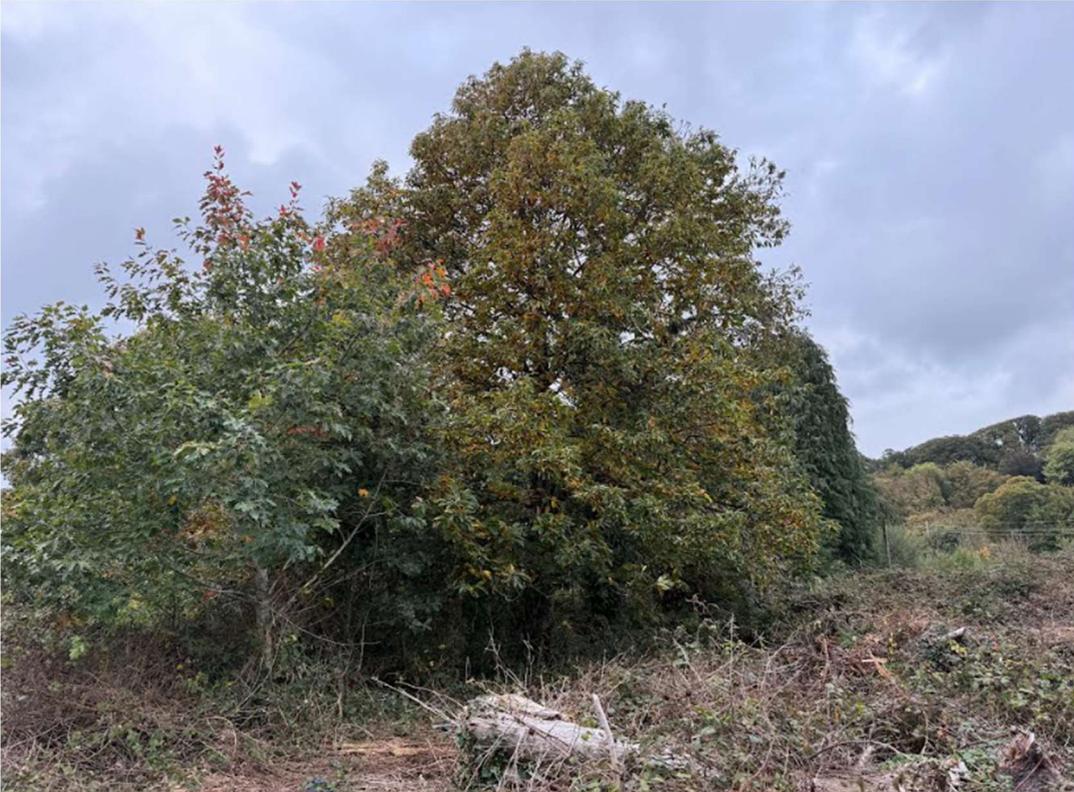
Photo 10: Tree no.0373, view northeast.

- 3.1.5 In the northern area of the site, there are 3no. Horse Chestnut trees (0373-75) and 3no. Red Oaks (0376-78), all in good structural and physiological condition. To the west of these, there is a linear group of tall Lawson Cypress and other conifer species, ranging between 20 and 22 metres in height. These trees form dense, upright clusters with closely spaced vertical stems. While most are in good condition, three to four individuals display notable canopy dieback.

- 4.2.1 **Tree no's. 0364-67 & 0369-81:** The proposed development footprint, including buildings, pavements, roads and attenuation tank directly conflicts with these trees. Retention is unrealistic with the proposed design and these trees will need to be removed. This leads to the loss of local amenity value and biodiversity. These trees are of mixed quality but generally considered moderate. The overall potential impact is moderate and certain to occur. The loss shall be mitigated through replacement planting with appropriate species in suitable locations to restore the site's long-term landscape and ecological value.
