Tree Report

Project: Maglin Greenway Phase 1

Report No.: MG1-FF-002

Date: May 2023

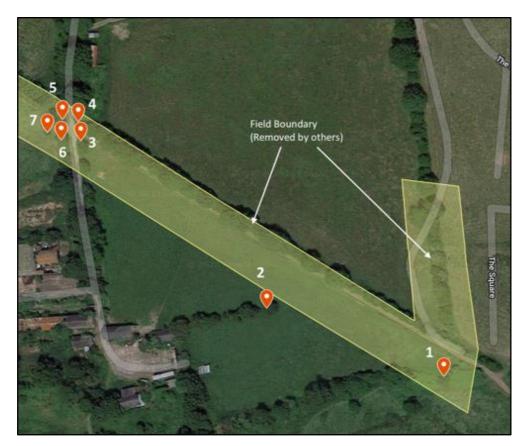
Figure 3: Results for eastern section.

Loss of hedgerows may be seen at sites 3, 4, 5 and 6. The impact here is reduced by the presence of two field entrances either side of the existing avenue. This avenue has well established boundaries along its length and is likely to be locally important to species such as commuting bats. Site 5 is likely to be impacted on with the potential loss of the sycamore to accommodate a potential future connection to a proposed development to the north of the greenway.

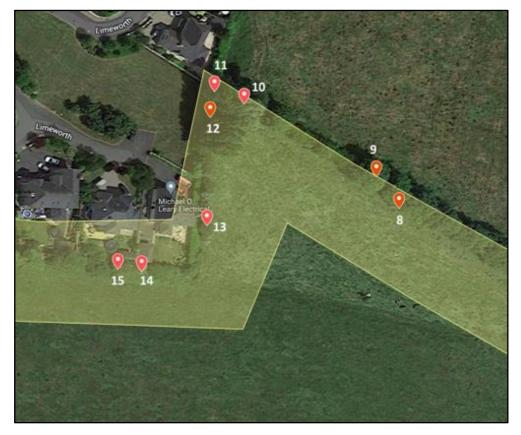
Figure 4: Results for fields east of Limeworth.

The Blackthorn scrub and Ash treeline at sites 8 and 9 are a nice habitat feature in the area. Root damage should be avoided where possible to the mature trees. There was no evidence of 'Ash dieback' during the survey. The blackthorn is spreading into the field.

There are two mature willows at site 10 beside the poplar trees at sites 11 and 12. These are leaning into the field and may require removal.

Two boundaries that have been planted with trees are located at sites 11 and 12. The poplars at site 11 have been topped. The Poplars at site 12 are mature and are a feature at this end of the housing estate. The route will likely not have any impact on these trees. The trees are in good condition and do not appear to have any bat roost potential.

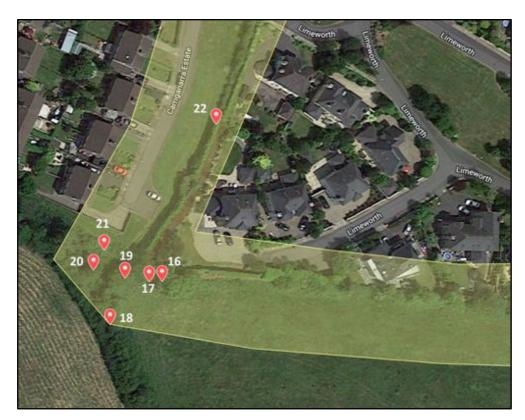
Figure 5: Results for fields south of Limeworth and Carriganarra Estate. Riparian section.

The boundary of the residences to the Southern end of Limeworth estate at sites 13, 14 and 15 are dense and may be trimmed back but should be retained where possible. Some of the boundary, along site 15, moving east has been cleared (45m) and is not as dense as you progress westwards. There are some mature hawthorns along the boundary that can be retained. There is a further length (30m) of laurel along the boundary of the last residence to the west.

The tree at site 16 is a large ash that has some damage on its northern side. This tree may require removal on safety grounds. It may also have some bat potential.

Sites 17 and 19 will need to be removed. There are mature hedgerow species of elder, hawthorn, willow and blackthorn with a dense understorey of similar plants.

Site 18 is along the riparian zone on the watercourse. It is quite open as most of the dense hedgerow growth is on the southern side of the river.

Site 20 is the next riparian zone to the west of the proposed route. The alder and willow here may be retained to act as a buffer to the watercourse. Site 21 is developing scrub dominated by briars and may require some pruning.
