CHRIST THE KING PRESENTATION CONVENT, EVERGREEN ROAD, CORK CITY, CO. CORK

Architectural Heritage Impact Assessment

September 2025

Ref: 024021

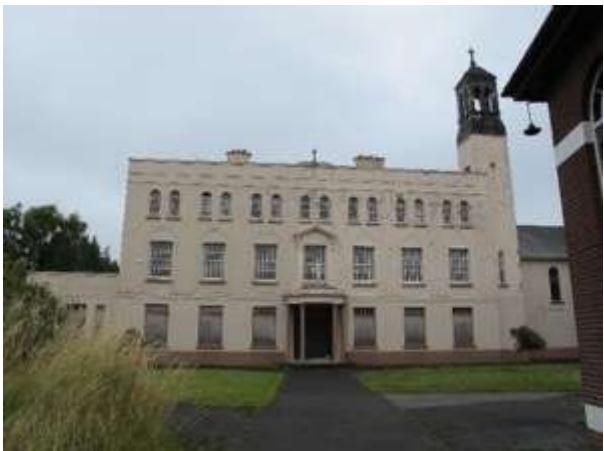
Fig.7: South elevation

<ul style="list-style-type: none"> While it retains its overall form and many features, the building has been empty for some years and has been allowed to fall into disrepair with significant water ingress noted particularly to the roof and walls of the main building. Deteriorated roof finish. Ineffective rainwater management. Widespread cracking to external cement render. Paint cracking, peeling, and flaking. Algae growth on surfaces and materials. Plywood affixed to ground floor windows and doors. Overgrown vegetation around building to north, east, and west. Algal growth to ground surface at rear.
Probable causes	<ul style="list-style-type: none"> Deterioration of roof finish. Failure of previous repairs. Blocked rainwater outlets. Ponding to roof. Open joints and cracks at parapet level. Ineffective direction of water away from building through surface water management system. Impermeable paint preventing water from exiting the building fabric. Cement render is non-porous and rigid, trapping water and cracking. Several years of disuse, ageing, and lack of maintenance.

Mitigation Measures	<p>Repairs to the external envelope and surface water management system to follow conservation best practice in accordance with the statutory status and architectural heritage context of the convent.</p> <p>Maintenance of vegetation on property will improve surrounds and prevent damage to historic fabric.</p>

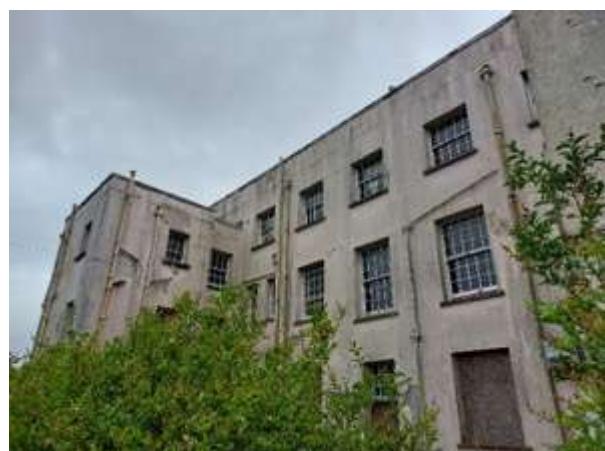
Fig.8: North elevation

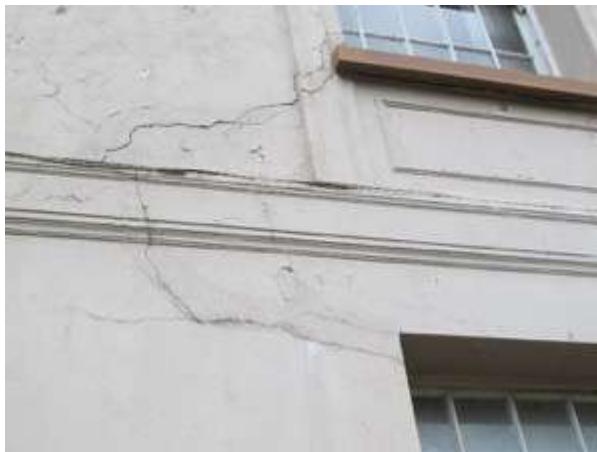
Fig.9: Cracking on south elevation

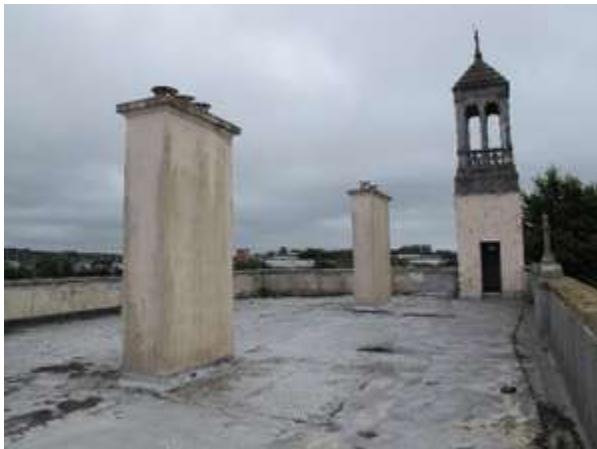
Fig.11: Looking east

<ul style="list-style-type: none">Roof covering has failed. Overlay/ lining collapsed from parapets in north-east corner.Cracking and open joints to concrete coping.Cracked render to parapet.Blocked rainwater outlets. Water ponding in south-west corner, north-east corner, and on west annex.Biological growth (plant life, lichen, moss).
Probable causes	<ul style="list-style-type: none">Failed roof covering, flashing and linings.Obstructed rainwater goods.Ageing materials / weathering over time.Inadequate maintenance.
Probable Consequences	<ul style="list-style-type: none">Water ingress and consequent decay/ loss of historic fabric.Possible structural damage from long-term water ingress.

<ul style="list-style-type: none"> Interior damp with build-up of mould and/or insect infestations leading to potential structural decay and degradation of indoor air quality.
Assessment	<p>Comprehensive strategy required for repair and refurbishment to roof fabric and rainwater management system to address water ingress.</p> <p>Comprehensive strategy required to address the widespread open joints and cracking to the coping and cement render to include the removal of biological growth to address water ingress and water becoming trapped in the historic fabric and causing decay.</p> <p>Further investigation and structural assessment of roof area recommended to identify any remedial works required.</p>
Mitigation Measures	<p>Repairs to the external envelope and surface water management system to follow conservation best practice in accordance with the architectural heritage context and statutory status of the convent.</p> <p>Works to repair roof will help address the significant water ingress issues of the building thus prolonging its lifespan.</p>

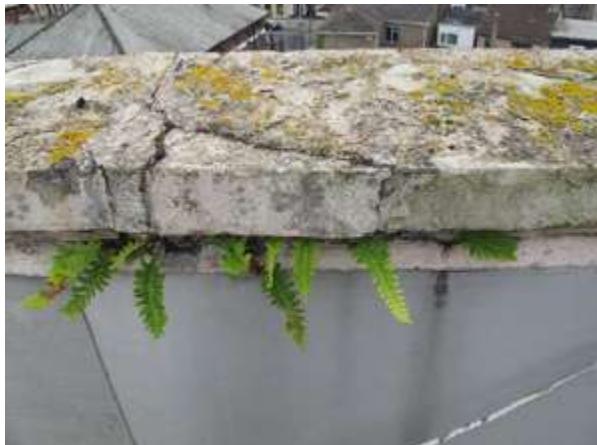
Fig.13: Plant growth and cracking to south concrete coping

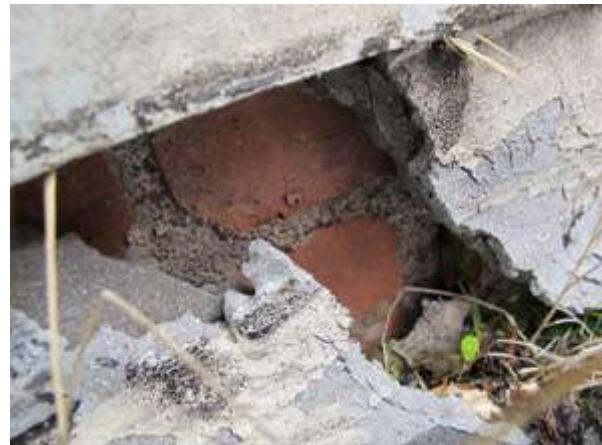
Fig.14: Damaged parapet render exposing red brick

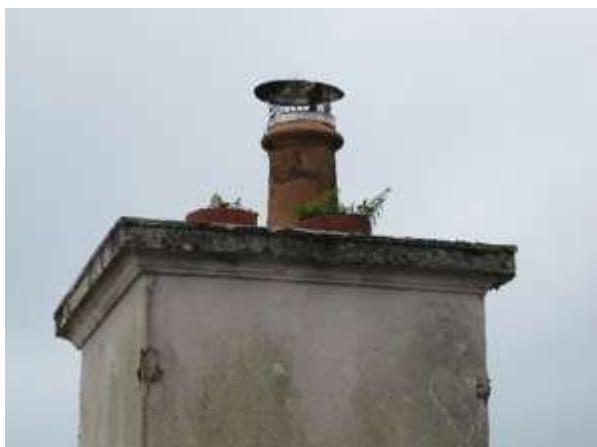
Fig.15: Plant growth in terracotta chimney can

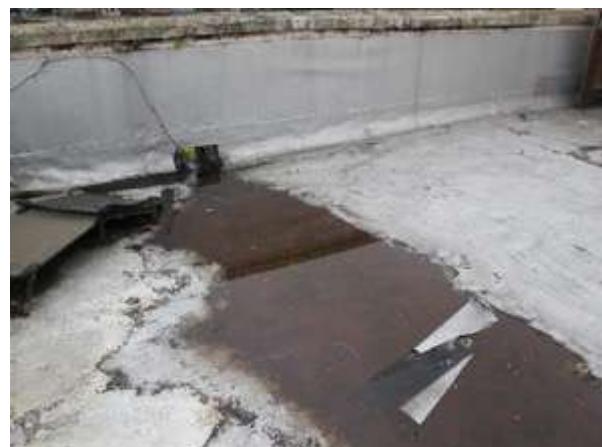
Fig.16: Water ponding (south-west area of roof)

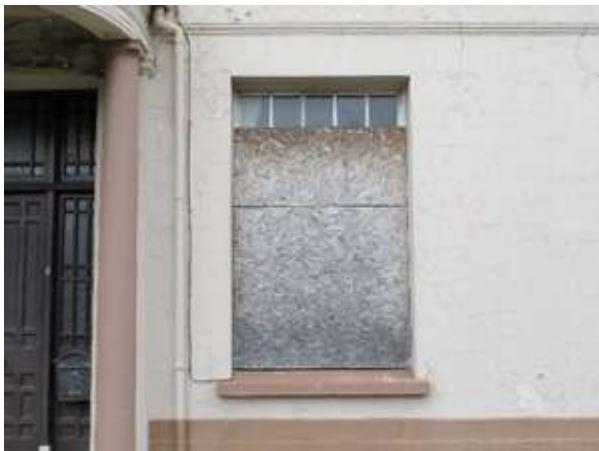
Fig.17: Modern plastic down pipe on south elevation

Description	Mix of original cast iron and modern replacement plastic rainwater goods, primarily painted to match elevations. Rectangular hoppers, round downpipes, plain brackets. The gutter to the west annex is plastic.
Condition Class: Moderately strong symptoms	<ul style="list-style-type: none">Rusting of the cast iron rainwater goodsVisible vegetation growth in hoppers.Algae growth on north elevation rainwater goods.
Probable causes	<ul style="list-style-type: none">Ageing, wear and inadequate maintenance.
Probable Consequences	<ul style="list-style-type: none">Poor drainage and water ponding/ retention.Rusted brackets may come away from walls.
Assessment	Rainwater goods should be cleared of plant life and debris. Modern plastic replacements should be replaced with appropriate cast iron. Refurbish rainwater goods complete. Repair and replace damaged sections only where necessary.

<p>Ensure rainwater system is adequate for increased deluge rain events. Additional provision of capacity may be required.</p> <p>Drainage inspection recommended to ensure effective direction of water away from the historic fabric.</p>
Mitigation Measures	<p>Refurbishing the rainwater goods and replacing inappropriate modern elements will improve both the functionality and the historic character.</p> <p>If/where required, provision of additional capacity should follow conservation best practice.</p>

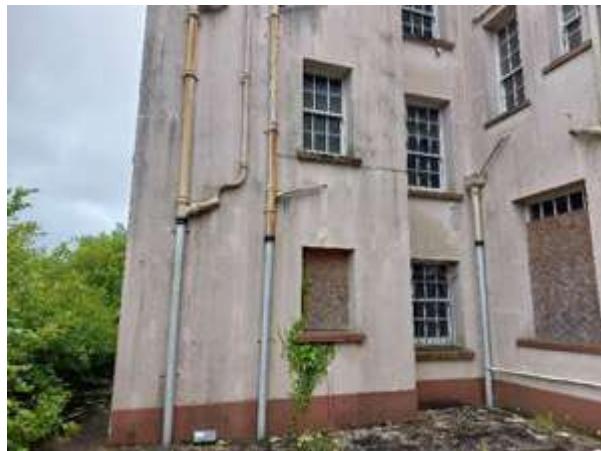
Fig.18: Mix of modern plastic and cast iron down pipes on north elevation

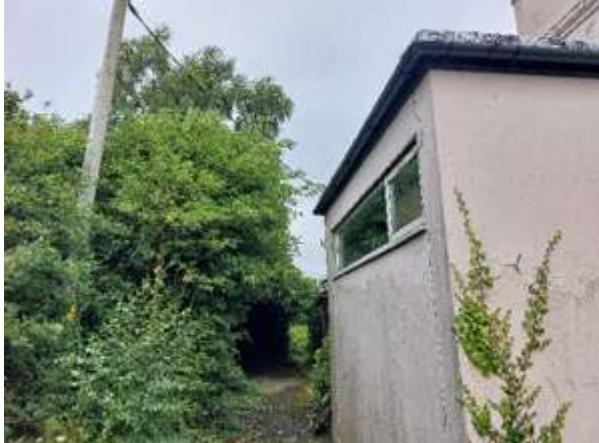
Fig.19: Plastic gutter on west annex

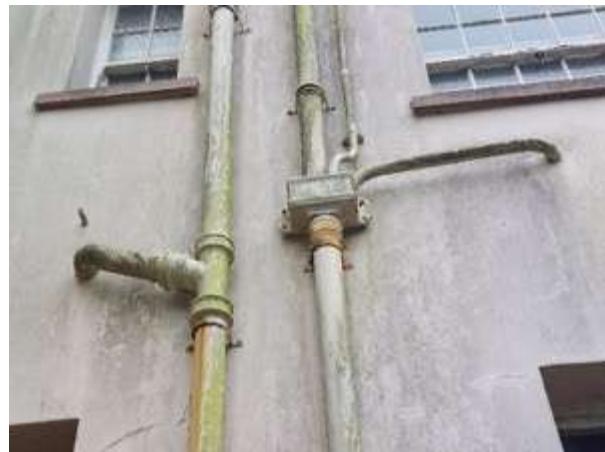
Fig.21: Algae build up on north elevation rainwater goods

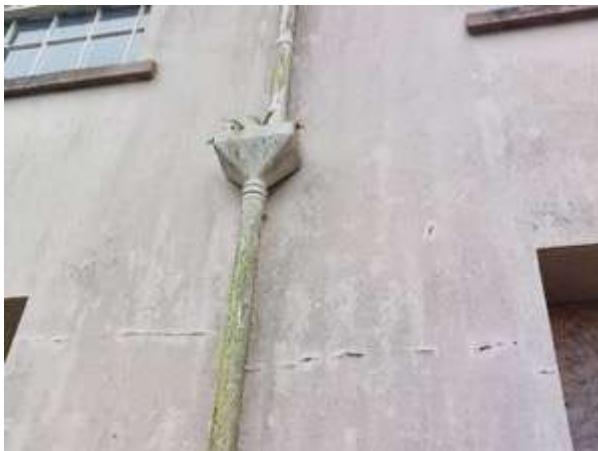
Fig.22: Plant growth in hopper

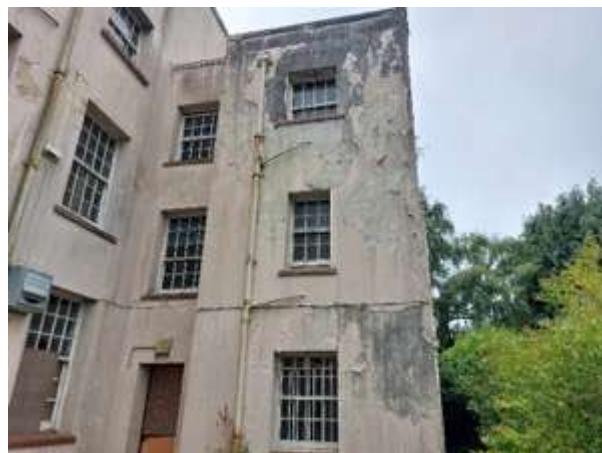
Fig.25: North elevation walls (looking west)

Description	Red brick walls with a painted cement render, investigated through opening up works. Decorative detailing to the render includes low relief moulded render plat bands and first floor window surrounds to south elevation of the principal building. There appears to have previously been a porch added and later removed to the north elevation (see Fig. 30).
Condition Class: Major symptoms	<ul style="list-style-type: none">Widespread, extensive, and significant cracking to cement render.Cracking, flaking, and peeling paintwork.Algae growth to north elevation.Ivy climbing walls.
Probable causes	<ul style="list-style-type: none">Cement render is non-porous and rigid, trapping water and cracking.Impermeable paint preventing water from exiting the building fabric.Ageing materials and inadequate maintenance.Water ingress from ponding on roof and through open joints and cracks exacerbating decay actions.Overgrowth of surrounding vegetation.

Probable Consequences	<ul style="list-style-type: none"> • Water ingress and consequent decay of historic fabric. • Continued deterioration of condition and structure. • Build-up of mould growth to interior.
Assessment	<p>Water ingress to the historic building fabric and to the interior is widespread and significant. The cracked render must be addressed to prevent further water ingress and damage. A comprehensive strategy is required to address the failed render in order to safeguard the building fabric and to allow the future use of the building. The removal and appropriate replacement of the cement render may be required to achieve this. To address the underlying causes of the failure of the render, a more flexible, vapour-permeable render mix and finish should be considered.</p> <p>Maintenance management works to surrounding vegetation.</p>
Mitigation Measures	<p>The strategy to address the failed render should be developed in collaboration with appropriately qualified specialists in order to ensure material compatibility as well as maintenance of character.</p> <p>The strategy to address the failed render must take into account conservation best practice and the architectural heritage context and statutory status of the convent. The existing render is a significant feature of the building, the decorative detail to the render is modest but forms an integral part of the character of the principal façade. Where it is considered necessary for the render to be removed, the existing decorative detail should be carefully recorded prior to removal and replaced to match by suitably qualified specialists.</p> <p>Any replacement render and finish should address the underlying causes of the failure of the existing render through its material properties in order to assure the effective functioning of the building envelope and to facilitate the ongoing use of the building.</p>

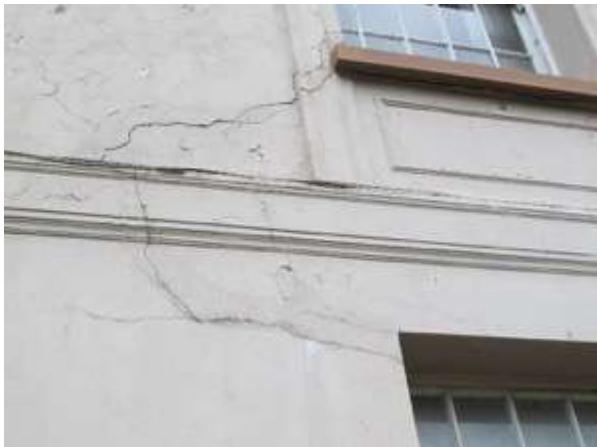
Fig.27: Cracking on south elevation

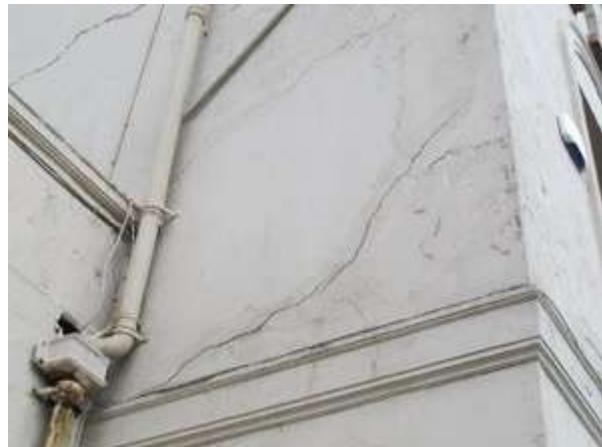
Fig.28: Cracking on south-west elevation

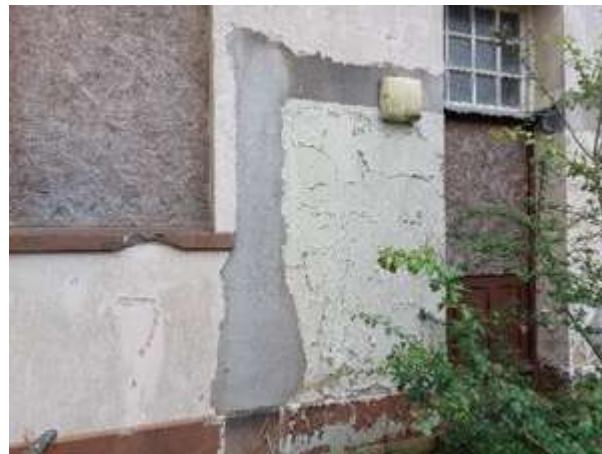
Fig.30: Evidence suggesting previous porch on north elevation

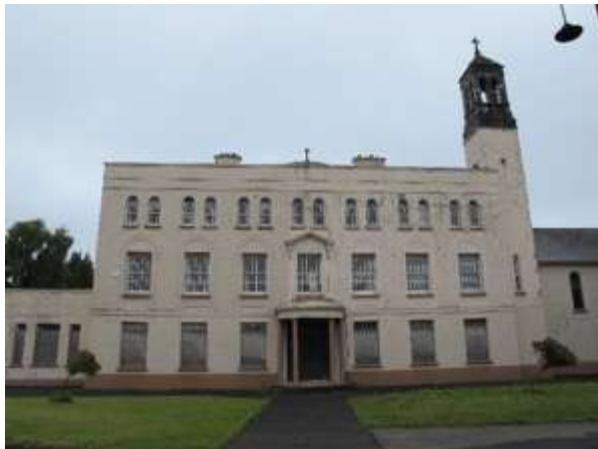
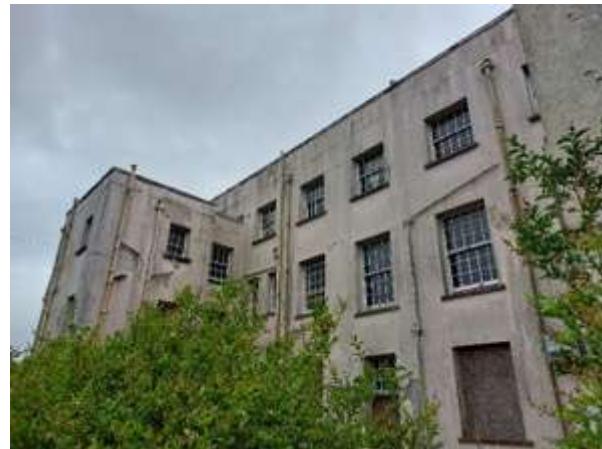
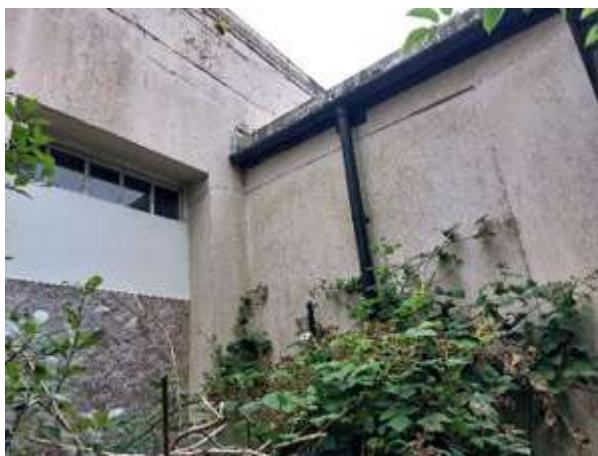
Fig.31: Windows of south elevation

Fig.32: Windows of north elevation

Fig.33: Windows of west elevation

Probable causes	<ul style="list-style-type: none"> Water ingress causing swelling of timbers. Lost or inadequately maintained opening mechanisms. Damage and water ingress to surrounding walls. Ageing, wear, and inadequate maintenance.
Probable Consequences	<ul style="list-style-type: none"> Unopenable windows. Water ingress and consequent decay of historic fabric. Continued deterioration of condition and structure. Lack of ventilation. Build-up of mould growth to interior.
Assessment	<p>The bottom rails could not be assessed due to affixed plywood of ground floor windows.</p> <p>The windows appear to be in moderate condition, with no visible evidence of extreme timber decay despite the water ingress to the walls. A comprehensive strategy to address the issues to the external envelope in general is required as continued lack of maintenance, repair, and refurbishment will cause deterioration to the windows.</p> <p>Windows to be repaired and refurbished to working order throughout. Window reveals to be refinished in coordination with the external render strategy. Paint and biological growth to be removed from the sills and appropriate repairs carried out.</p> <p>Investigation and structural assessment of lintels is recommended particularly given the extensive water ingress to the external walls.</p>

Mitigation Measures	Window refurbishment should be carried out by suitably experienced operatives to maintain the historic character of the building and ensure its effective ongoing use.

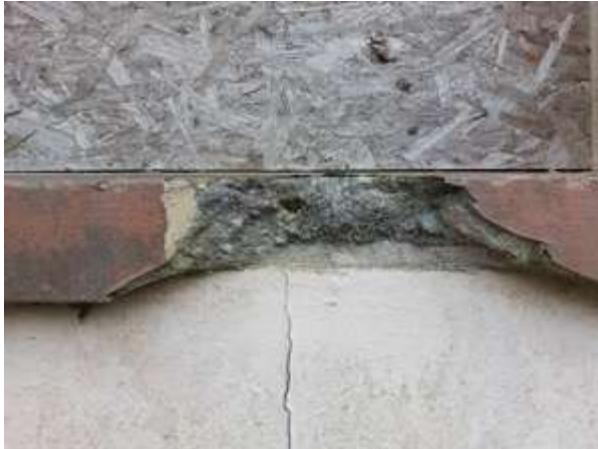
Fig.37: Damaged concrete windowsill

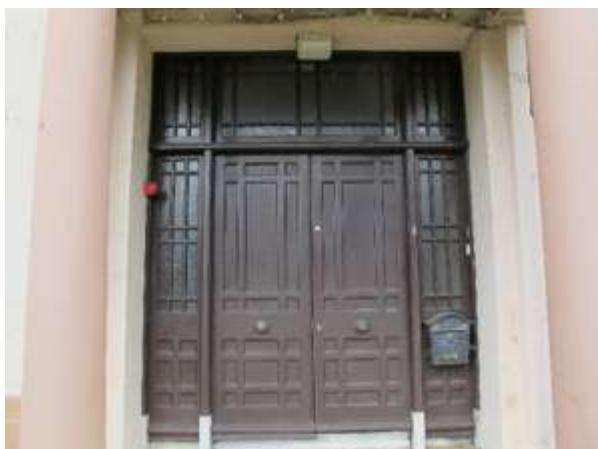
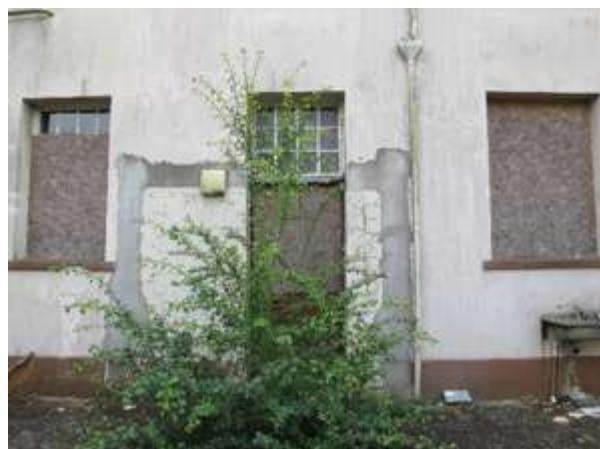
Fig.38: Principal entrance door to south elevation

Fig.39: Central door to north elevation obscured by vegetation

<ul style="list-style-type: none"> Main entrance doors secure and in working condition. Some modern elements added. Timber of doors appears sound. No visible damage to glazed panes. Plywood affixed to 4 no. doors.
Probable causes	<ul style="list-style-type: none"> Ageing materials, use, and lack of maintenance. Modern interventions. Water ingress.
Probable Consequences	<ul style="list-style-type: none"> Water ingress and consequent decay of historic fabric. Timber warping.
Assessment	<p>Plywood must be removed to allow proper assessment of 4 no. doors. The doors to west and north elevations are locked/ have plywood affixed thus their functioning could not be assessed.</p> <p>The front door functions well, appears secure, and has not severely warped.</p>

Mitigation Measures	Removal of plywood and refurbishment of doors will improve the historical character and functionality of the building.

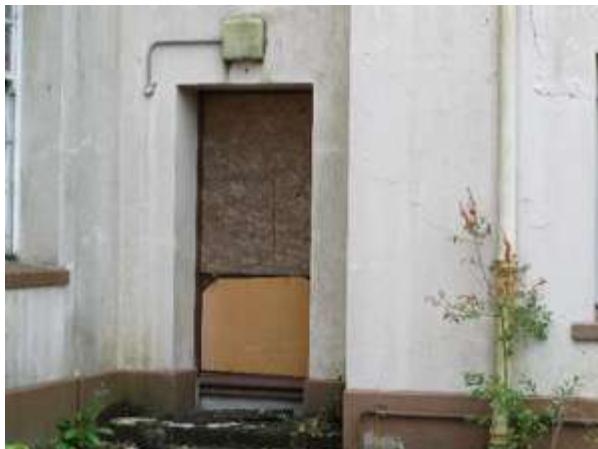
Fig.40: Plywood affixed to door to northwest return

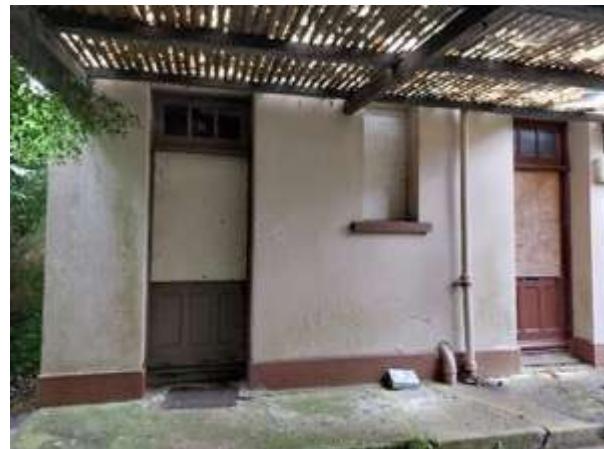
Fig.41: West elevation doors

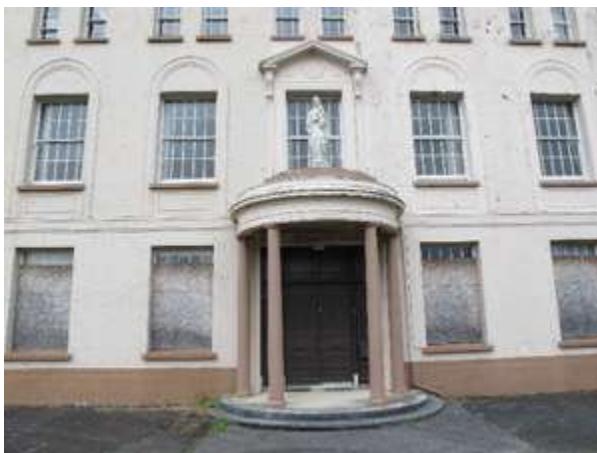
Fig.42: Entrance porch.

<ul style="list-style-type: none"> • Signs of water ingress and cracking to entablature and ceiling. • Cracking and crumbling to lintel/entablature over door, area currently secured with a mesh. • Biological growth. • Overpainting. Cracked, flaking, and peeling paint. • Impermeable paint trapping water. Large blister to paint on column. • Cracking and plant growth to the terrazzo.
Probable causes	<ul style="list-style-type: none"> • Water ingress. • Ageing, wear, and inadequate maintenance. • Use of inappropriate materials such as impermeable paint to columns.
Probable Consequences	<ul style="list-style-type: none"> • Possible structural damage to lintels. • Further loss of historic fabric. • Continued water ingress and consequent decay of historic fabric. • Continued plant life causing further cracking.

Assessment	<p>Access for close inspection of the roof was not possible. External survey was from ground level only with no high access.</p> <p>The roof of the porch is showing clear signs of water ingress and damage. Following removal of the paint further inspection and investigative works to be carried out to determine the extent of damage and repairs required.</p> <p>Investigation and structural assessment of the roof, entablature, lintel, and columns is recommended particularly given the extensive water ingress to the external walls and clear signs of decay.</p> <p>Removal of biological growth and any redundant modern services and fixings.</p> <p>Roof finish, flashings, and rainwater management system to be inspected and refurbished to direct water away from the historic fabric. Additional rainwater capacity may be required to cope with increased deluge events.</p>

<p>Repair and refurbish to match existing in coordination with the proposed external render strategy. Any new finishes to be compatible with the historic fabric and avoid trapping water.</p> <p>Repair cracks to historic fabric including columns and terrazzo to match existing.</p>
Mitigation Measures	<p>Proposed refurbishment works to be carried out in accordance with conservation best practice and by suitably experienced operatives.</p> <p>Works to be planned in coordination with the proposed external render strategy.</p> <p>Any new finishes to be compatible with the historic fabric, to avoid trapping water, and to assist in the movement of water away from the historic fabric.</p>

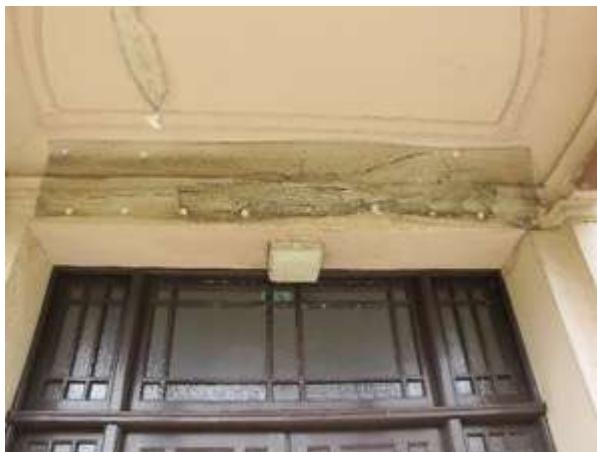
Fig.44: Damage to ceiling currently secured with mesh

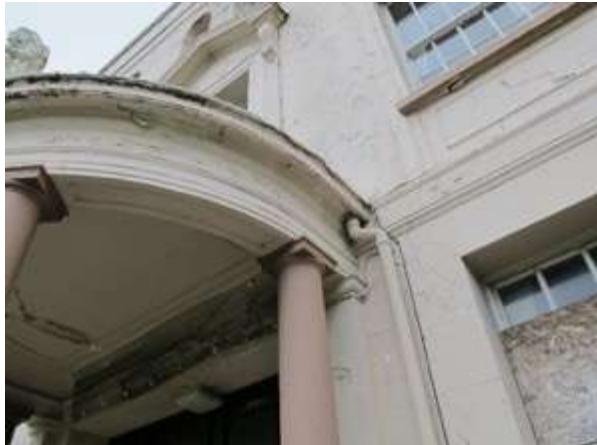
Fig.46: Biological growth to the entablature

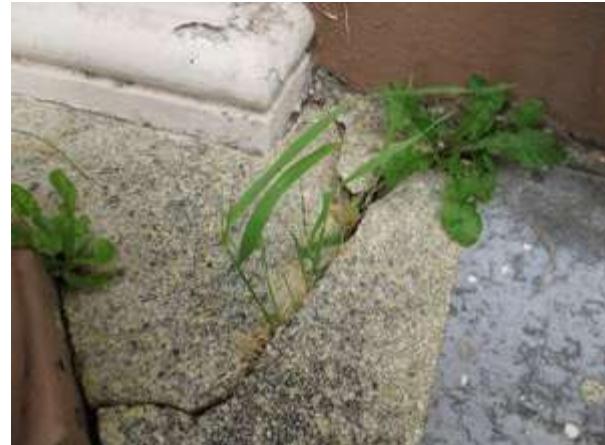
Fig.47: Plant growth in cracked terrazzo

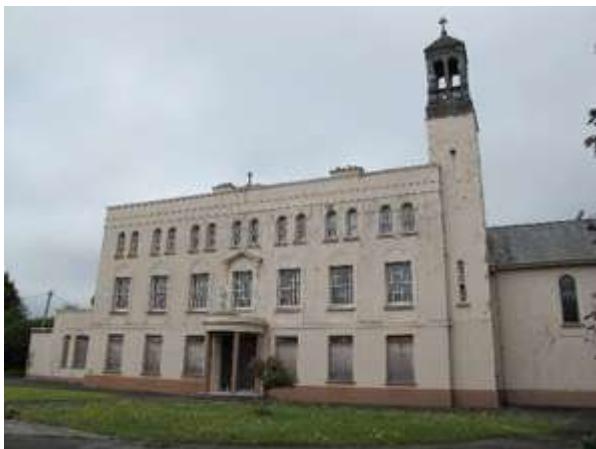
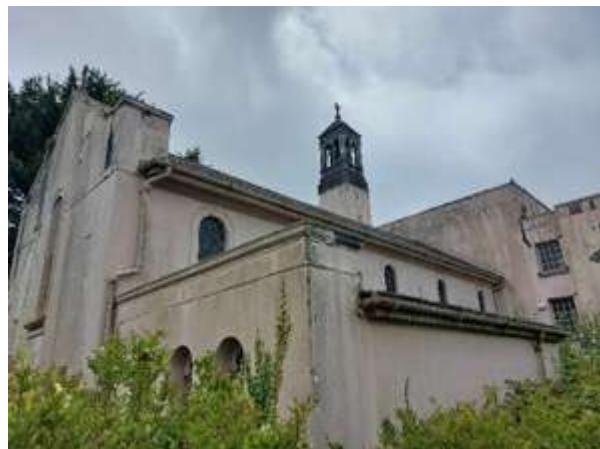
Fig.48: South elevation of bell tower

Fig.49: View of bell tower from north-east

Final stage: <ul style="list-style-type: none">Water ingress and leaching of joints with marked areas of damp staining, white deposits and, in places, suspended stalactites.Open joints.Staining.Biological growth.Incomplete rainwater goods. Rendered tower: <ul style="list-style-type: none">Cracking to cement render.Cracking, peeling, and flaking of paint.Incomplete rainwater goods.
Probable causes	<ul style="list-style-type: none">Weathering of exposed elements.Ageing, wear, and inadequate maintenance.Cement render is non-porous and rigid, trapping water and cracking.

Probable Consequences	<ul style="list-style-type: none">Water ingress and consequent decay of fabric.Loss of historic fabric.
Assessment	Survey was from ground level only with no high access. Close inspection of the final stage was not possible. The decoratively-detailed final stage in masonry is showing marked signs of water infiltration. This area is highly exposed to weathering. While the structure is not yet showing overt signs of instability such as deformation or displacement of elements, there are significant signs of water ingress and leaching of joints. It is recommended that close inspection and structural assessment be carried out to determine the extent of damage and repairs required.

<p>It is recommended that the opportunity be taken to carry out conservation repairs and refurbishment to the final stage during the proposed works. This area is not easily accessible and is in need of maintenance to avert further deterioration. Repoint open joints. Consider removal of leached deposits and light cleaning. Inspect skyward surfaces and develop additional weathering strategy where required.</p> <p>Repair and refurbish rendered tower to match existing in coordination with the proposed external render strategy. Any new finishes to be compatible with the historic fabric and avoid trapping water.</p> <p>Rainwater management system to be inspected and refurbished to direct water away from the historic fabric. Missing elements to be replaced to match existing. Additional rainwater capacity may be required to cope with increased deluge events.</p>
Mitigation Measures	<p>Proposed refurbishment works to be carried out in accordance with conservation best practice and by suitably experienced operatives. Cleaning and weathering strategy to be developed.</p> <p>Works to be planned in coordination with the proposed external render strategy.</p> <p>Any new finishes to be compatible with the historic fabric, to avoid trapping water, and to assist in the movement of water away from the historic fabric.</p>

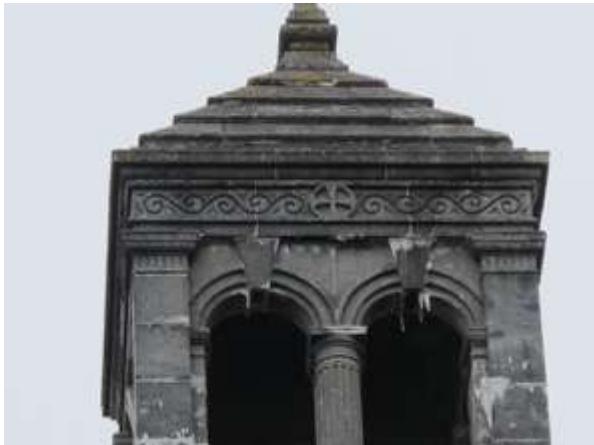
Fig.50: Detail of carved limestone detailing and roof

<ul style="list-style-type: none"> Open joints visible. Cracks visible in masonry blocks. Leaching of joints and white deposits to masonry. Biological growth. Formation of stalactites under masonry blocks. Copper lightning conductor staining stone.
Probable causes	<ul style="list-style-type: none"> Exposure to weathering. Ageing, wear, and inadequate maintenance. Inaccessibility of roofing structure.
Probable Consequences	<ul style="list-style-type: none"> Water ingress and consequent damage to fabric. Loss of historic fabric.
Assessment	<p>Survey was from ground level only with no high access. Close inspection of the final stage was not possible.</p> <p>The masonry has been exposed to weathering and It is recommended that the opportunity be taken to carry out conservation repairs and refurbishment to avert further deterioration.</p> <p>Rake and repoint open joints. Repair cracks to masonry.</p>

Mitigation Measures	Repointing of joints with lime based mortar will improve the longevity of the masonry structure. Conservation repairs will help ensure the structure maintains its historic character.

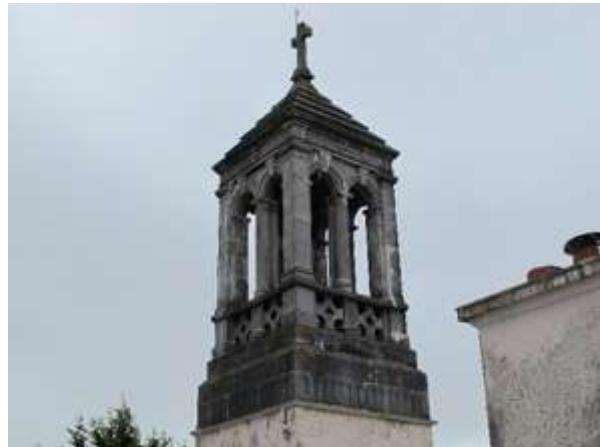
Fig.51: North-west elevation

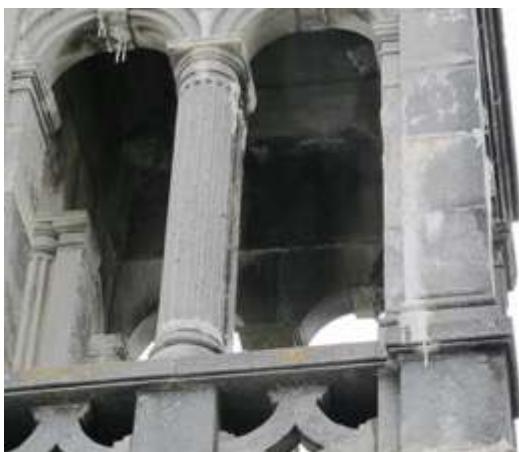
Fig.52: Damp staining, leaching, deposits and stalactite formations to final stage

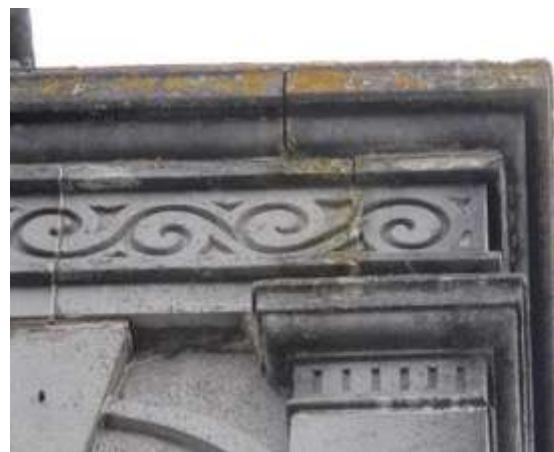
Fig.53: Open joints and cracking to final stage

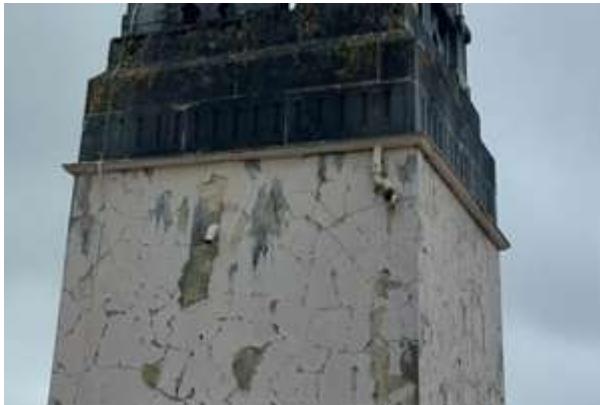
Fig.56: Gutter to bell tower, note missing downpipe

Description	Cast iron rainwater goods, painted to match walls. Gutters, down pipes, and simple brackets.
Condition Class: Moderately strong symptoms	<ul style="list-style-type: none"> Visible rusting of cast iron. Missing portions eg. down pipe from base of ashlar masonry upper stage. Plant life blocking drainage.
Probable causes	<ul style="list-style-type: none"> Ageing, wear, and inadequate maintenance.
Probable Consequences	<ul style="list-style-type: none"> Water ingress and consequent decay of fabrics. Blocked drainage can cause water ingress.
Assessment	Debris build up to roof gutters cannot be assessed due to lack of access.

The rainwater goods require clearing of debris and plant life to ensure effective drainage. Rainwater goods to be refurbished complete. Areas of damage should be inspected, repaired or replaced as necessary with acceptable like-for-like rainwater goods. Additional rainwater capacity may be required to cope with increased deluge events.
Mitigation Measures	The clearing and repair of rainwater goods will allow these to function properly thus improving the longevity of the building.

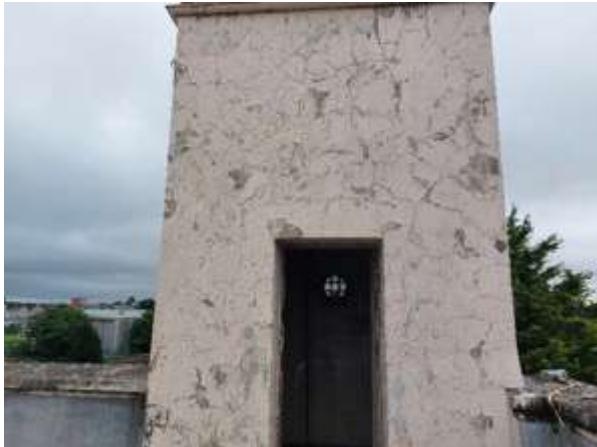
Fig.58: West elevation of third floor

Description	Red brick with painted cement render.
Condition Class: Major symptoms	<ul style="list-style-type: none"> Visible cracking of cement render. Cracking, peeling, and flaking of paint. Some algal growth.
Probable causes	<ul style="list-style-type: none"> Cement render is non-porous and rigid, trapping water and cracking. Ageing, wear, and inadequate maintenance.
Probable Consequences	<ul style="list-style-type: none"> Water ingress and consequent decay to exterior and interior fabric.
Assessment	The cracking of the render will require immediate attention to prevent further water ingress and damage. A comprehensive strategy is required to address the failed render in order to safeguard the building fabric and to allow the future use of the building. The removal and appropriate replacement of the cement render may be required to achieve this. To address the underlying causes of the failure of the render, a more flexible, vapour-permeable render mix and finish should be considered.

Mitigation Measures	The strategy for the render to be developed in collaboration with appropriately qualified specialists to ensure material compatibility as well as maintenance of character.
----------------------------	---

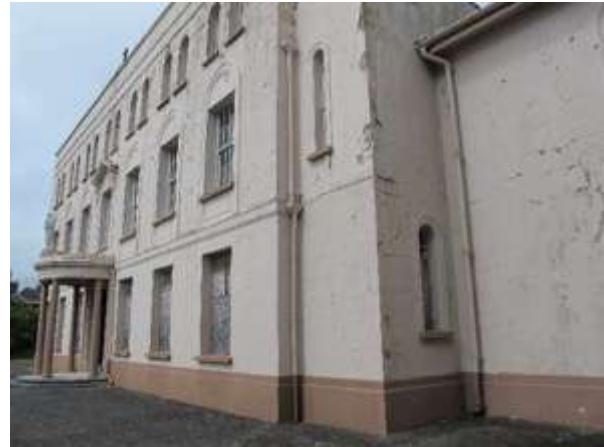
Fig.59: South and east elevation of ground and first floor

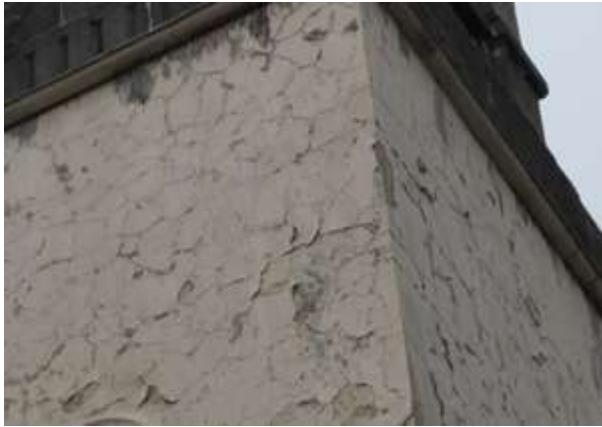
Fig.60: Detail of south-east top floor elevation

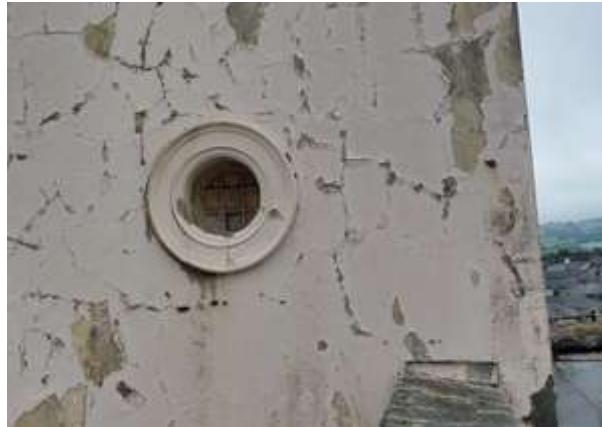
Fig.61: North elevation

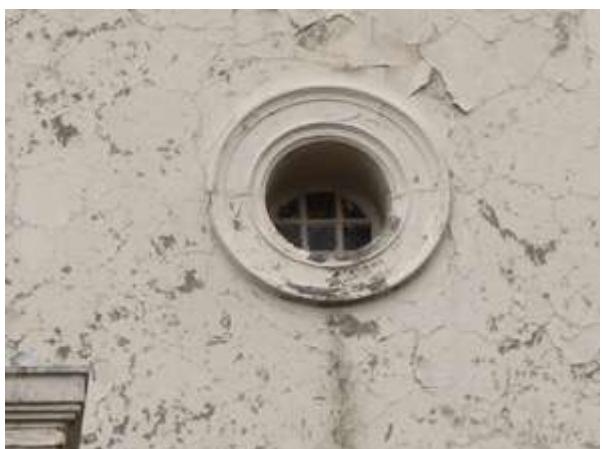
Fig.62: Example of third floor window

Description	6 no. windows to the bell tower. 3 no. multi-pane round-headed timber casement windows with moulded render surrounds and concrete windowsills. 3 no. round windows to third floor with moulded render surrounds.
Condition Class: Minor symptoms	<ul style="list-style-type: none"> Windows are in situ but generally not fully operational. Plywood affixed to ground floor window. Visible glass appears intact. Cracking and flaking to moulded render surrounds.
Probable causes	<ul style="list-style-type: none"> Ageing, wear, and inadequate maintenance.

<ul style="list-style-type: none">Cement render is non-porous and rigid, trapping water and cracking.
Probable Consequences	<ul style="list-style-type: none">Water ingress and consequent decay of timber window fabric.
Assessment	<p>External survey was from ground level only with no high access. Removal of plywood affixed to ground floor window would allow a thorough assessment of timber frame.</p> <p>Windows to be repaired and refurbished to working order throughout. Any areas of decay or damage to timber window frames and glazing bars should be repaired by a suitably qualified contractor.</p> <p>A comprehensive strategy to address the issues to the external envelope in general is required as continued lack of maintenance, repair, and refurbishment will cause deterioration to the windows.</p>
Mitigation Measures	Conservation works to the windows would improve the performance of the bell tower and stay in keeping with the historic character. Window refurbishment should be carried out by suitably experienced operatives to maintain the historic character of the building and ensure its effective ongoing use.

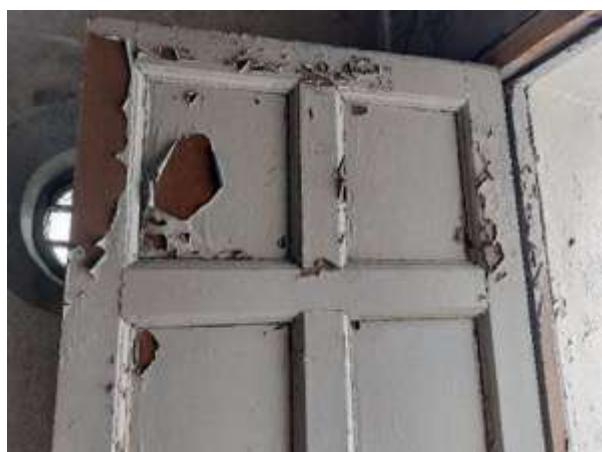
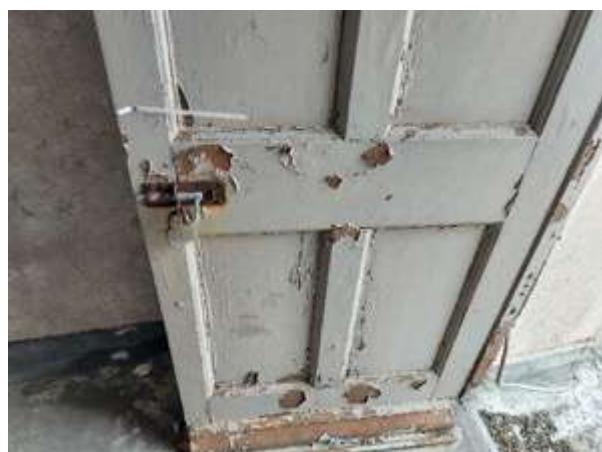
Fig.65: Third floor exterior door of bell tower

Fig.66: Third floor exterior door of bell tower

Description	1 no. external door on the third floor of bell tower. Painted timber six-panelled door and frame with metal bolt.
Condition Class: Major symptoms	<ul style="list-style-type: none"> Peeling, cracking, and flaking of paint. Visible rust to the bolt. Door is not secured.

Probable causes	<ul style="list-style-type: none"> Exposure to weather conditions. Ageing, wear, and inadequate maintenance.
Probable Consequences	<ul style="list-style-type: none"> Warping of timber. Water ingress and consequent decay of fabrics. Bird or bat ingress.
Assessment	The door requires refurbishment.
Mitigation Measures	Any repairs or replacement should be like-for-like. Improving the functionality of the door will better secure the bell tower.

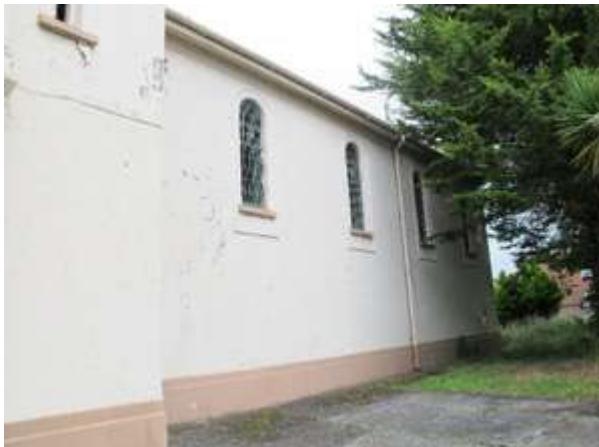
Fig.67: South elevation of chapel

<ul style="list-style-type: none"> Visible cracking to cement render. Impermeable paint bulging, peeling, cracking, and flaking. Biological growth and plant life to elevations and roofs. Plywood affixed to ground floor windows.
Probable causes	<ul style="list-style-type: none"> Cement render is non-porous and rigid, trapping water and cracking. Ageing, wear, and inadequate maintenance. Overgrowth of surrounding vegetation.
Probable Consequences	<ul style="list-style-type: none"> Damage to interior and exterior structures. Mould growth leading to degradation in interior air quality.
Assessment	<p>Access to rear (north) was not possible due to overgrown vegetation.</p> <p>Area around structure requires maintenance from a health and safety perspective, such as removal of overgrown vegetation and cleaning of algae covered surfaces.</p> <p>Consider widespread plan for removal and appropriate replacement of cement render.</p>

Mitigation Measures	Maintenance of vegetation on property will improve surrounds and prevent damage to historic fabrics, improving its historic character.

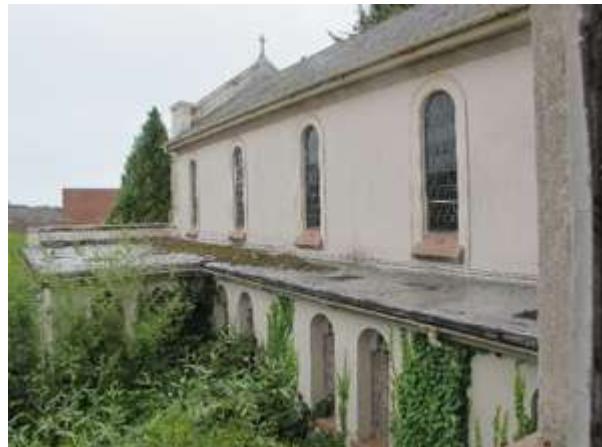
Fig.68: North elevation of chapel

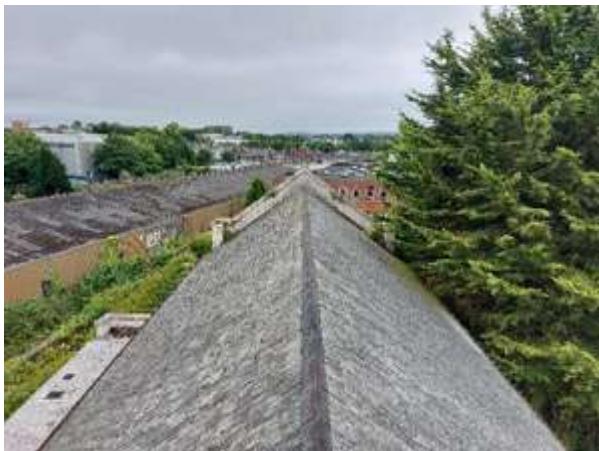
Fig.71: Roof of chapel looking east

Description	Chapel: pitched natural slate roof. Terracotta ridge tiles. Parapet at east gable with concrete coping having cross to apex. Sacristy annex: flat roof. Partial parapet at east with concrete coping.
Condition Class: Moderately strong symptoms	Chapel: <ul style="list-style-type: none">• Biological growth on and between slates, to gutters and to cracks to coping.• Cracking to slates, loose slate.• Replacement slates inappropriately fixed. Sacristy annex: <ul style="list-style-type: none">• Ponding and biological growth to flat roof.• Cracking to concrete coping to flat roof.
Probable causes	<ul style="list-style-type: none">• Poor drainage and/ or blocked rainwater goods.• Age and inappropriate repairs.• Note also large tree at southwest overhanging pitched roof.
Probable Consequences	<ul style="list-style-type: none">• Water ingress and consequent decay of interior and exterior fabrics.• Water ponding.• Water ingress to fabric underlying slates.

Assessment	Internal roofing structures were not accessible. Biological growth and plant life should be removed. Repairs with appropriate mortar to concrete coping. Damaged, cracked, and loose slates should be replaced with slate to match existing appropriately fixed.
Mitigation Measures	Repairs to roofing fabric will help reduce any water ingress thus improving the longevity of historic fabric and maintaining character.

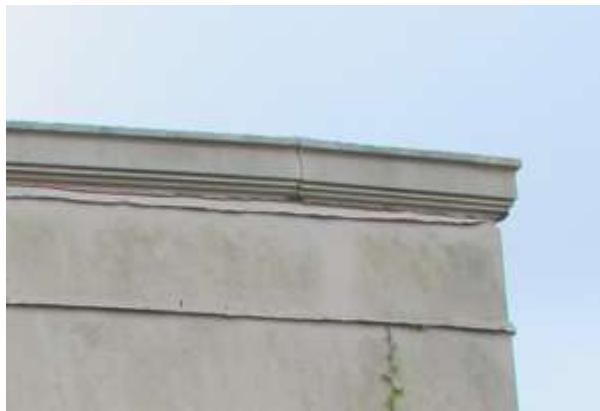
Fig.73: Cracking of concrete coping on sacristy annex

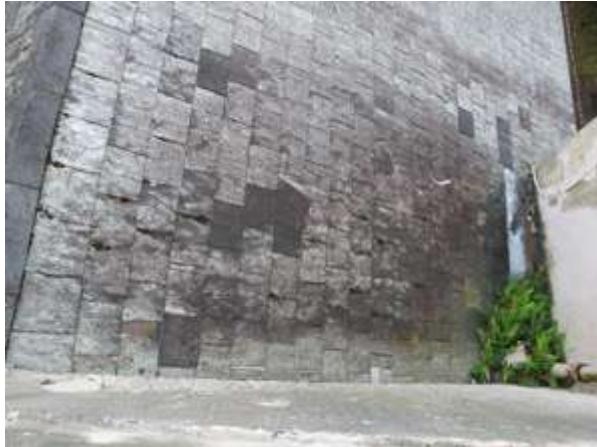
Description	Cast iron rainwater goods painted to match walls. Gutters, down pipes, and simple brackets.
Condition Class: Moderately strong symptoms	<ul style="list-style-type: none"> Rusting of cast iron. Debris and plant life creating blockages. Visible algae growth.
Probable causes	<ul style="list-style-type: none"> Age and lack of maintenance.
Probable Consequences	<ul style="list-style-type: none"> Poor drainage and water ingress. Rusted brackets may come away from walls.
Assessment	Rainwater goods should be cleared of plant life and debris. Repair/ replace damaged sections.

Fig.77: Plant life blocking drainage

Mitigation Measures	The clearing and repair of rainwater goods will improve their functionality and historic character.
----------------------------	---

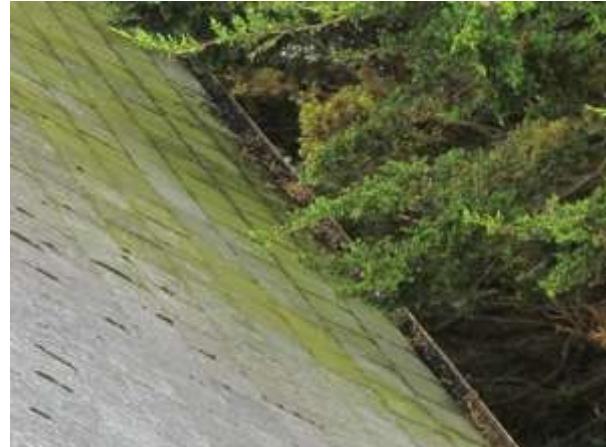
Fig.78: Debris in south elevation gutter

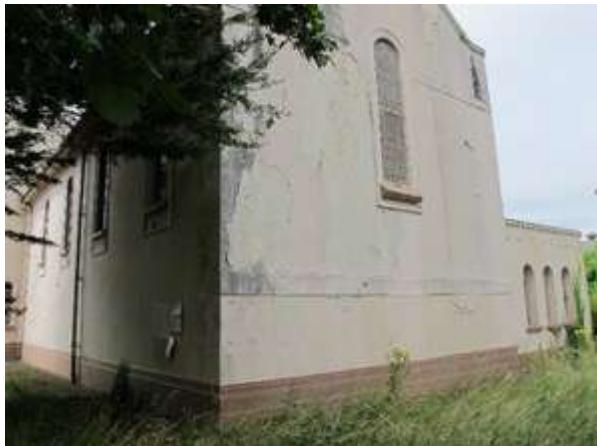
Fig.79: South and east elevation

Description	Red brick walls with painted cement render. Plain moulded band on east gable elevation.
Condition Class: Major symptoms	<ul style="list-style-type: none"> Cracking to cement render. Cracking, peeling, and flaking paint. Algae, ivy, and bramble growth to walls at north.
Probable causes	<ul style="list-style-type: none"> Cement render is non-porous and rigid, trapping water and cracking. Age and lack of maintenance. Overgrowth of surrounding vegetation.

<ul style="list-style-type: none">Poor water drainage roof.
Probable Consequences	<ul style="list-style-type: none">Water ingress and consequent decay of historic fabric.Continued deterioration of condition and structure.Build up of mould growth to interior.
Assessment	<p>Access to rear (north) was not possible due to overgrown vegetation.</p> <p>The cracking of the render will require immediate attention to prevent further water ingress and damage. Widescale plan required for removal and appropriate replacement of cement render, and repair and refurbishment to roofing fabrics and structure to address water ingress.</p> <p>Maintenance works to remove surrounding vegetation.</p>
Mitigation Measures	Widescale plan for repairs/ replacement of render to be approved by appropriate conservation specialist to ensure breathability and correct historical character.

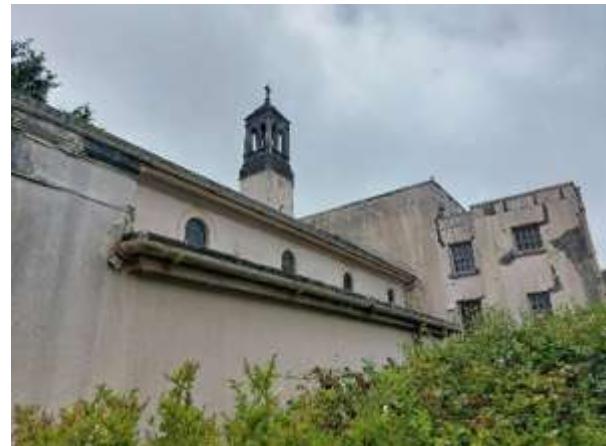
Fig.80: North elevation

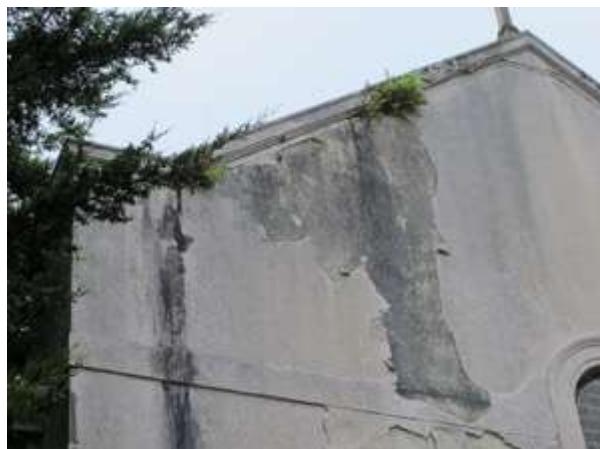
Fig.81: Algae growth on east elevation

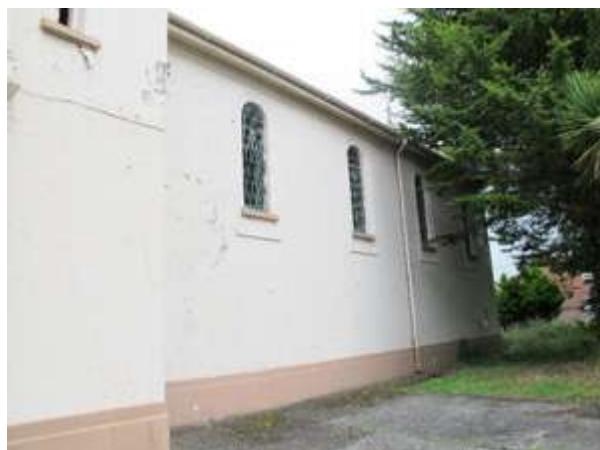
Fig.83: Stained glass windows on south elevation

Description	Chapel: 10 no. round-headed stained glass windows with moulded render surrounds and concrete windowsills. Sacristy annex: 11 no. round-headed timber multi-pane sliding sash windows. Plywood affixed to exterior.
Condition Class: Minor symptoms	<ul style="list-style-type: none"> Stained glass windows appear to be in good condition. Inspection was from ground level only with no high access. Wire-guard over large stained glass window on east elevation. Cracking, peeling, and flaking to windowsills and moulded surrounds. Vegetation overgrowth into ground floor windows.
Probable causes	<ul style="list-style-type: none"> Age, use, and lack of maintenance Water ingress. Overgrowth of vegetation in surrounds.
Probable Consequences	<ul style="list-style-type: none"> Water ingress and consequent decay of fabrics. Vegetation may damage window fabrics and structures.
Assessment	<p>Ground floor windows have plywood affixed preventing thorough assessment of bottom rail for signs of decay. Stained glass windows appear to have remained in good condition.</p> <p>It should be ensured that the wire-guard is of appropriate material (eg., stainless steel) to prevent rusting and consequent damage.</p> <p>Maintenance work required to surrounding vegetation to prevent continued overgrowth onto building.</p>

Mitigation Measures	<p>Any works to stained glass windows to be carried out following best practices for historic stained glass.</p> <p>Maintenance of vegetation on property will improve surrounds and prevent damage to historic fabrics, improving its historic character.</p>
