CHRIST THE KING PRESENTATION CONVENT, EVERGREEN ROAD, CORK CITY, CO. CORK

Architectural Heritage Impact Assessment

September 2025

Ref: 024021

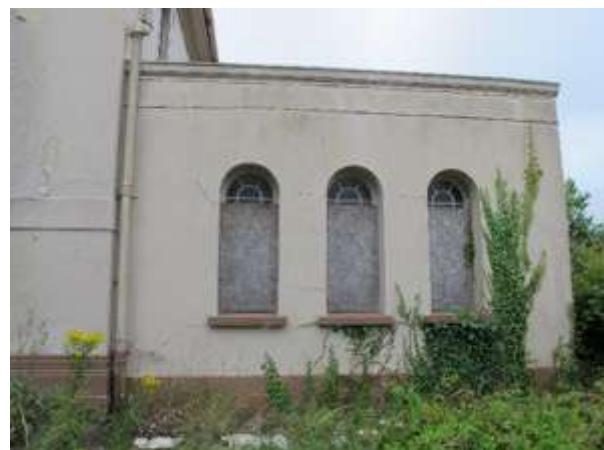
Fig.84: Windows on east elevation of sacristy annex

Description	Chapel: 10 no. round-headed stained glass windows with moulded render surrounds and concrete windowsills. Sacristy annex: 11 no. round-headed timber multi-pane sliding sash windows. Plywood affixed to exterior.
Condition Class: Minor symptoms	<ul style="list-style-type: none"> Stained glass windows appear to be in good condition. Inspection was from ground level only with no high access. Wire-guard over large stained glass window on east elevation. Cracking, peeling, and flaking to windowsills and moulded surrounds. Vegetation overgrowth into ground floor windows.
Probable causes	<ul style="list-style-type: none"> Age, use, and lack of maintenance Water ingress. Overgrowth of vegetation in surrounds.
Probable Consequences	<ul style="list-style-type: none"> Water ingress and consequent decay of fabrics. Vegetation may damage window fabrics and structures.
Assessment	<p>Ground floor windows have plywood affixed preventing thorough assessment of bottom rail for signs of decay. Stained glass windows appear to have remained in good condition.</p> <p>It should be ensured that the wire-guard is of appropriate material (eg., stainless steel) to prevent rusting and consequent damage.</p> <p>Maintenance work required to surrounding vegetation to prevent continued overgrowth onto building.</p>

Mitigation Measures	<p>Any works to stained glass windows to be carried out following best practices for historic stained glass.</p> <p>Maintenance of vegetation on property will improve surrounds and prevent damage to historic fabrics, improving its historic character.</p>

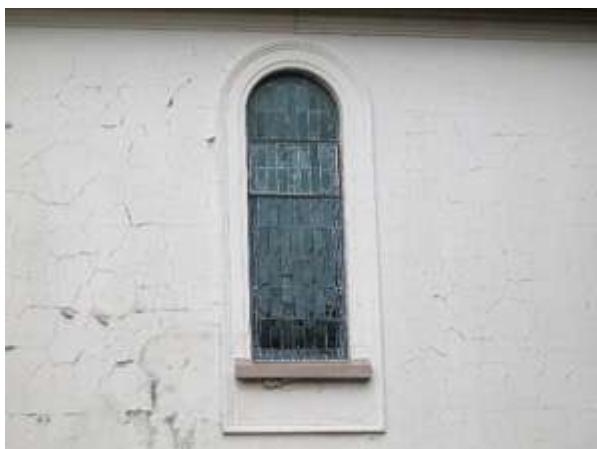
Fig.85: Example of stained glass window

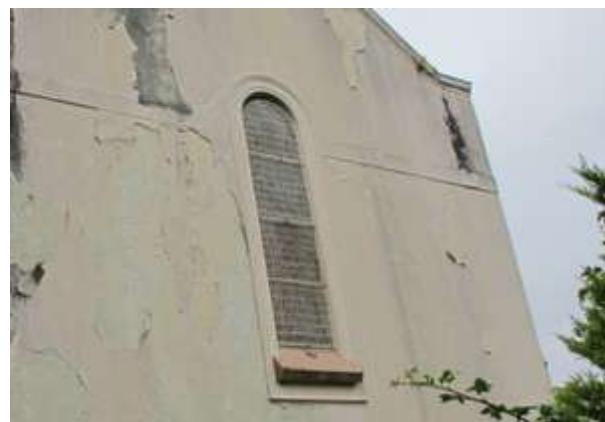
Fig.86: Wire-guard over large stained glass window

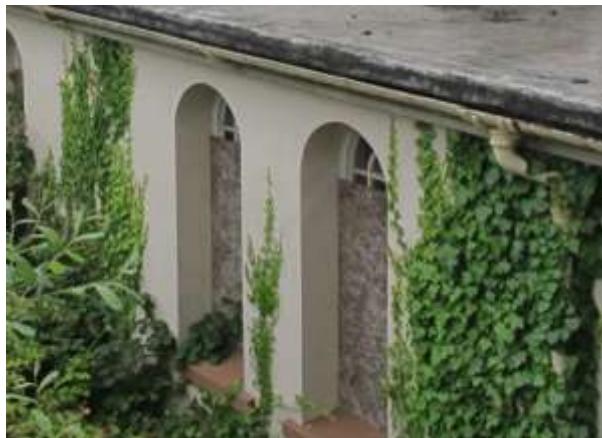
Fig.87: Overgrowth to ground floor windows

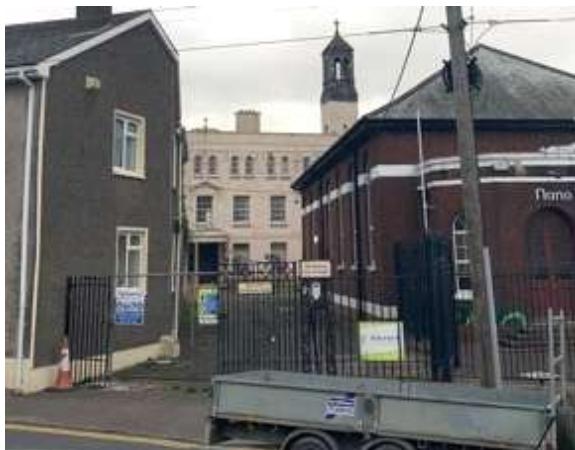
Fig.88: Evergreen Road entrance

<ul style="list-style-type: none"> Gate partially dismantled. Western leaf of vehicular gate and decoratively-detailed fixed panel and associated plinth between vehicular gate and pedestrian gate removed. Fixed panel has been cut off at ground level. Associated portion of plinth wall not yet identified. Removed elements stored outside west annex. Temporary fencing in place at entrance. Visible rust and corrosion to iron. Some lost finials to fence.
Probable causes	<ul style="list-style-type: none"> Exposure to weather conditions. Age, disuse, and lack of maintenance. Removal of sections of railings and gates.

Probable Consequences	<ul style="list-style-type: none"> Decay and corrosion of iron fabrics.
Assessment	<p>The gates and railings remain partially in-situ. Removed sections appear to be complete except that the removed portion of the plinth has not yet been identified. Removed sections to be securely stored to avoid loss.</p> <p>The gates and railings, while largely intact, show signs of significant corrosion and loss of elements in places. Refurbish, repair, and reinstate gates and railings. It is recommended that all elements of the gates and railings be carefully recorded, taken down, and removed to a workshop for repair and then reinstated upon completion of the proposed works.</p>
Mitigation Measures	Refurbishing the gates and railings and reinstating the removed sections would positively contribute to the streetscape of the Architectural Conservation Area.

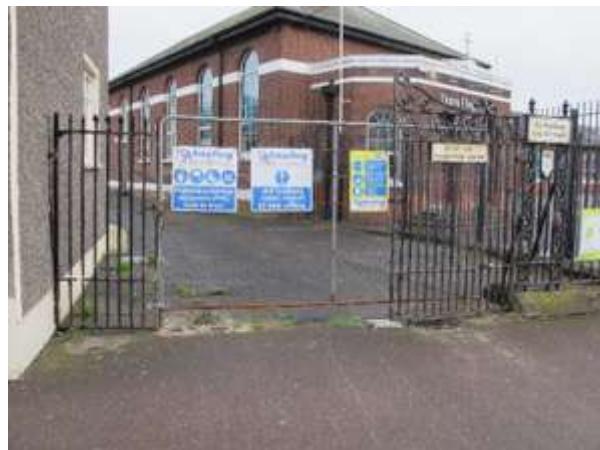
Fig.89: Railings and gates at Evergreen Road entrance

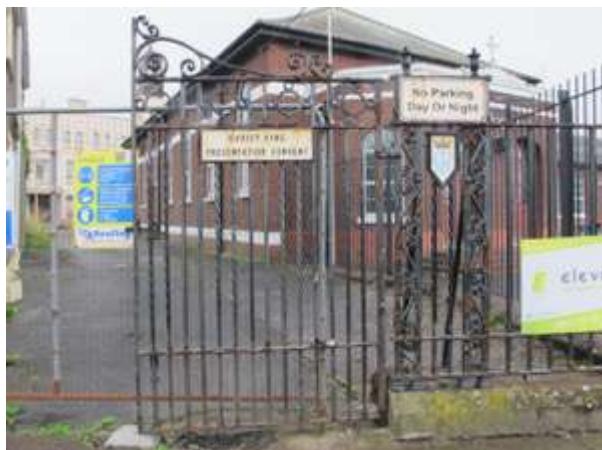
Fig.90: Detail showing gate leaf

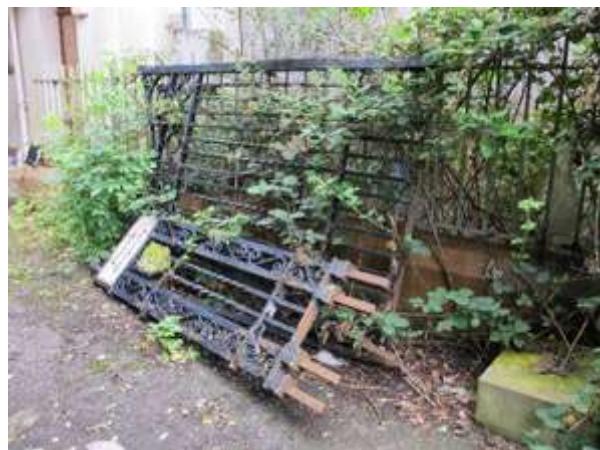
Fig.91: Dismantled railings and gates by west annex

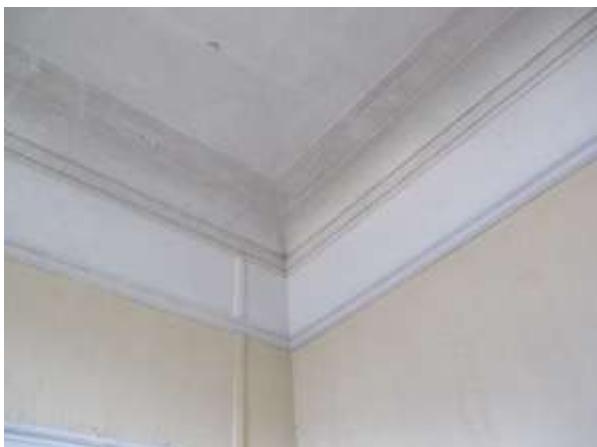
Fig.92: Simple moulded cornice (EXG-16)

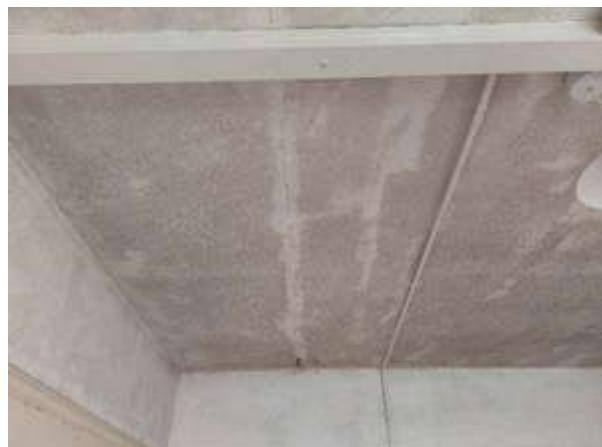
Fig.93: Mould growth and cracking to ceiling (EX2-07)

<ul style="list-style-type: none"> Visible sagging to ceiling eg. second floor corridor (room EX2-01). Cracking to plaster. Damp staining. Mould build up and efflorescence. Cracking, peeling, and flaking paint.
Probable causes	<ul style="list-style-type: none"> Water ingress from external envelope. Water ponding on roof. Damp atmosphere of interior. Age and lack of maintenance. Evidence of leak / leaking water tank in ceiling over second floor east staircase.
Probable Consequences	<ul style="list-style-type: none"> Water ingress and the consequent decay and damage of fabric. Possible structural damage to ceilings. Loss of historic fabric.

Assessment	<p>Ceilings, particularly to the upper floors, are showing significant signs of water ingress with consequent damage, decay, and mould growth. The risk of insect infestation, toxic mould build up, structural damage and fabric degradation is considerable. There are possible structural implications from the long-term water ingress and lack of adequate drainage which may be causing structural damage to the historic fabric. Further investigation and structural assessment of ceilings recommended to identify extent of remedial works required.</p> <p>Sources of water ingress (roof, exterior render, etc) to be investigated and resolved.</p> <p>Areas affected by damp, mould, efflorescence, and water ingress will require repair to plaster and paint.</p>
Mitigation Measures	Repairs to be carried out in compatible materials. Where decorative detailing exists this should be retained and repaired where necessary to match the existing.

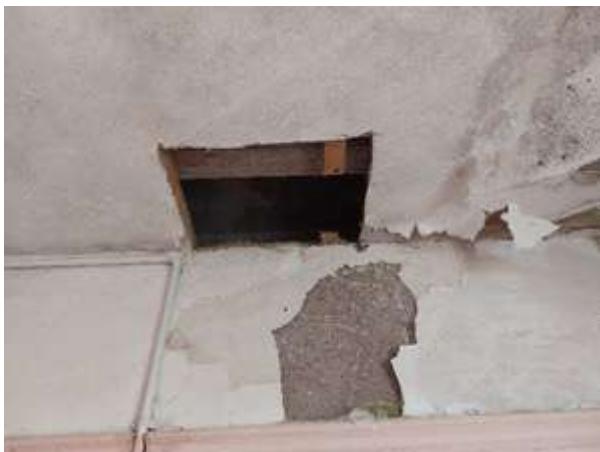
Fig.98: Example of opening up works to ceiling (EX2-06)

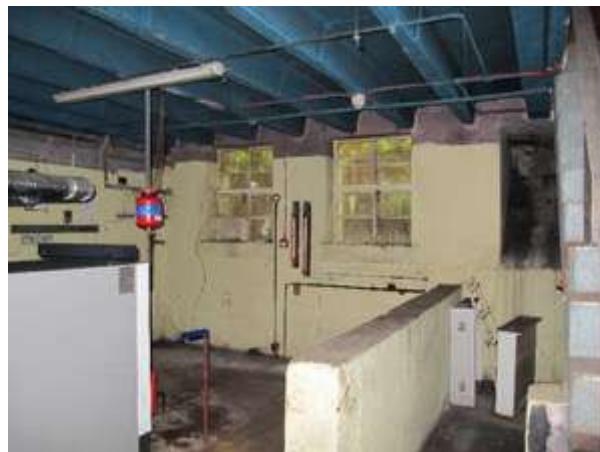
Description	Plain plaster ceilings throughout, painted white. There is a simple moulded cornice to the entrance hall (room EXG-01) and to the rooms to the east of the entrance hall (rooms EXG-15 & EXG-16) on the ground floor. The ceiling to the basement to the west annex has exposed concrete beam construction.
Condition Class: Major symptoms

Fig.99: Basement ceiling at west annex

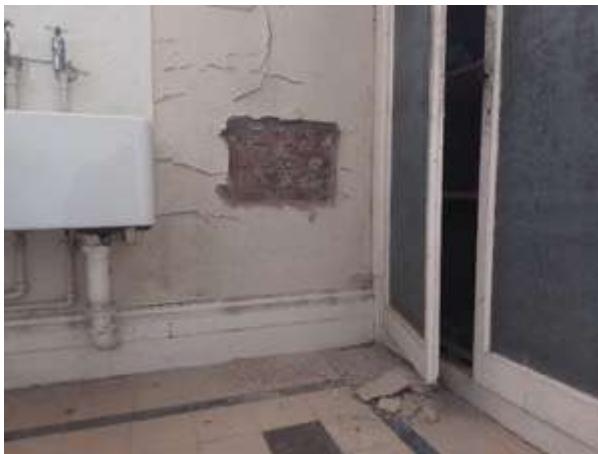
Fig.100: Example of interior wall opening up works showing red brick (EXG-08)

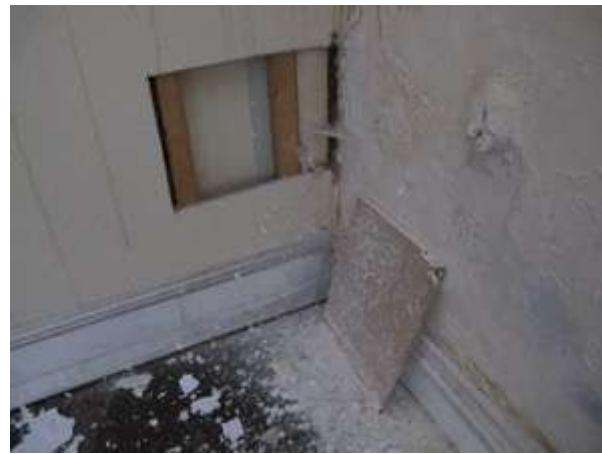
Fig.101: Plasterboard wall in EXG-16

Description	<p>General: Red brick walls with a smooth plaster painted in variety of colours.</p> <p>Ground Floor: Red brick walls with smooth plaster. Plaster board partition wall in between EXG-16 and EXG-15 with historic timber panelling behind, requires further investigation (see Figure 99).</p> <p>First Floor: Red brick walls with smooth plaster render.</p> <p>Second Floor: Red brick walls with smooth plaster render. Partition wall to create bathroom (EX2-11 and EX2-10)</p>
Condition Class: Major symptoms	<ul style="list-style-type: none"> Visible cracking. Efflorescence. Biological growth, mould, fungus. Bubbling, peeling, and flaking paint.
Probable causes	<ul style="list-style-type: none"> Water ingress. Exterior cement render. Damp atmosphere of interior. Age, use, and lack of maintenance.
Probable Consequences	<ul style="list-style-type: none"> Water ingress and consequent damage to fabric and structure. Loss of historic fabric. Degraded air quality from mould build up.

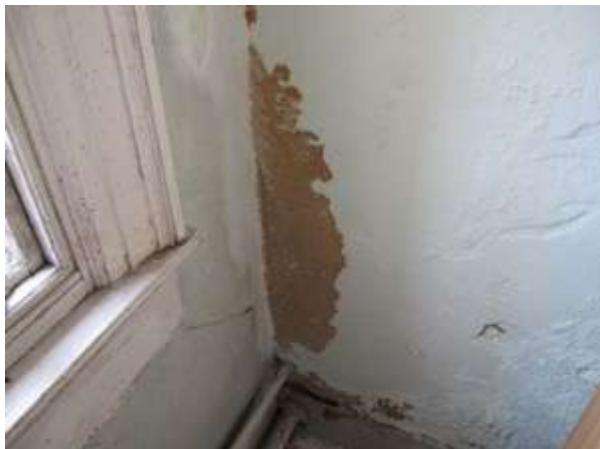
Fig.102: Fungus to second floor wall (EX2-19)

Assessment	<p>Source of water ingress (exterior render and roof) to be investigated and resolved.</p> <p>Following this, walls should be allowed to dry out before required repairs carried out.</p> <p>Fungus, mould, and efflorescence build ups will need to be treated and removed.</p>
Mitigation Measures	Resolving water ingress and repairs to wall will conserve building.

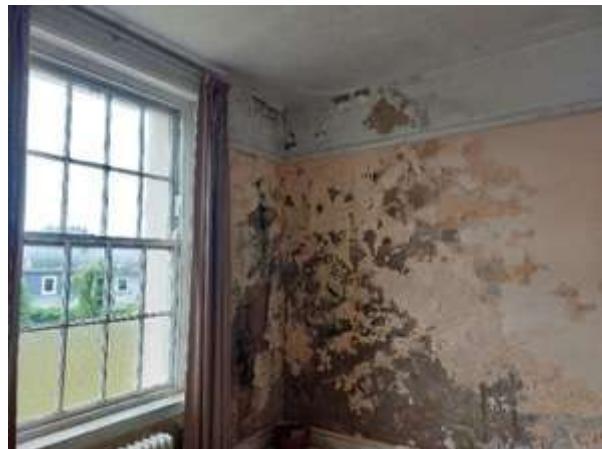
Fig.103: Efflorescence and damp on wall (EX1-23)

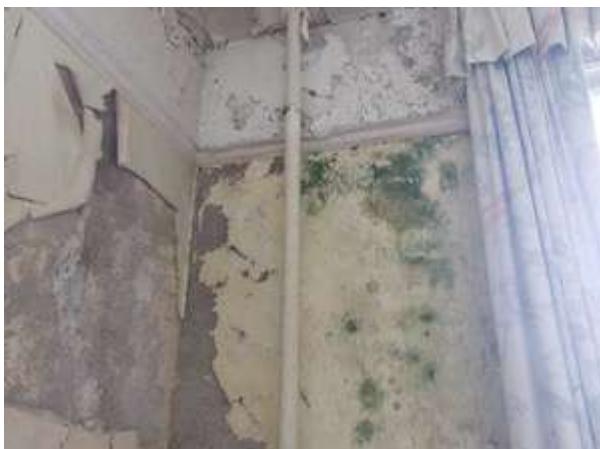
Fig.104: Example of extent of damp to walls (EX1-20)

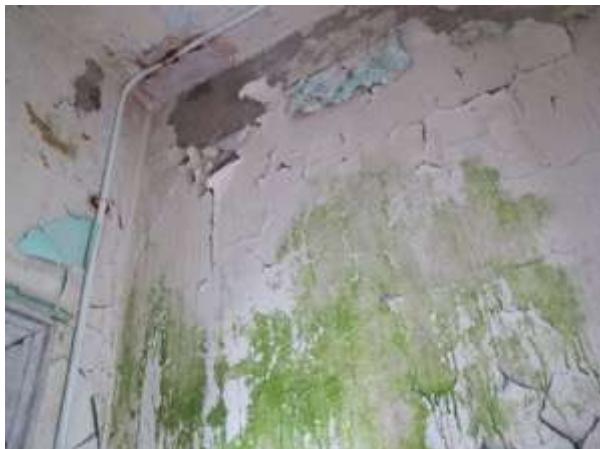
Fig.106: Interior wall of second floor of bell tower (EX2-16) damp staining, algal growth

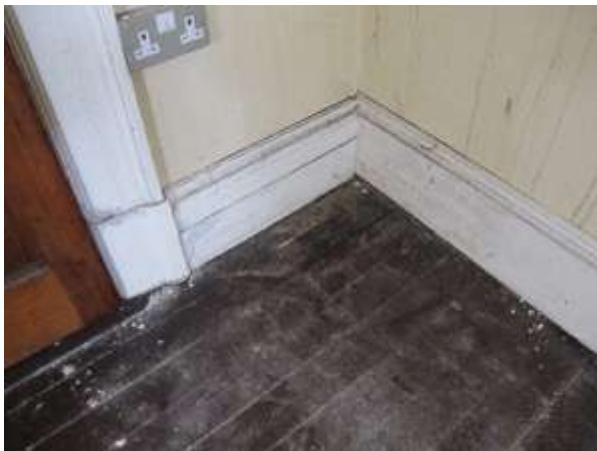
Fig.107: Non-suspended timber flooring ground floor (EXG-16)

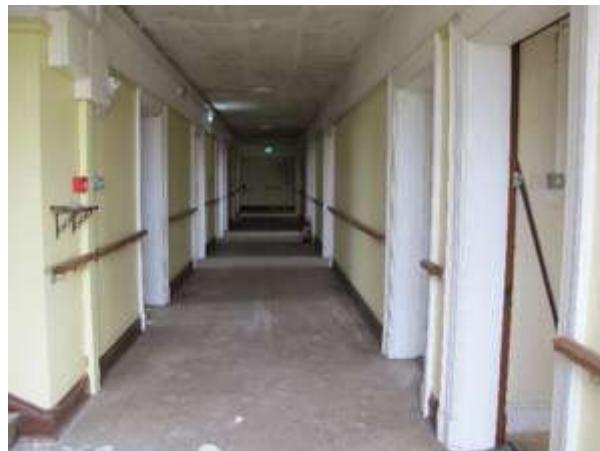
Fig.108: Cork tiles typical of first and second floor corridors

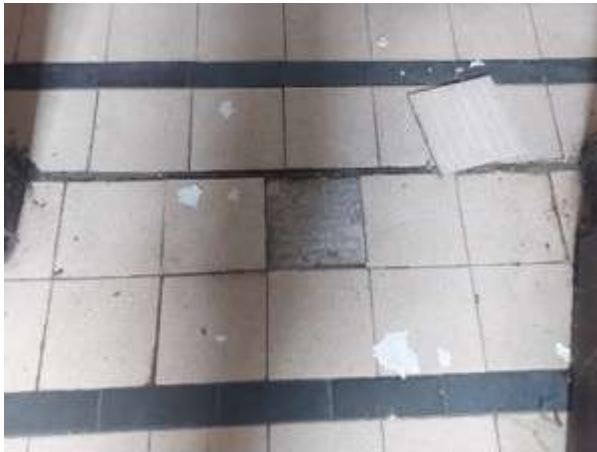
Fig.111: Tiles to kitchen area (EXG-06)

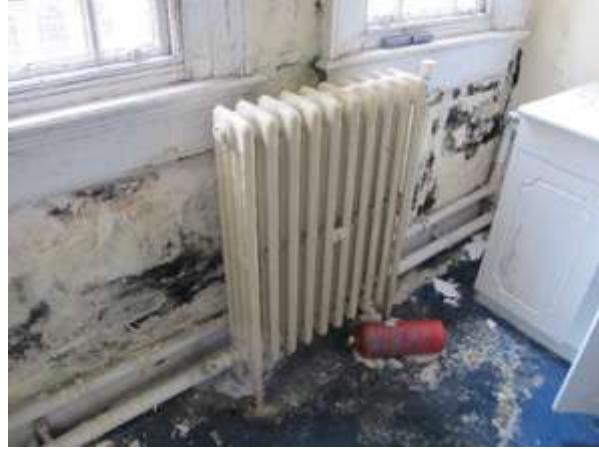
Description	<p>General: Variety of floor finishes throughout including carpet, tiles, laminate, and cork tiles. Ceramic tiles to bathrooms to rear returns.</p> <p>Basement (west annex): Concrete.</p> <p>Ground Floor: Non-suspended timber floors. Cast in-situ terrazzo flooring to entrance hall, ground floor corridor and stair halls. Ceramic tiles to kitchen (rooms EXG-06 - EXG-08) and to bathrooms. Modern floor coverings including carpet and lino overlaid to some rooms. Poured concrete to west annex.</p> <p>First Floor: Timber floor overlaid with carpet, laminate, and cork tiles.</p> <p>Second Floor: Timber floor overlaid with carpet, laminate, and cork tiles.</p>
Condition Class: Major symptoms	<ul style="list-style-type: none"> • Mould build up and efflorescence. • Sodden timber to ground floor in places. • Modern overlays (carpet, lino) worn out and damp. • Broken and cracked tiles.
Probable causes	<ul style="list-style-type: none"> • Water ingress. • Damp atmosphere of interior. • Use, age, and lack of maintenance.

Fig.114: Mould and efflorescence on carpet overlay (EX2-17)

Probable Consequences	<ul style="list-style-type: none"> • Water ingress and consequent decay of fabrics. • Structural damages. • Loss of original fabrics.
Assessment	<p>Sources of water ingress (exterior render and roof) to be investigated and resolved.</p> <p>Remove modern overlays such as carpets to allow inspection of underlying floor and to allow these to breath and/or dry out. Further inspection to assess extent of repairs required.</p>
Mitigation Measures	The terrazzo, timber floorboards and decorative ceramic tiles make a positive contribution to the character of the building and should be retained, repaired, and refurbished where possible.

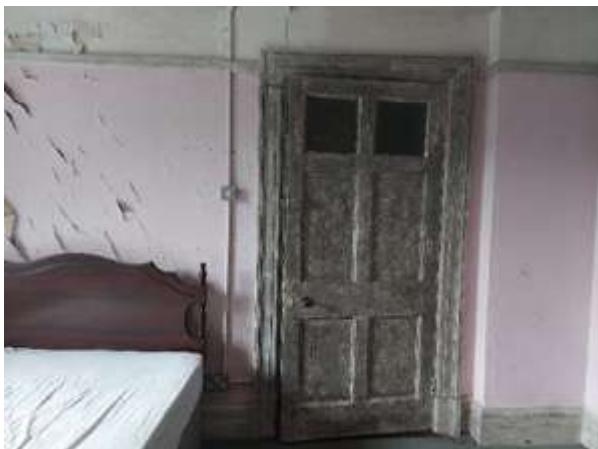
Description	<p>General: timber panelled doors, some painted white. Several doors with glazed multi-pane upper portions. Opaque/textured glazing in some locations.</p> <p>Ground Floor: 31 no. interior timber doors, 28 no. timber six-panelled doors and 3 no. paired doors. Brass and glass doorknobs. 7 no. exterior doors with glazed multi-pane upper portions with plywood affixed to exterior.</p> <p>First Floor: 20 no. timber panelled doors with brass doorknobs. 1 no. pair of timber exterior door leafs with 10 glazed panes at west end of corridor.</p> <p>Second Floor: 20 no. timber six-panelled doors with brass doorknobs.</p> <p>Third Floor: 1 no. door leading onto roof.</p>
Condition Class: Major symptoms	<ul style="list-style-type: none"> • Mould build up. • Warping causing difficulty opening/ closing. • Peeling, cracking, and flaking of paint. • Addition of non-original latches and bolts. • Door to roof is not secure.

Probable causes	<ul style="list-style-type: none"> • Water ingress and consequent decay and warping of fabrics. • Age, disuse, and lack of maintenance.
Probable Consequences	<ul style="list-style-type: none"> • Continued build up of mould. • Decay of timber fabrics. • Structural damage from warping of door frames.
Assessment	<p>The sources of water ingress to be investigated and resolved.</p> <p>Timber doors to be refurbished or repaired with like-for-like as required to manage mould build, decay, and warping.</p>
Mitigation Measures	Refurbishment or replacement with like-for-like timber doors will improve functionality while maintaining historic character.

Fig.121: Mould build up on timber door (EXG-05)

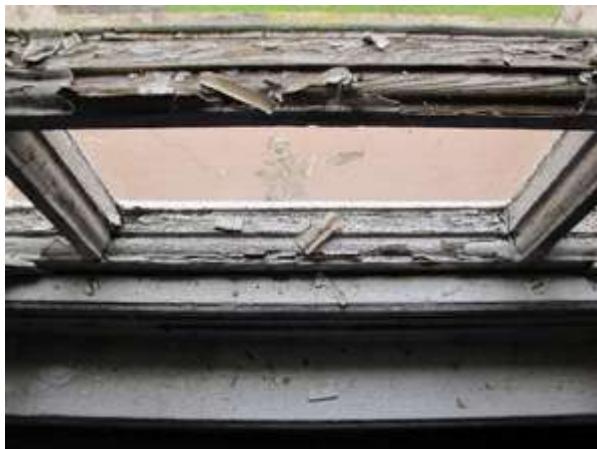
<ul style="list-style-type: none"> Mould build up on timber frames, glazing bars, and surrounds. Cracking, peeling, and flaking of paint. No significant evidence of timber decay. Several glass panes in west annex missing.

Fig.136: Peeling paint to timber glazing bar (EX2-17)

Probable causes	<ul style="list-style-type: none"> Water ingress to exterior walls. Overall damp atmosphere of interior. Age, use, and lack of maintenance.
Probable Consequences	<ul style="list-style-type: none"> Water ingress and consequent damage to timber fabric. Damage to surrounding walls and fabrics from water ingress, damp, and mould.
Assessment	<p>Significant mould and damp identified to timber features of windows in building. However there does not appear to be significant evidence of decay to the windows. Refurbishment of timber windows to working order, any localised areas of repairs or replacement to be like-for-like.</p> <p>The source of water ingress (exterior render and roof) should be investigated and resolved.</p>
Mitigation Measures	Refurbishment of existing windows will maintain the historic character of the building while improving functionality.

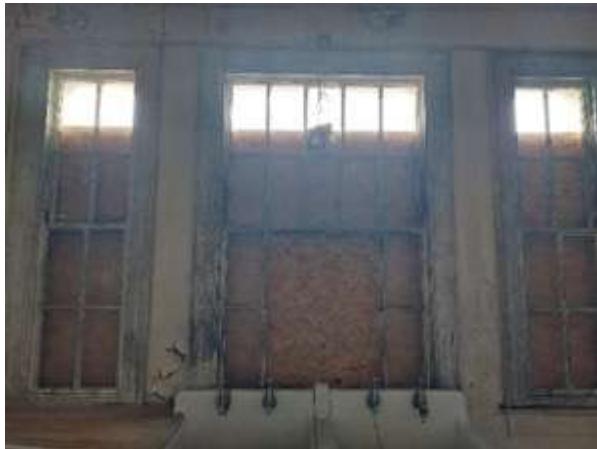
Fig.138: Example of timber sash with missing glazing panes and bars in west annex (EXG-19)

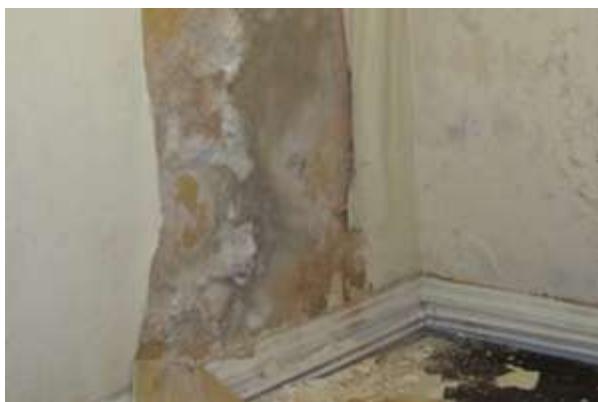
Description	<p>Timber moulded architraves to doors throughout. Painted white or varnished to match doors.</p> <p>Timber moulded window surrounds throughout. Painted white or varnished to match window.</p> <p>Timber picture rails throughout, painted to match walls or portion of wall above.</p> <p>Simple timber skirtings throughout, primarily painted white or varnished to match architrave with occasional skirting painted to match carpets.</p>
Condition Class: 	<ul style="list-style-type: none"> • Mould build up on timber. • Decay to some timber. • Skirting removed or missing in areas. • Damp staining and efflorescence. • Cracking, peeling, and flaking paint. • Portions of picture rails removed or missing in some areas.
Probable causes	<ul style="list-style-type: none"> • Water ingress. • Overall damp atmosphere of interior. • Age, use, and lack of maintenance.
Probable Consequences	<ul style="list-style-type: none"> • Water ingress and consequent damage to timber fabrics. • Loss of fabrics to eventual decay or warping.

Fig.142: Efflorescence damaging timber skirting (EXG-15)

Assessment	<p>The source of water ingress (exterior render and roof) should be investigated and resolved.</p> <p>Severe mould build up is creating a hazardous environment and must be treated. Timber architraves, surrounds, and skirting should be refurbished localised repair or replacement with like-for-like as required to manage mould build, decay, and warping.</p> <p>Damaged or missing sections of picture rails to be repaired and replaced.</p>
Mitigation Measures	<p>Refurbishment of timber features would have a positive impact on the historic character of the building.</p>

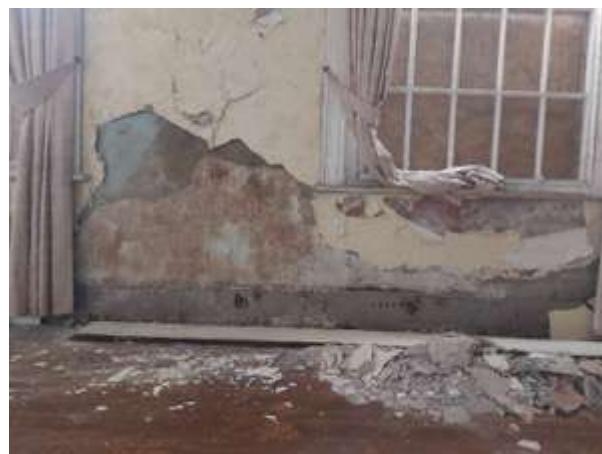
Fig.143: Removed skirting from damp wall (EXG-02)

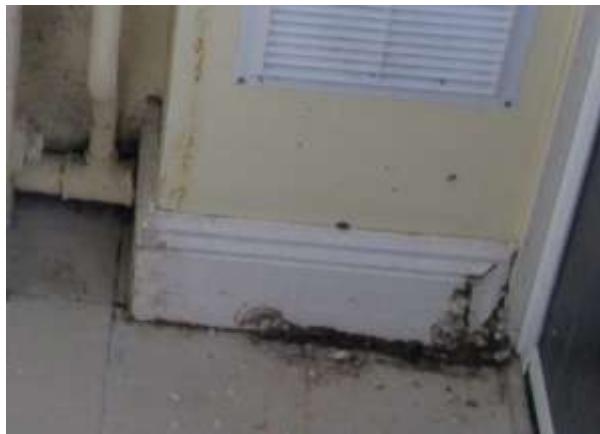
Fig.144: Growth on timber skirting (EX2-10)

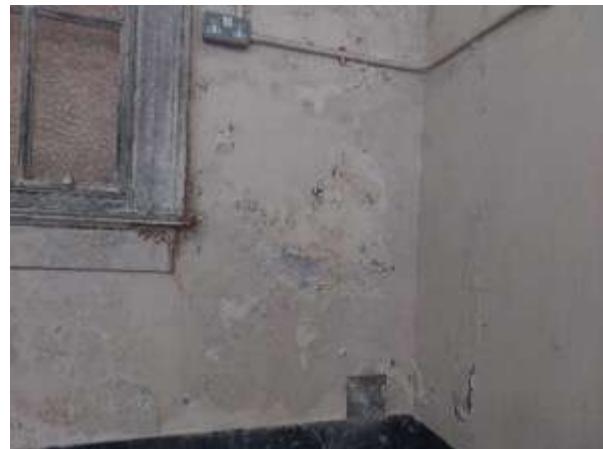
Fig.145: Mould build up to window surround (EXG-19)

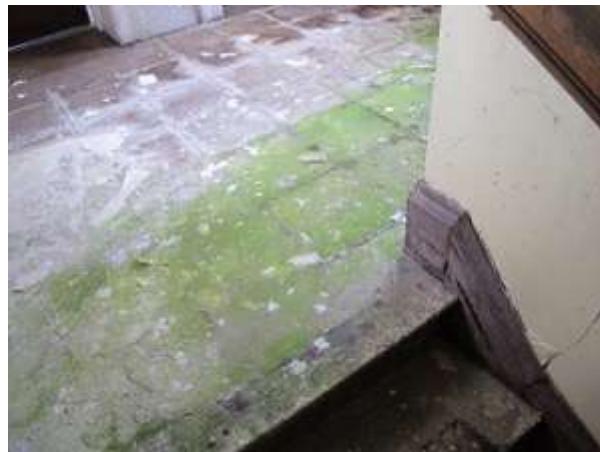
Description	2 no. staircases, one east and one west. Concrete staircases with cork tiles and timber boards to treads, cast concrete balustrade with integral moulded capping painted to resemble wood, and timber handrail and skirting. 1 no. concrete stairs to basement level.
Condition Class: Moderately strong symptoms	<ul style="list-style-type: none"> • Varnish layer breaking down. • Mould build up to cork tiles. • Damage to concrete balustrade. • Segments of cork tiles missing
Probable causes	<ul style="list-style-type: none"> • Age, use, and lack of maintenance. • Water ingress. • Damp atmosphere of interior.
Probable Consequences	<ul style="list-style-type: none"> • Water ingress and consequent damage to fabrics.
Assessment	<p>Sources of water ingress to be investigated and resolved.</p> <p>Repair and refurbish stairs to match existing.</p> <p>Areas of flooring will likely need repair/ replacement.</p>

Fig.153: Mould build up on east staircase to second floor (EX2-12)

Mitigation Measures	The staircases are a significant feature and their refurbishment will make a positive contribution to the character of the building.

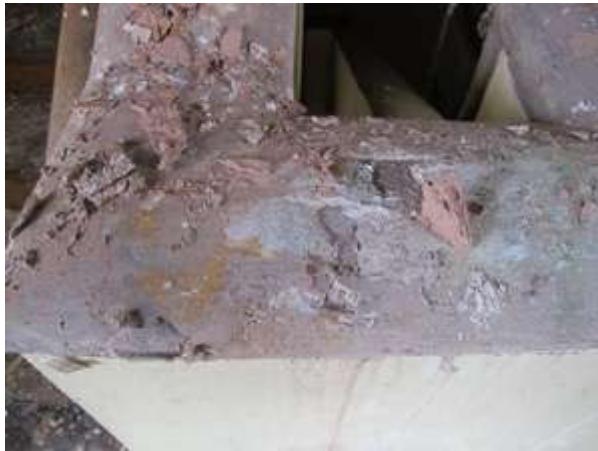
Fig.154: Damage to capping of concrete balustrade of east staircase to second floor (EX2-12)

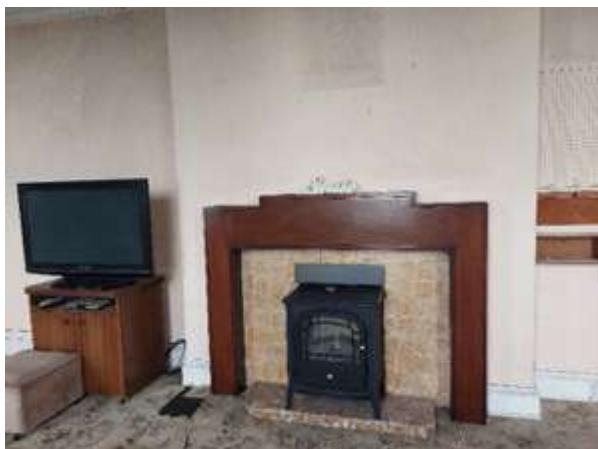
Fig.156: Fireplace in room (EX1-23)

Description	Fireplaces: 4 no. modern tiled fireplaces remain in-situ: 3 no. tiled fireplaces to the first floor. Fireplace in EX1-23 has a modern stove installed. 1 no. tiled fireplace to the second floor.
-------------	---

Pass-through cabinet (room EXG-02 to corridor EXG-03) with opaque glazed window over. Cast iron radiators: throughout the building, primarily painted white.
Condition Class: Minor symptoms	<ul style="list-style-type: none"> • Fireplace openings loosely boarded over. • Wall damage behind some radiators. • Minor rusting and paint cracking to radiators. • Minor mould build up on pass-through cabinet.
Probable causes	<ul style="list-style-type: none"> • Water ingress. • Age, use, and lack of maintenance.
Probable Consequences	<ul style="list-style-type: none"> • Decay and/ or deterioration of fabrics.
Assessment	The functioning of the radiators and fireplaces was not in the scope of this assessment.
Mitigation Measures	Any heritage features proposed for removal to be documented prior to removal/demolition.

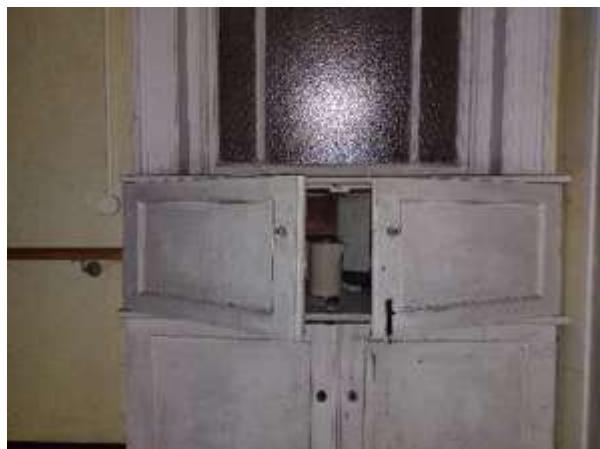
Fig.157: Pass-through cabinet (EXG-02)

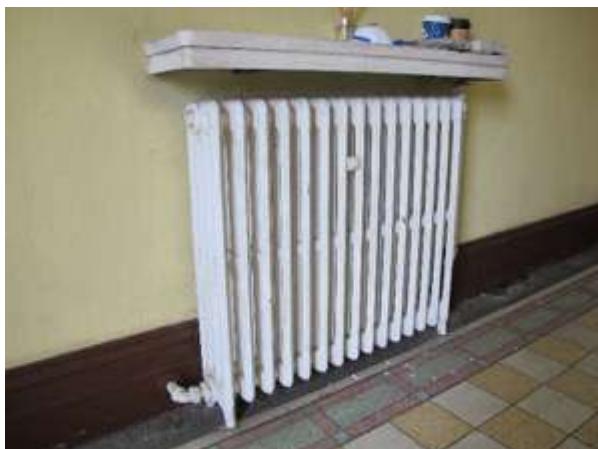
Fig.158: Example of cast iron radiator (EXG-01)

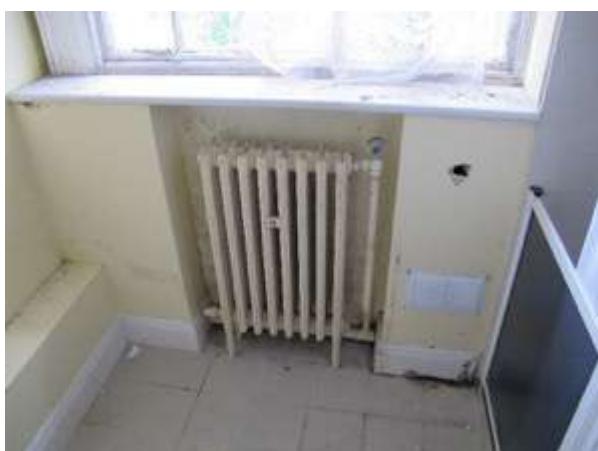
Fig.160: Rusting to radiator (EX2-10)

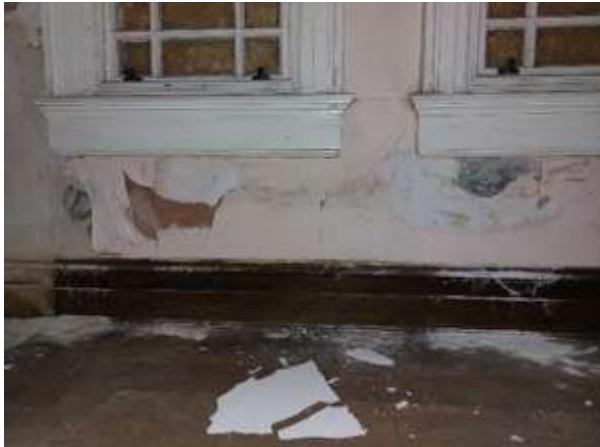
Description	Walls are red brick with smooth plaster with moulded window surrounds and details. Simple painted timber picture rail to sacristy annex.
Condition Class: Major symptoms	<ul style="list-style-type: none">Water ingress, plaster decay, and efflorescence.Bubbling, peeling, and cracking of paint.Mould build up
Probable causes	<ul style="list-style-type: none">Water ingress due to compromised external envelope, open joints, cracked external render.Age, use, and lack of maintenance.
Probable Consequences	<ul style="list-style-type: none">Continued water ingress and consequent decay of historic fabrics.Damage to interior fabrics and structures.

Assessment	The walls of the sacristy annex showed significant surface damage due to water ingress. This was present in the chapel to a slightly lesser extent. The sources of the water ingress should be investigated and resolved.
Mitigation Measures	Resolving water ingress will allow better conservation of walls.

Fig.167: Water ingress and damage to sacristy east wall (EXG-29)

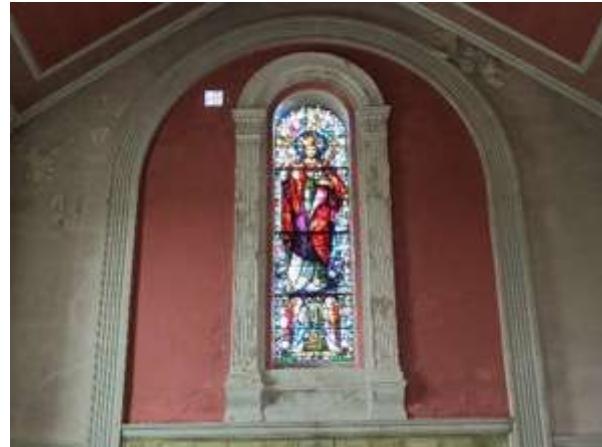
Fig.168: Signs of water ingress to east wall

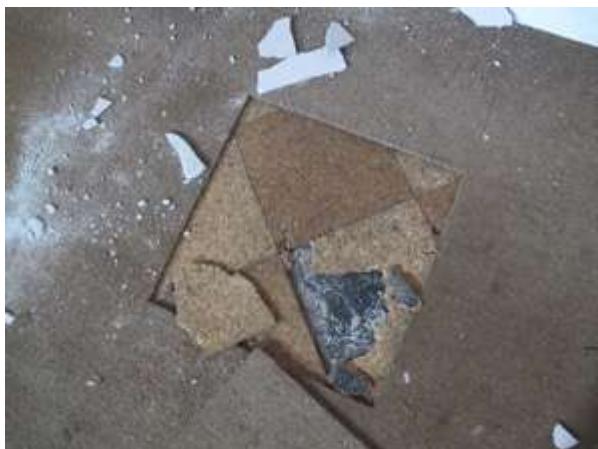
Fig.171: Area with carpet removed in chapel nave

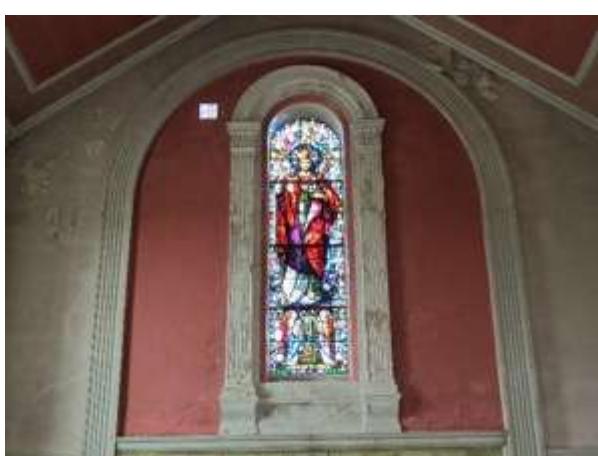
Fig.177: Stained glass window over the altar (EXG-30)

Assessment	Inspection was from ground level and the chapel gallery only. The stained glass windows appear to be in good condition and correctly fitted into window opes. The slight buckling of the window over the altar should be monitored and will likely not require any immediate works. Opening panels and mechanisms require refurbishment to working order.
Mitigation Measures	Monitoring of buckled stained glass windows.

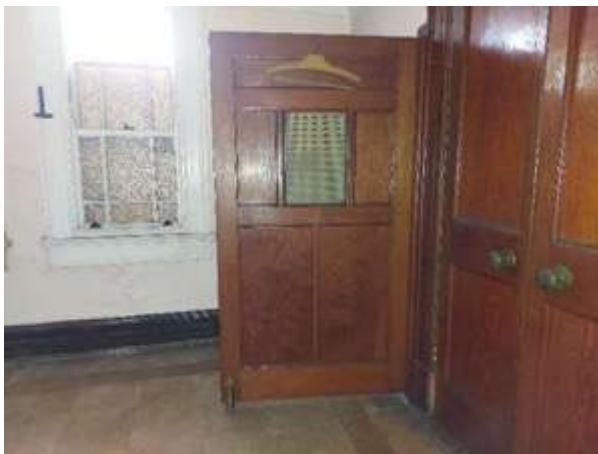
Fig.195: Hinged timber screen wall in sacristy (EXG-29)

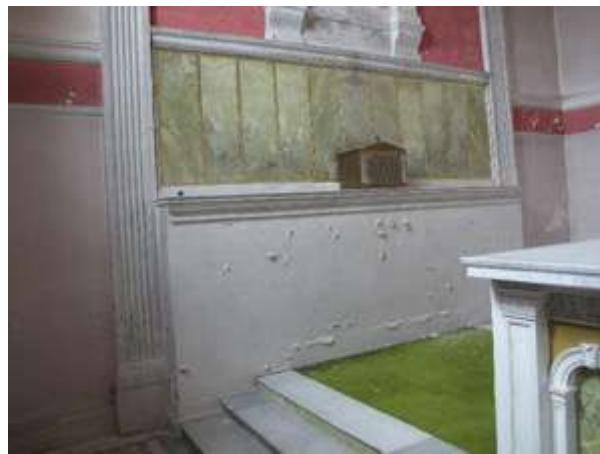
Description	<p>12 no. cast iron radiators painted white, some with decorative timber covers.</p> <p>decoratively-detailed metal gallery railing having timber top rail.</p> <p>Small tabernacle and marble reredos behind altar.</p> <p>Hinged timber screen wall in sacristy.</p>
Condition Class: Minor symptoms	<ul style="list-style-type: none"> Mould build up to timber radiator covers. Some dislodgement of tiles and damage to marble in the reredos.

Fig.196: Marble reredos and tabernacle (east of altar)
